# Fifth Five-Year Review Operable Units A and B-1 Former Adak Naval Complex

## **Naval Air Station Adak**

**Fifth Five-Year Review  
Operable Units A and B-1  
Former Adak Naval Complex  
NAVAL AIR STATION ADAK, ADAK ISLAND, ALASKA**

**December 2021**

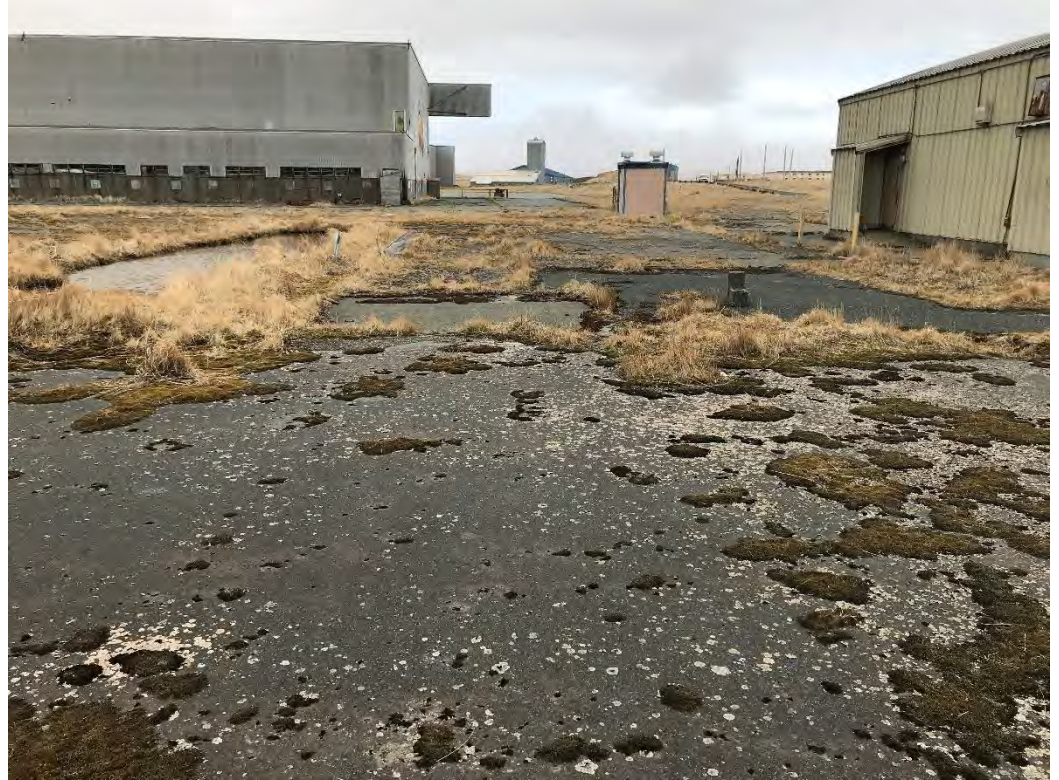
**Description:** Overview of  
Tanker Shed UST, 42494  
site. Photo taken on south  
end of site. Ponding just  
west of the building is  
visible.

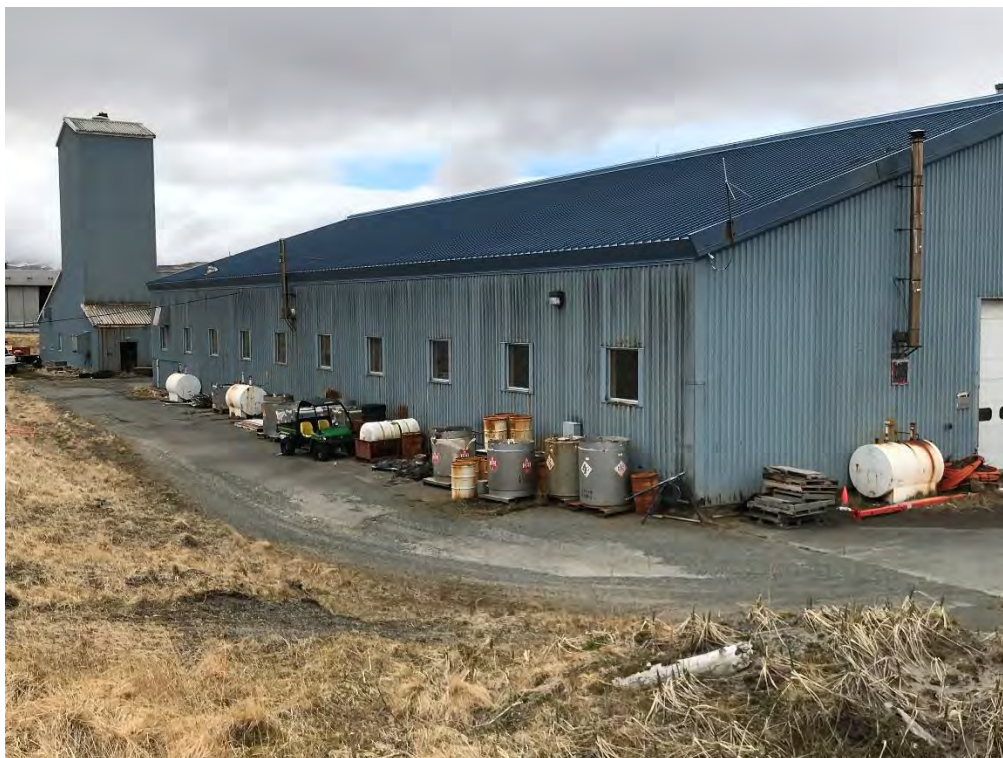
**Description:** Overview of  
SWMU 35, Ground  
Support Equipment  
Building. Photo taken on  
northeast end of site.  
Storage along east side of  
building.

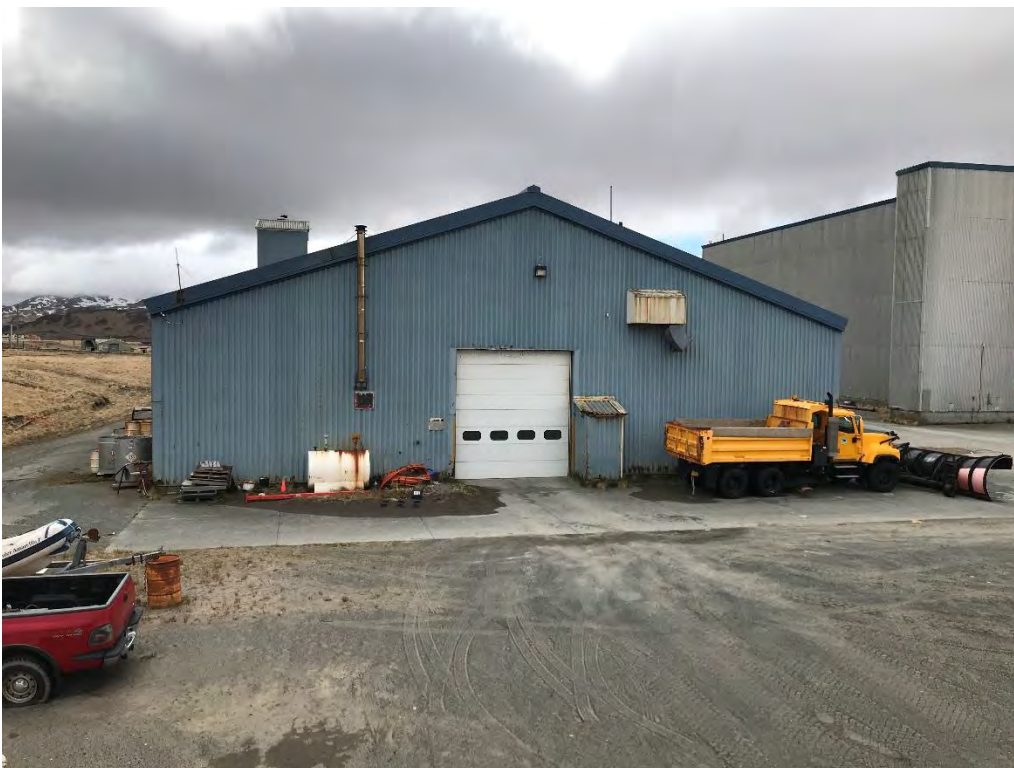
**Description:** Overview of  
SWMU 35, Ground  
Support Equipment  
Building. Photo taken on  
north end of site.

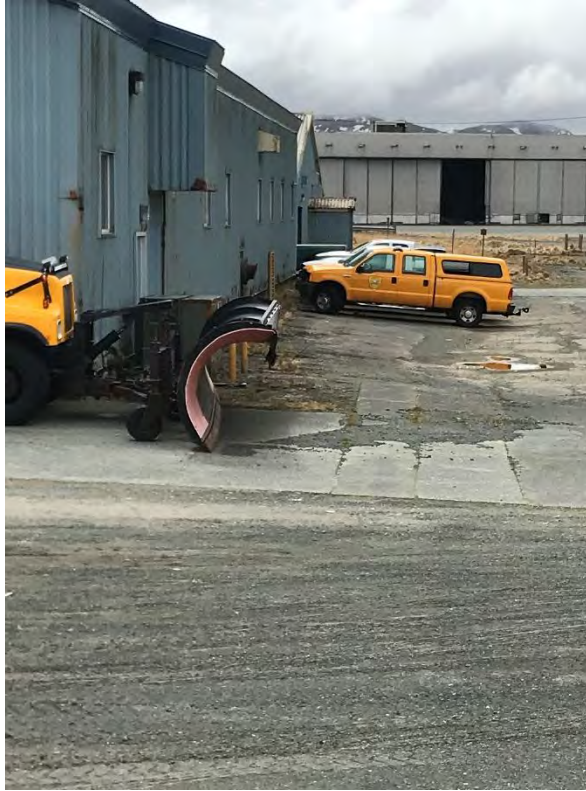
**Description:** West side of  
SWMU 35, Ground  
Support Equipment  
Building. Photo taken on  
north end of site.

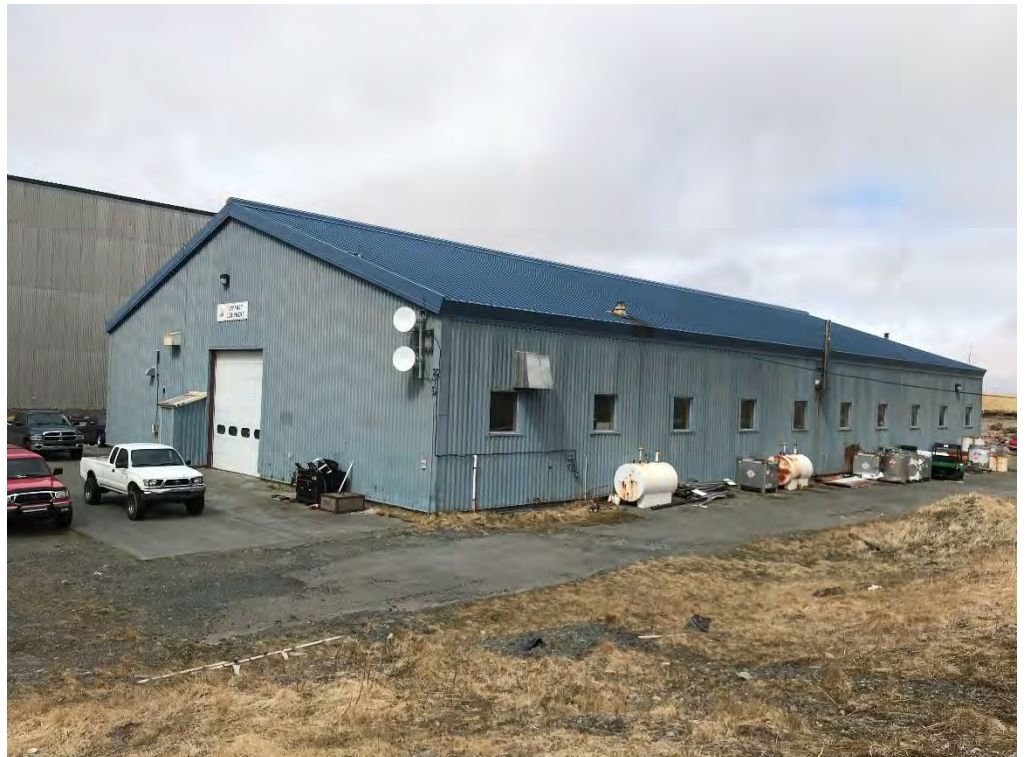
**Description:** Overview of  
SWMU 35, Ground  
Support Equipment  
Building. Photo taken on  
southeast end of site.

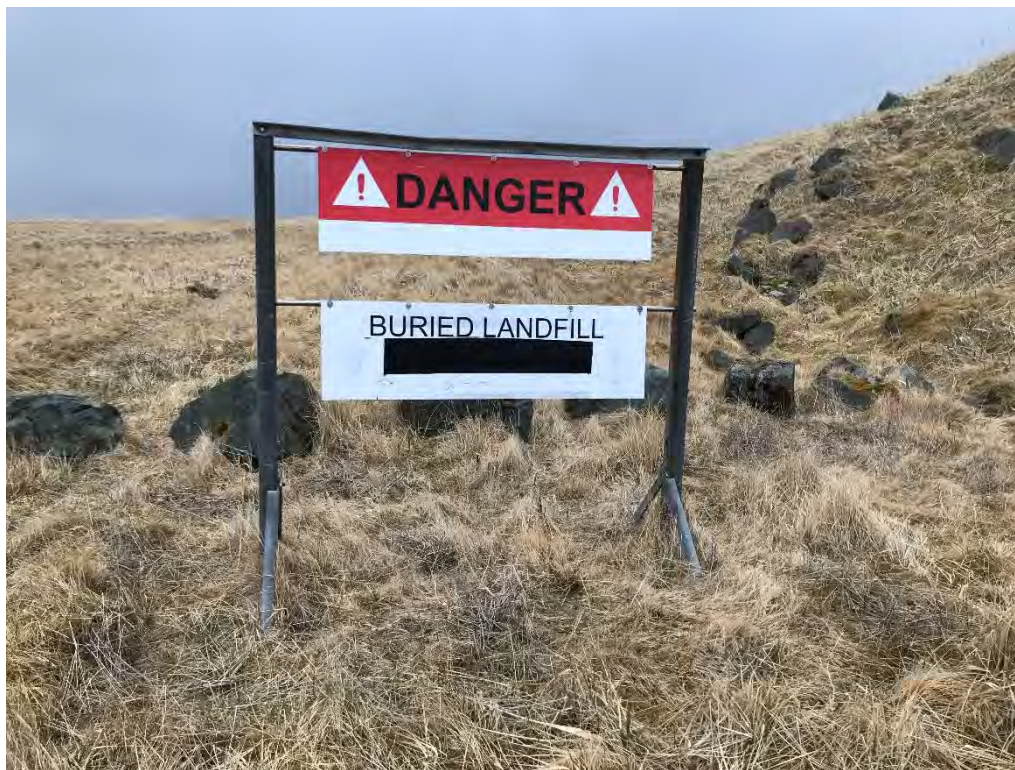
**Description:** Danger  
buried landfill sign  
entering SWMU 13 along  
northern access road.

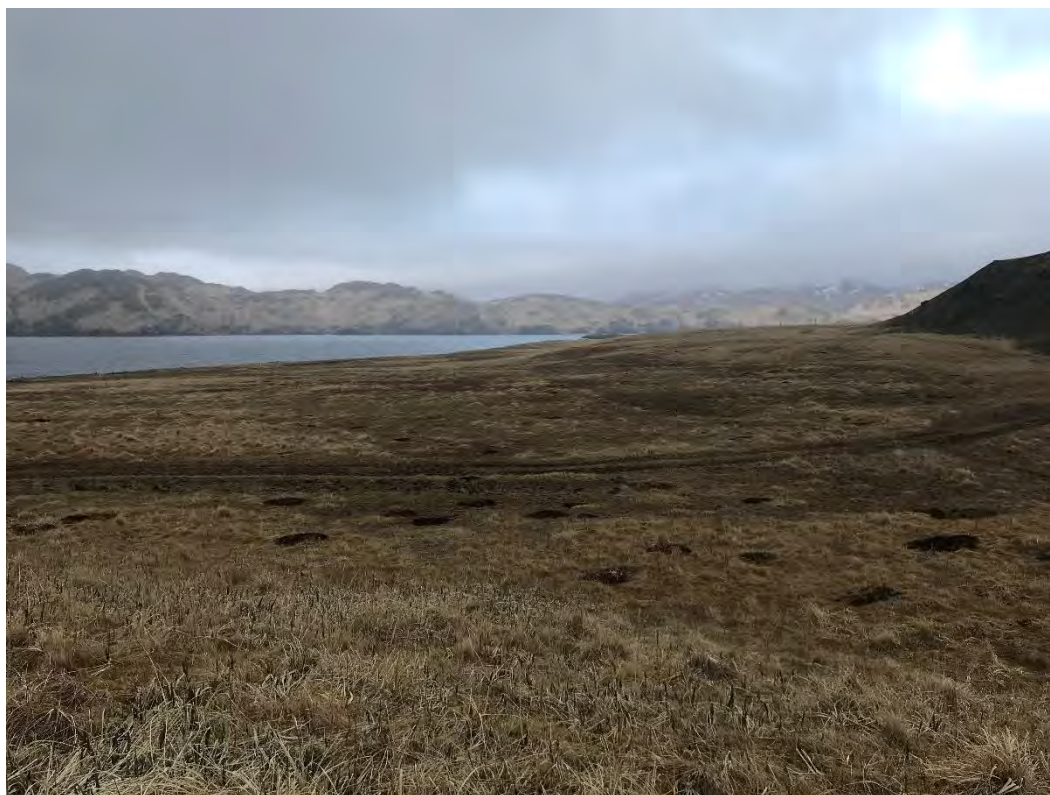
**Description:** Overview of  
SWMU 13, Metals Landfill.  
Photo taken on north end  
of landfill at top of access  
road.

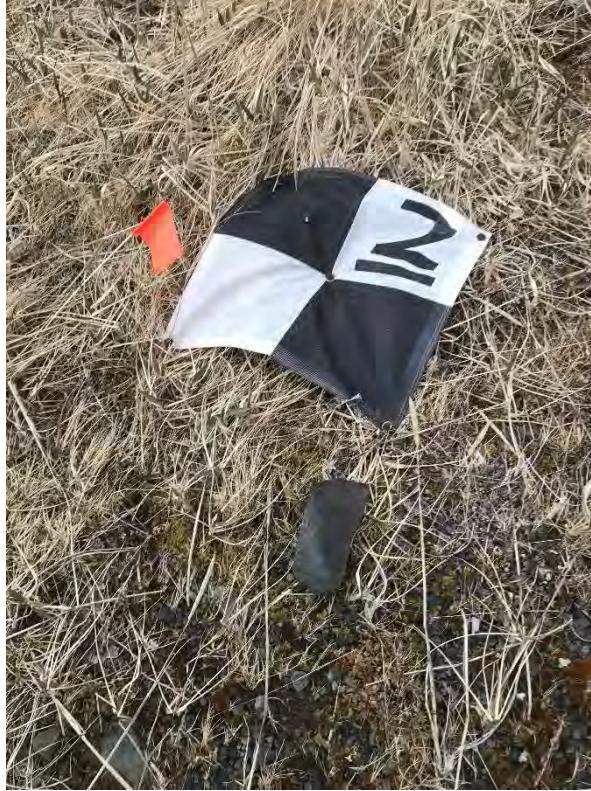
**Description:** One of  
several survey marker  
used for aerial drones on  
top of SWMU 13, Metals  
Landfill.

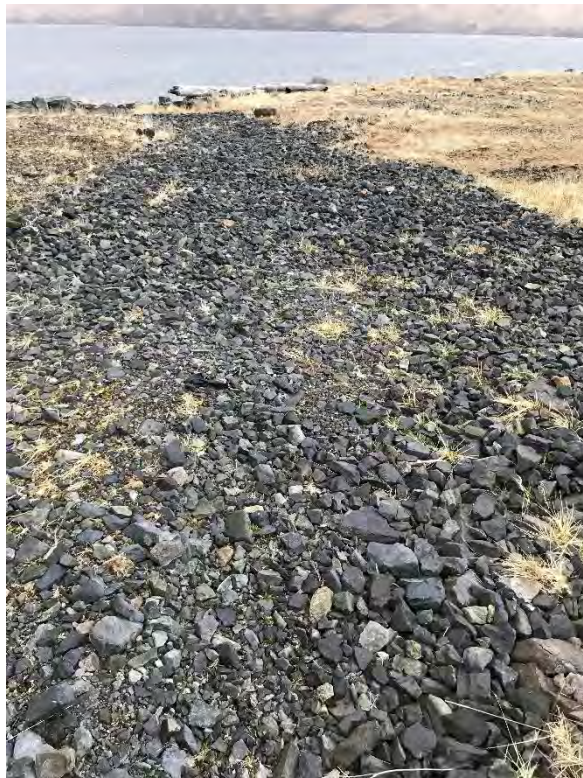
**Description:** Good  
condition of ground  
surface swale adjacent to  
access roads on top of  
SWMU 13, Metals Landfill.

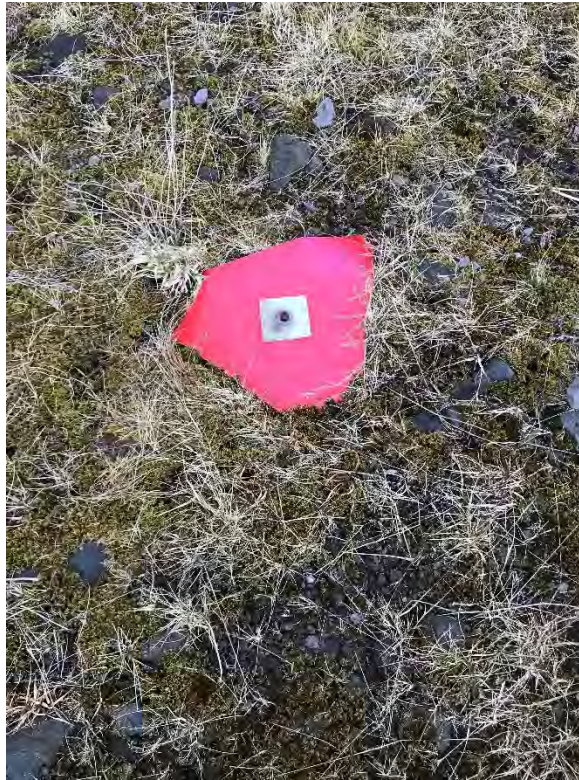
**Description:** Survey  
marker located on top and  
center of SWMU 13,  
Metals Landfill.

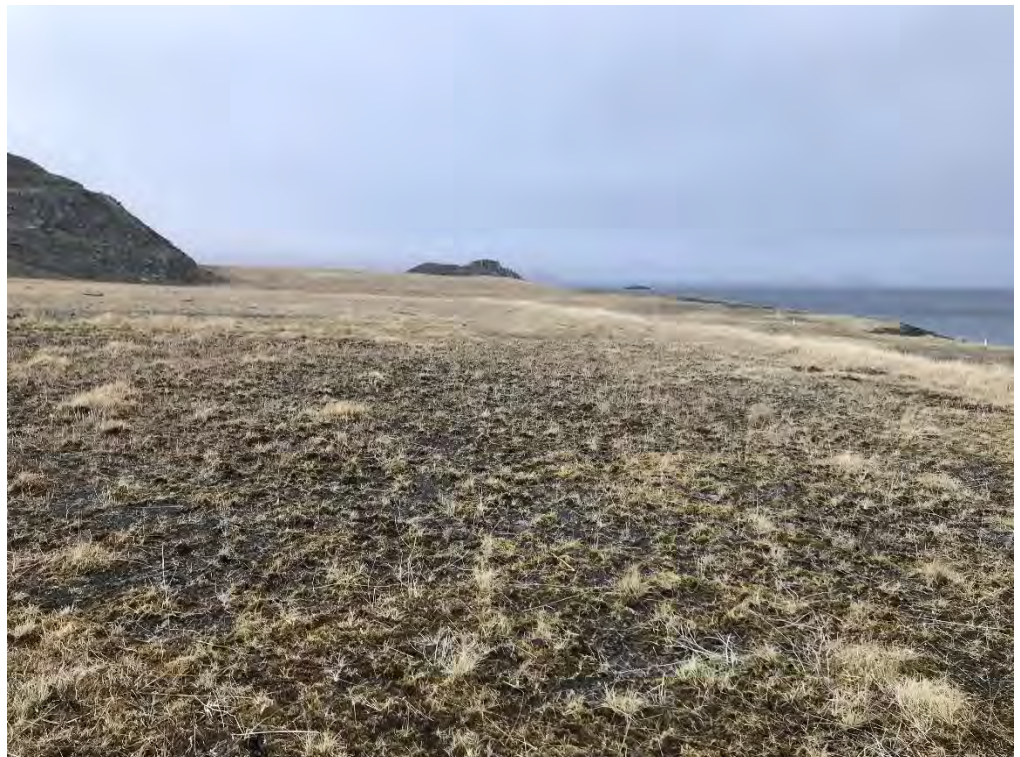
**Description:** Overview of  
SWMU 13, Metals Landfill.  
Photo taken on south end  
of landfill.

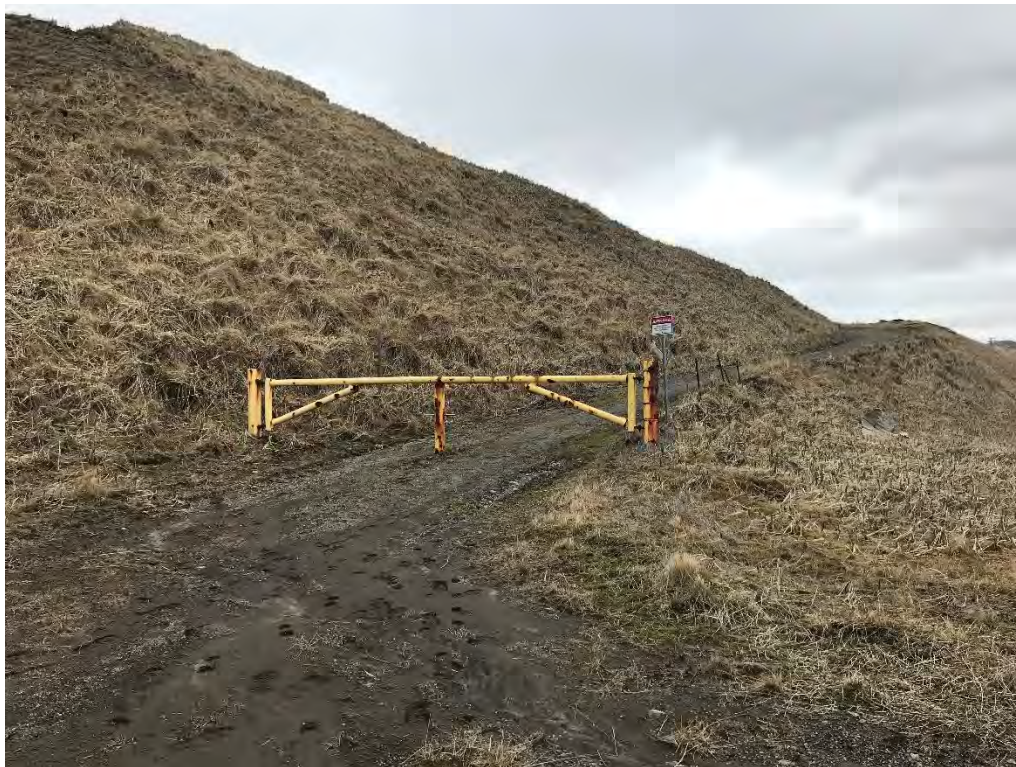
**Description:** Access gate  
with institutional controls  
sign along access road  
heading up to SWMU 13,  
Metals Landfill. South end  
of the landfill.

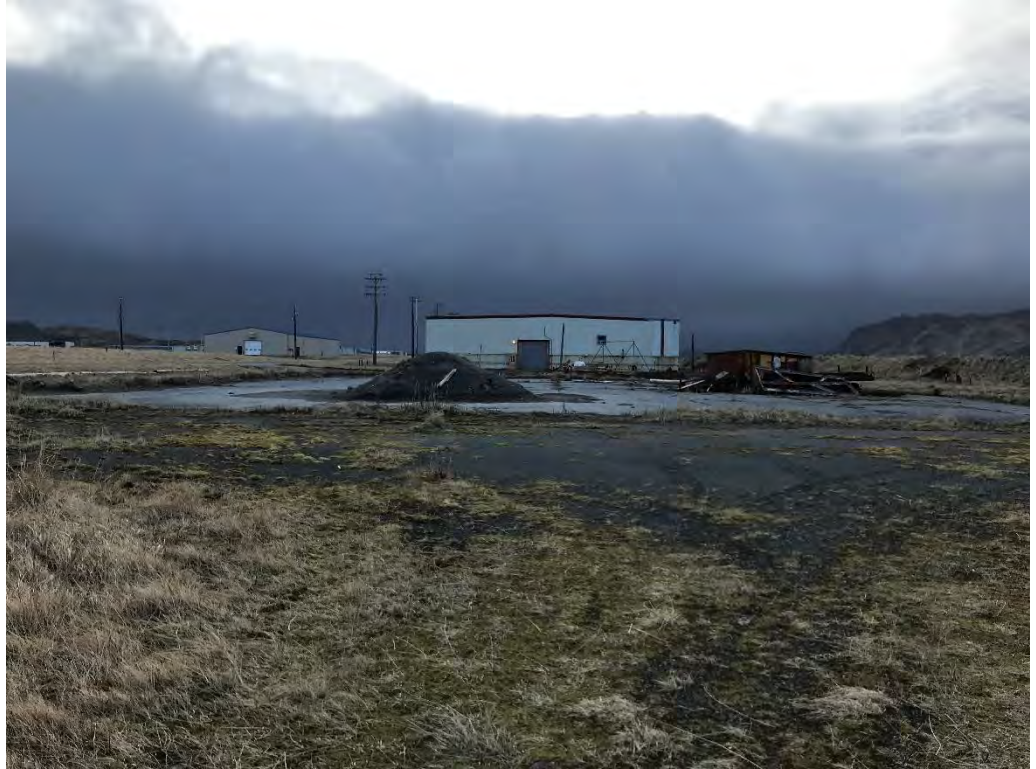
**Description:** Overview of  
NMCB Building Area.  
Photo taken on west side  
of site. Dirt piles visible in  
the forefront.

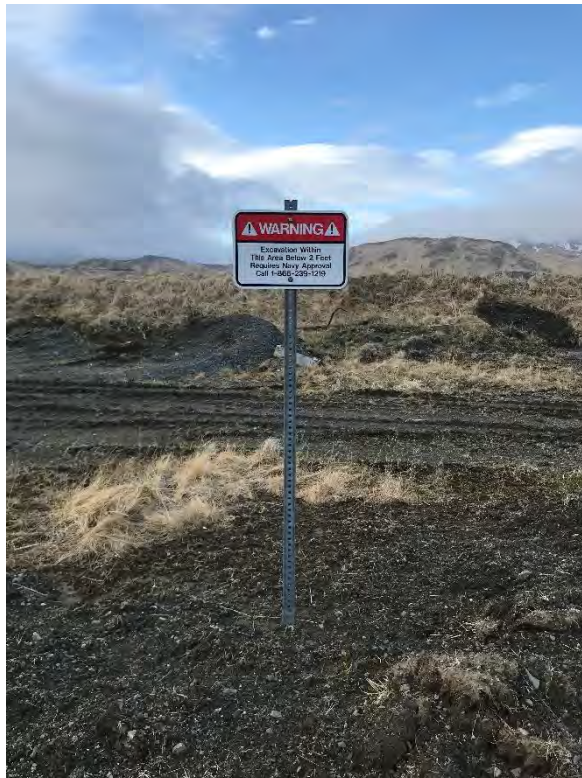
**Description:** Institutional  
controls sign located at  
NMCB Building Area, T-  
1416 Expanded Area.

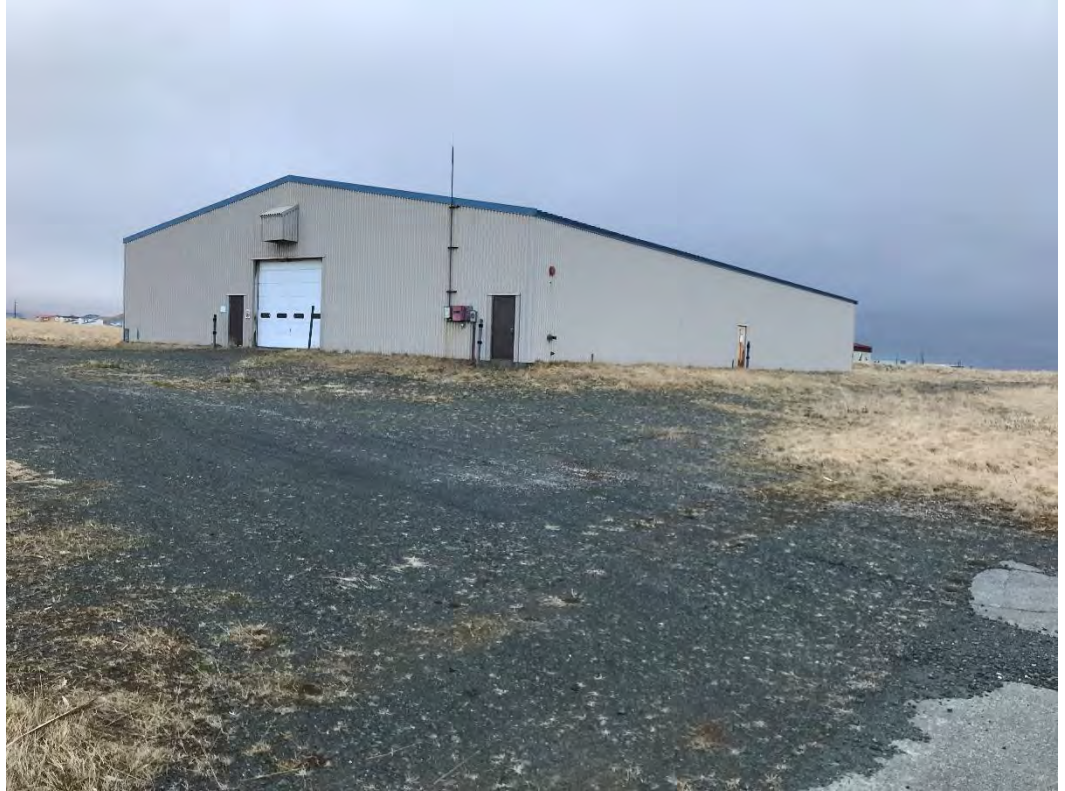
**Description:** Overview of  
NMCB Building Area.  
Building 42069 located on  
northeast end of site.

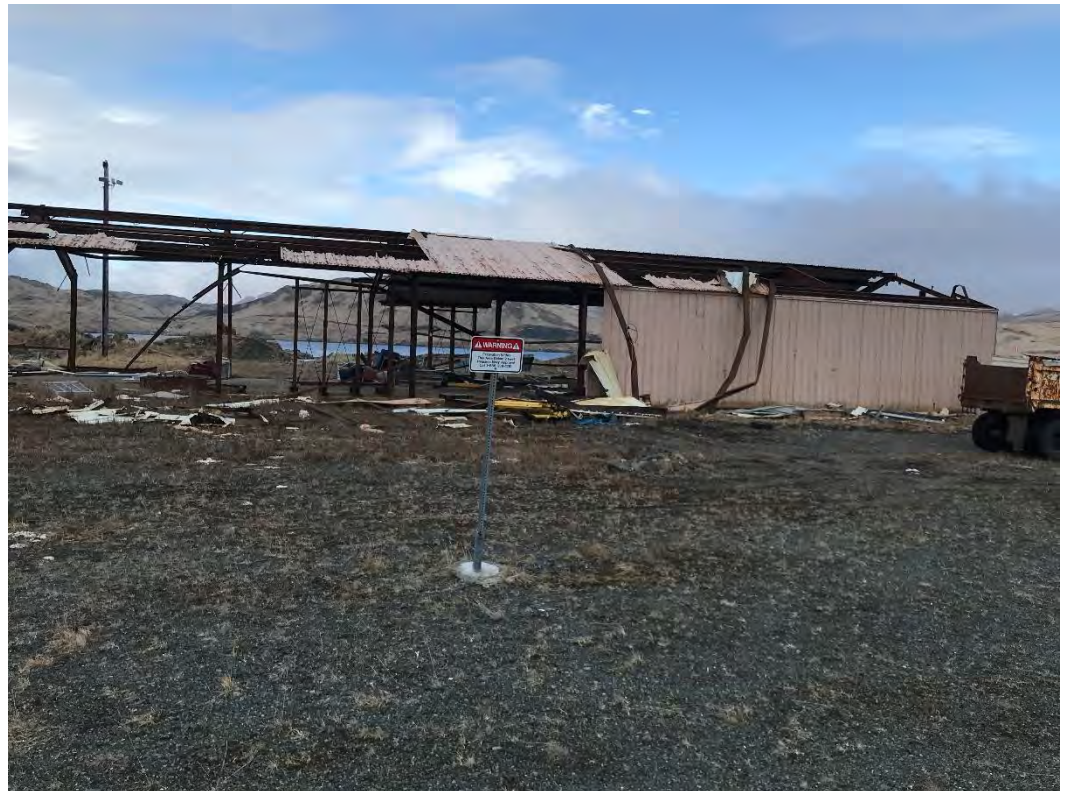
**Description:** Building that  
is falling apart and  
institutional controls sign  
located on southwest  
portion of the site.

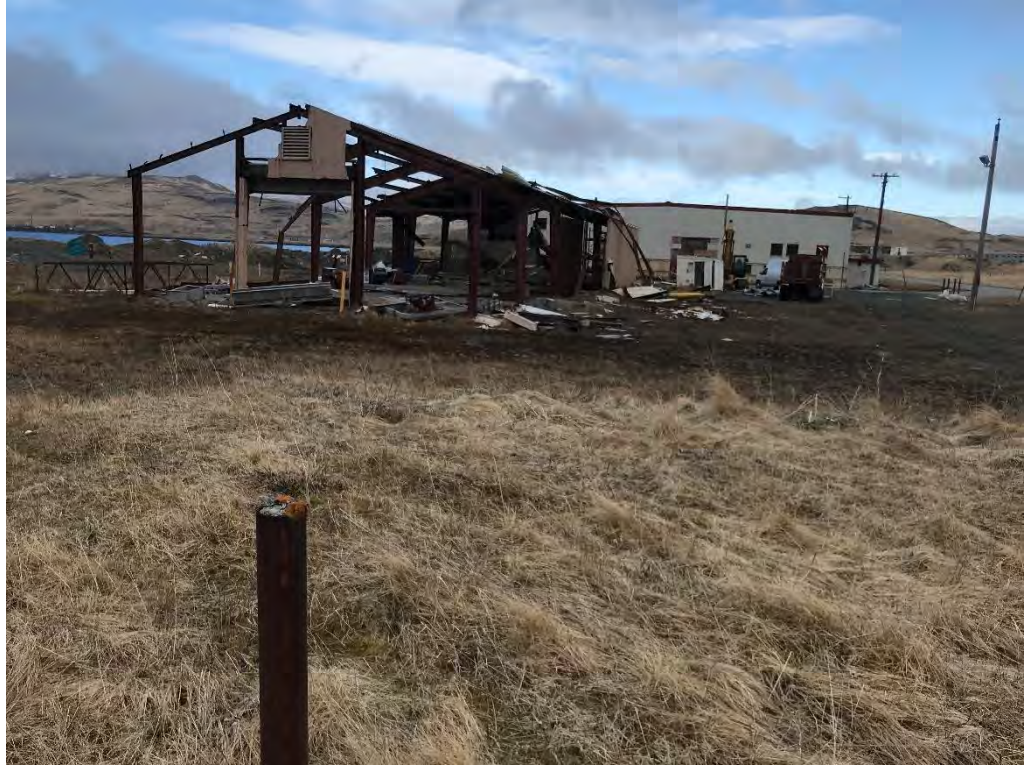
**Description:** Overview of  
NMCB Building Area.  
Photo taken on east side  
of property. Scattered  
debris visible.

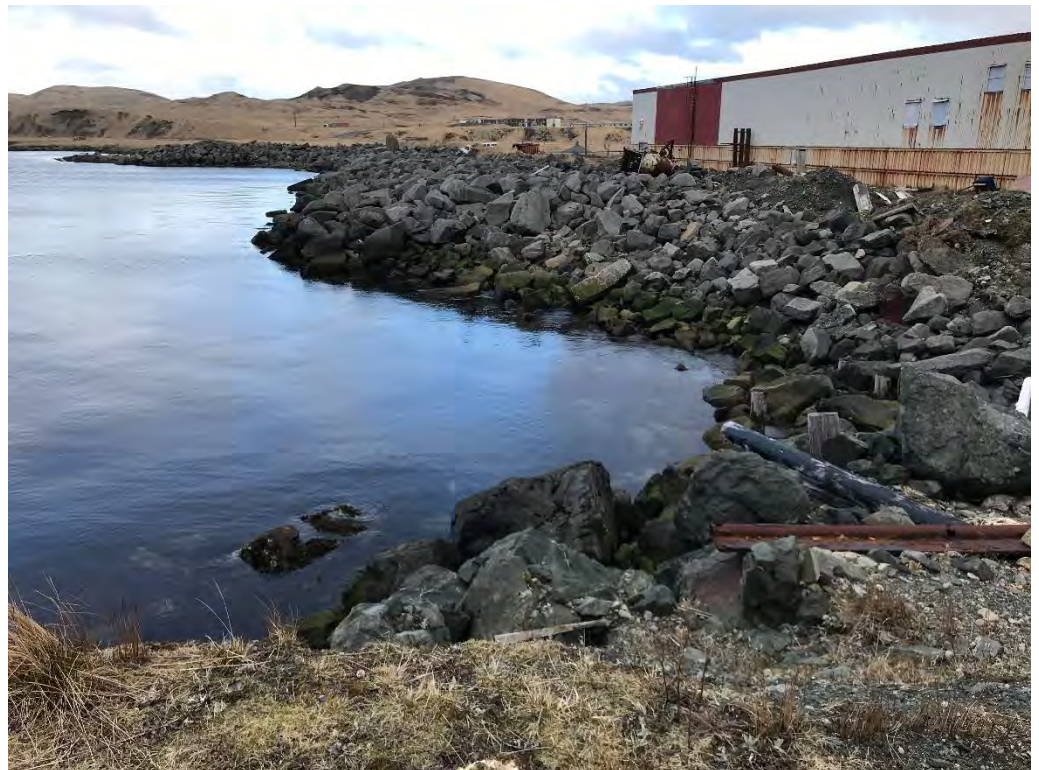
**Description:** Southern  
shoreline along NMCB  
Building Area, T-1416  
Expanded Area.

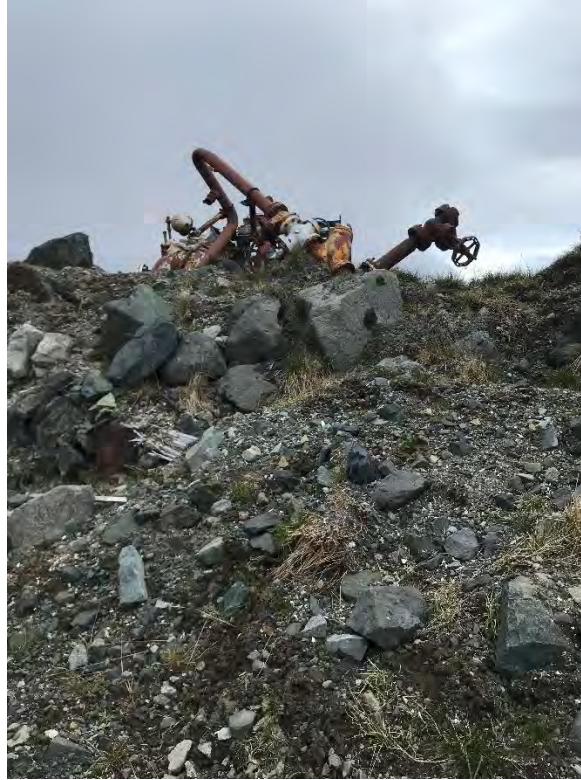
**Description:** Metal debris  
along shoreline of NMCB  
Building Area, T-1416  
Expanded Area.

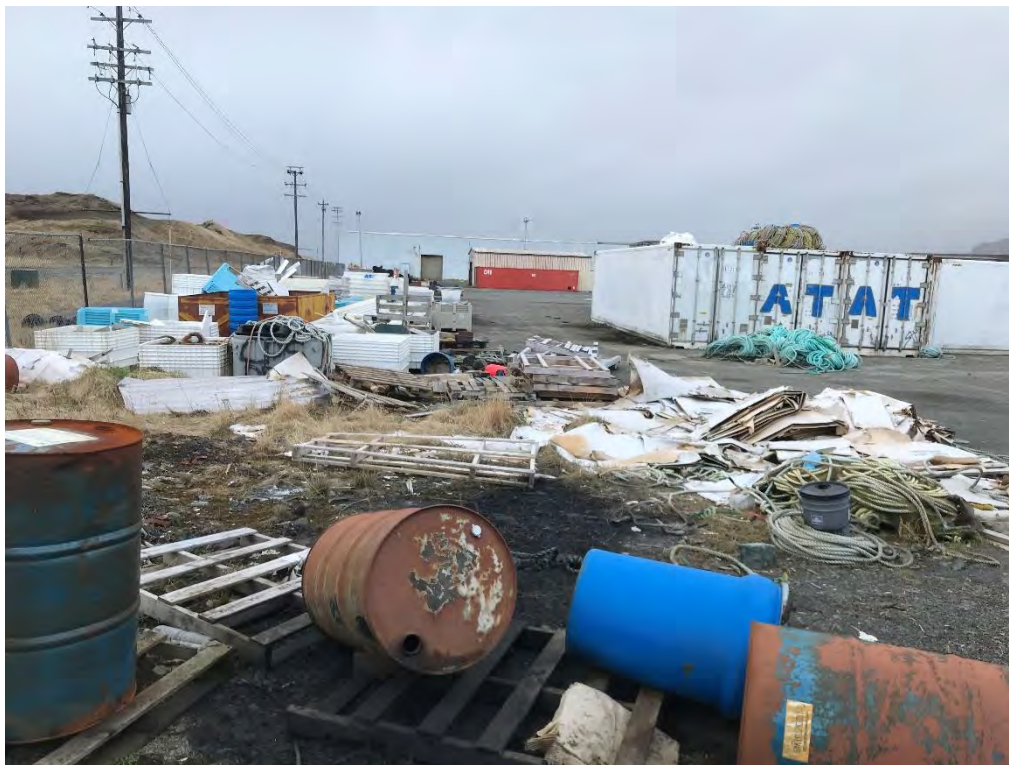
**Description:** Drums and  
debris along northern  
boundary of SWMU 15,  
Future Jobs/DRMO.

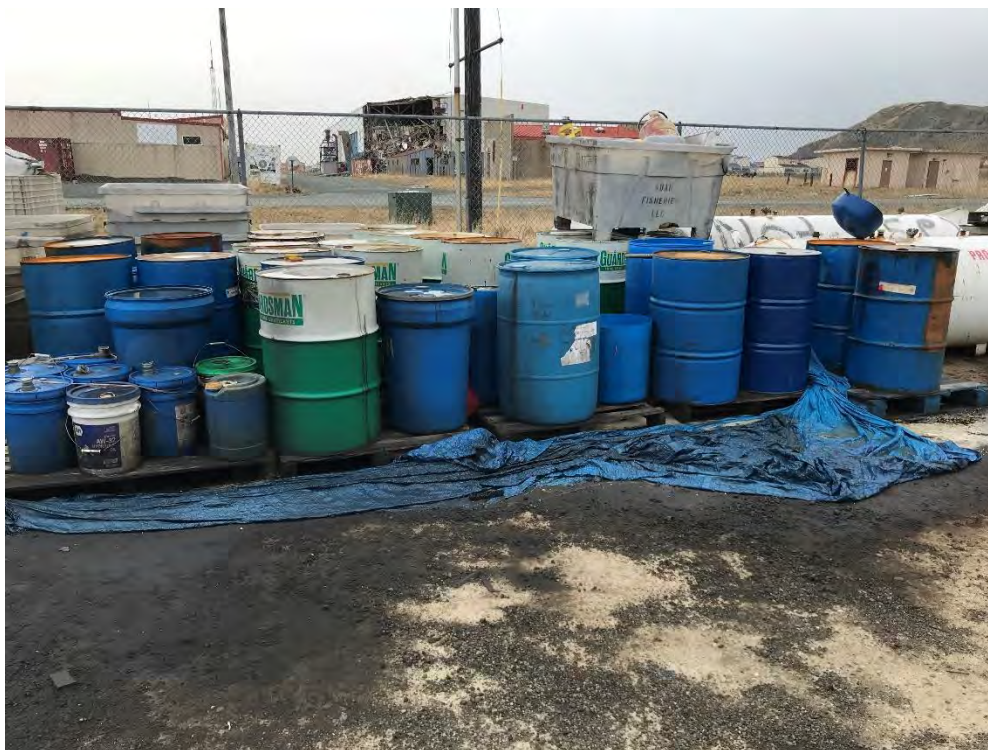
**Description:** Waste  
barrels located on  
northern boundary of  
SWMU 15, Future  
Jobs/DRMO.

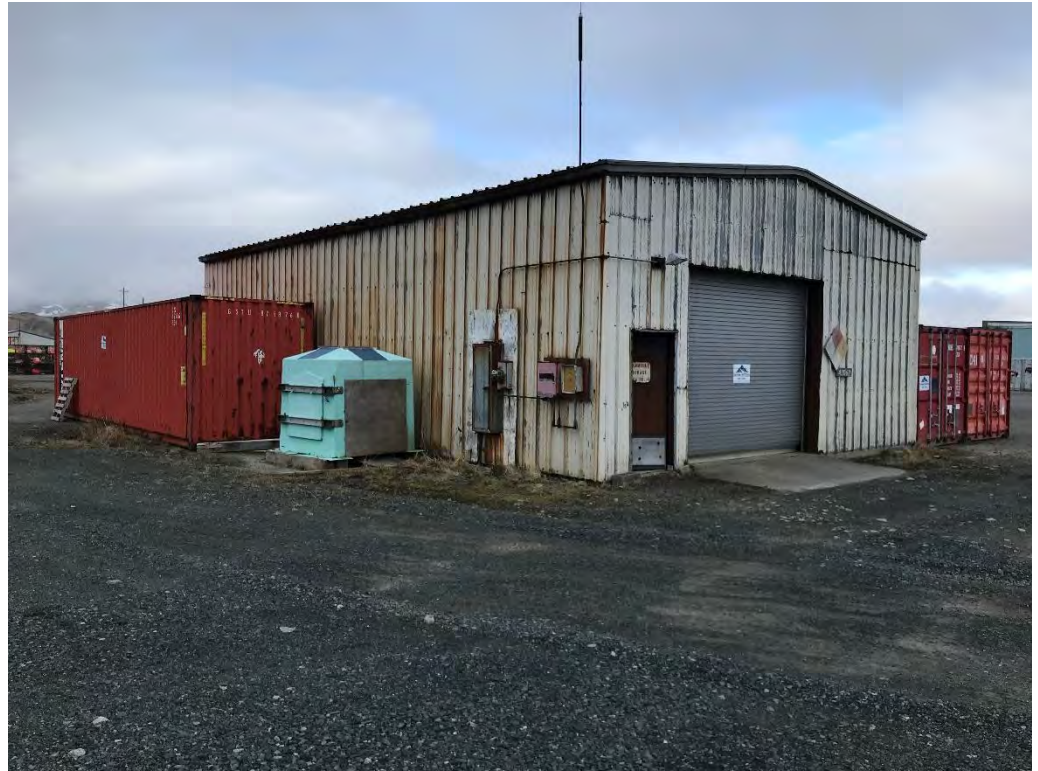
**Description:** Occupied  
building used for storage  
located at northeast  
corner of SWMU 15,  
Future Jobs/DRMO.

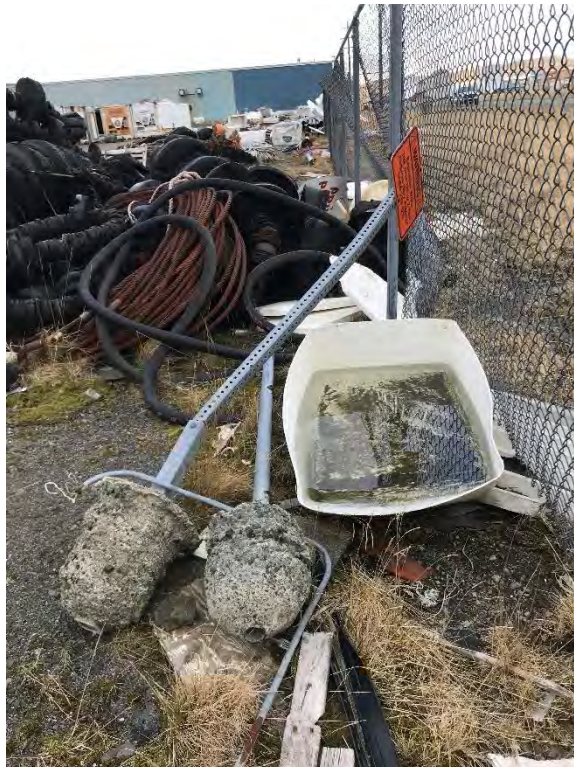
**Description:** Damaged  
institutional controls signs  
along northeast corner of  
fence line at SWMU 15,  
Future Jobs/DRMO.

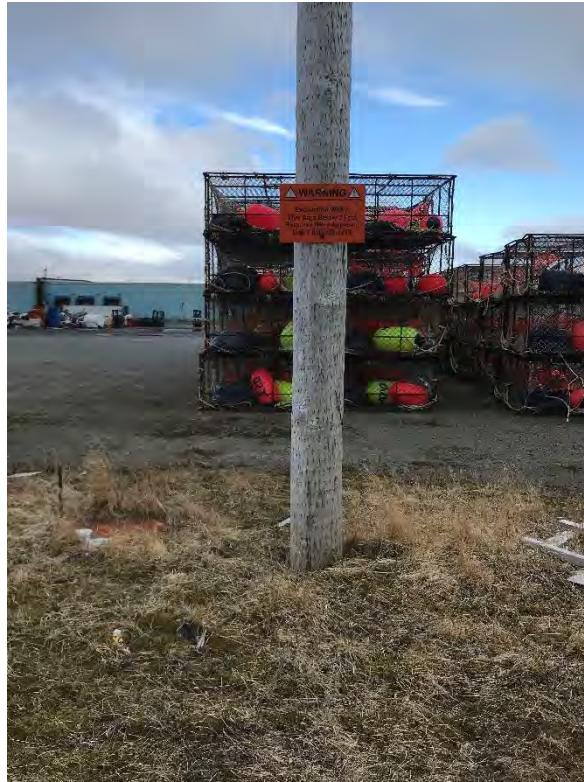
**Description:** Institutional  
controls sign located at on  
the east side of SWMU  
15, Future Jobs/DRMO.

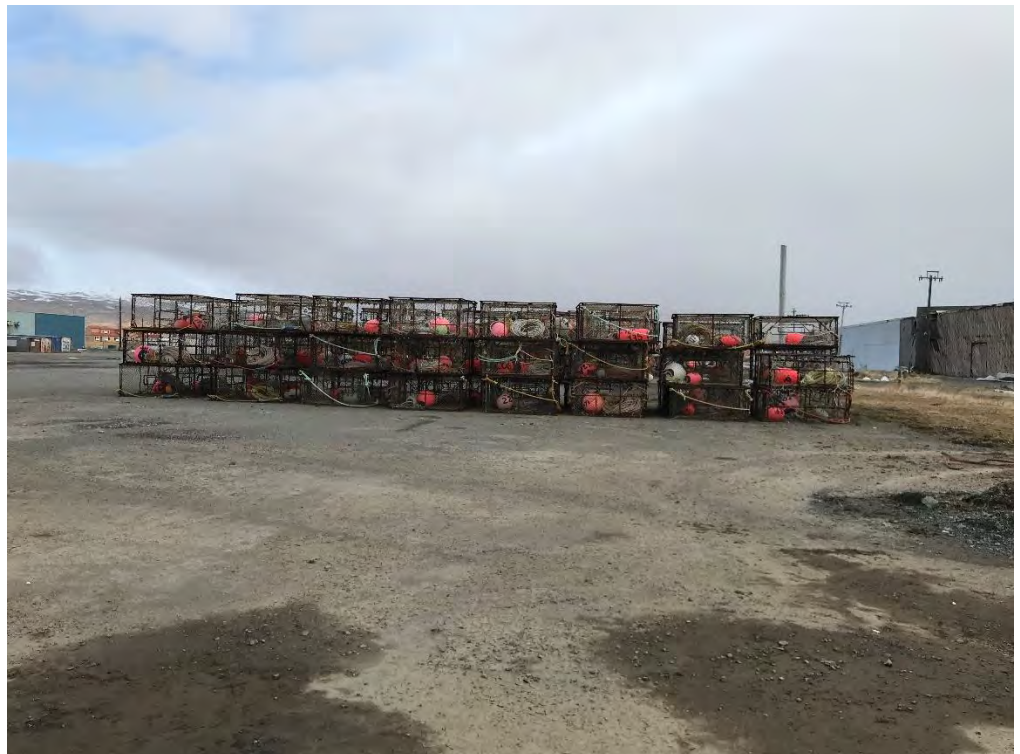
**Description:** Overview of  
SWMU 15, Future  
Jobs/DRMO. Photo taken  
on south side of property.  
Crab trap storage visible  
in forefront.

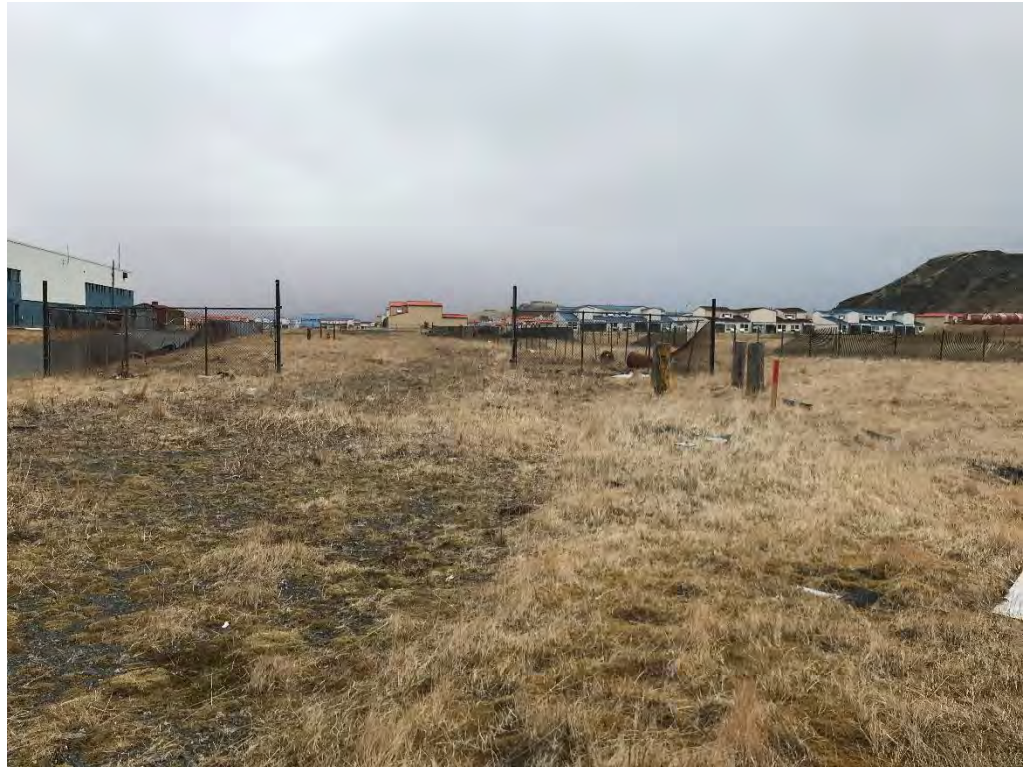
**Description:** Overview of  
SWMU 10, Old Baler  
Building. Photo taken on  
south side of property.

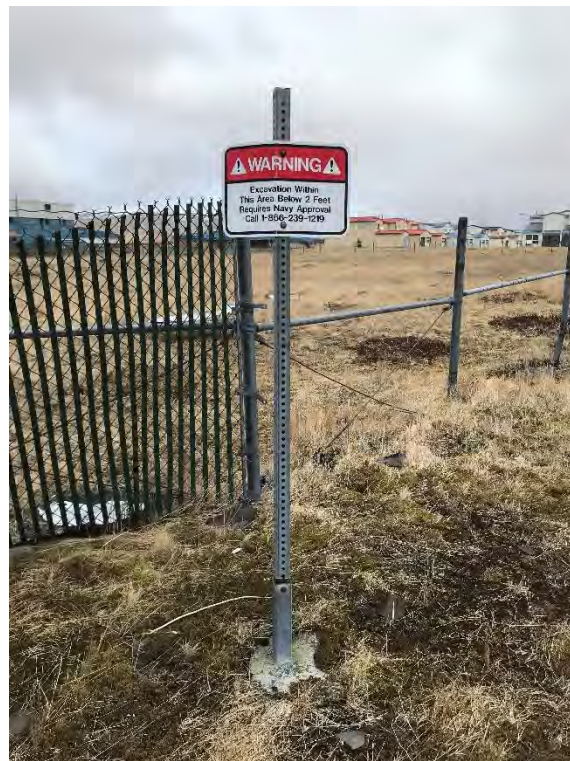
**Description:** Institutional  
control sign located on  
east side of site.

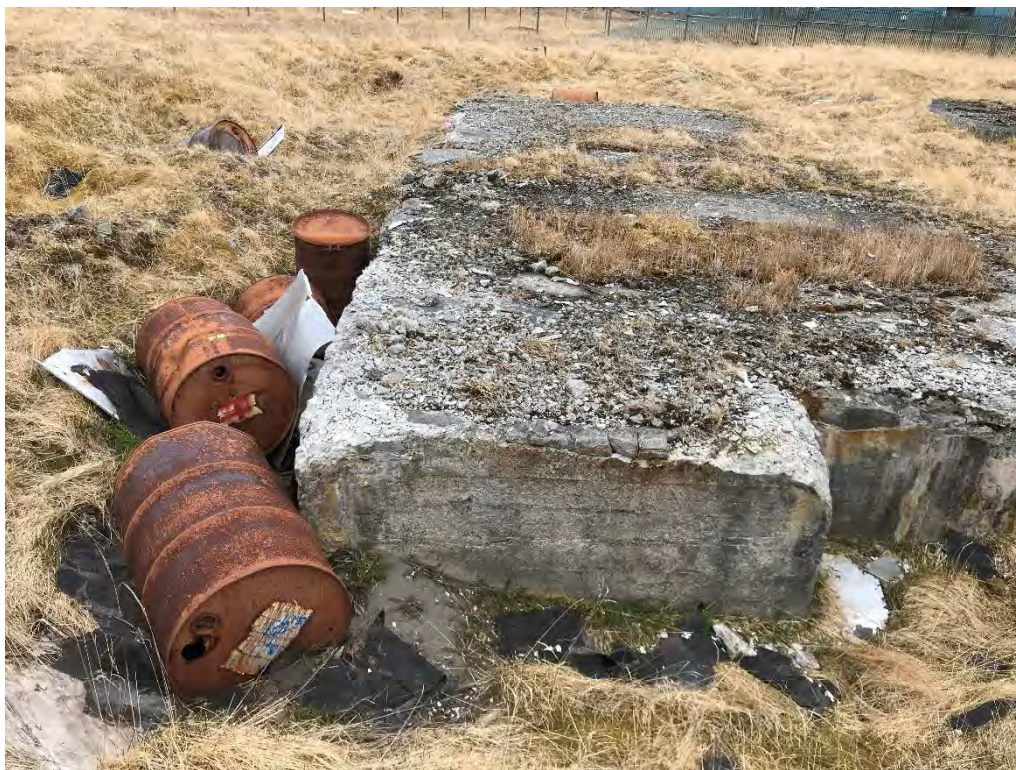
**Description:** Drums and  
scattered debris located in  
center of site.

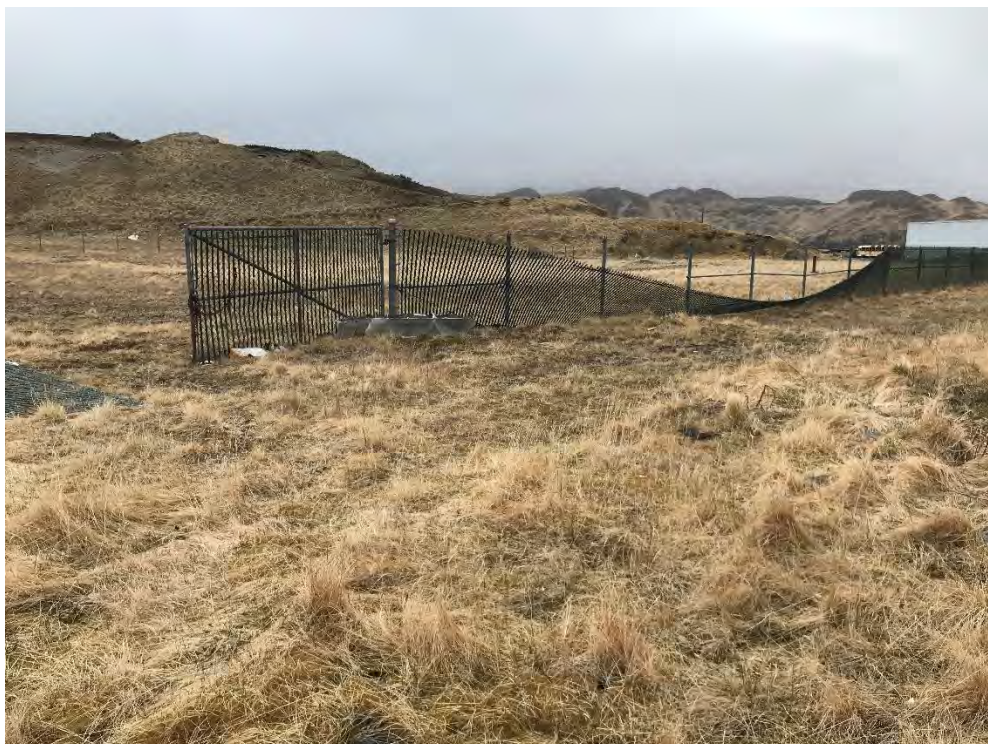
**Description:** Overview of  
SWMU 10, Old Baler  
Building. Photo taken on  
northwest corner of  
property.

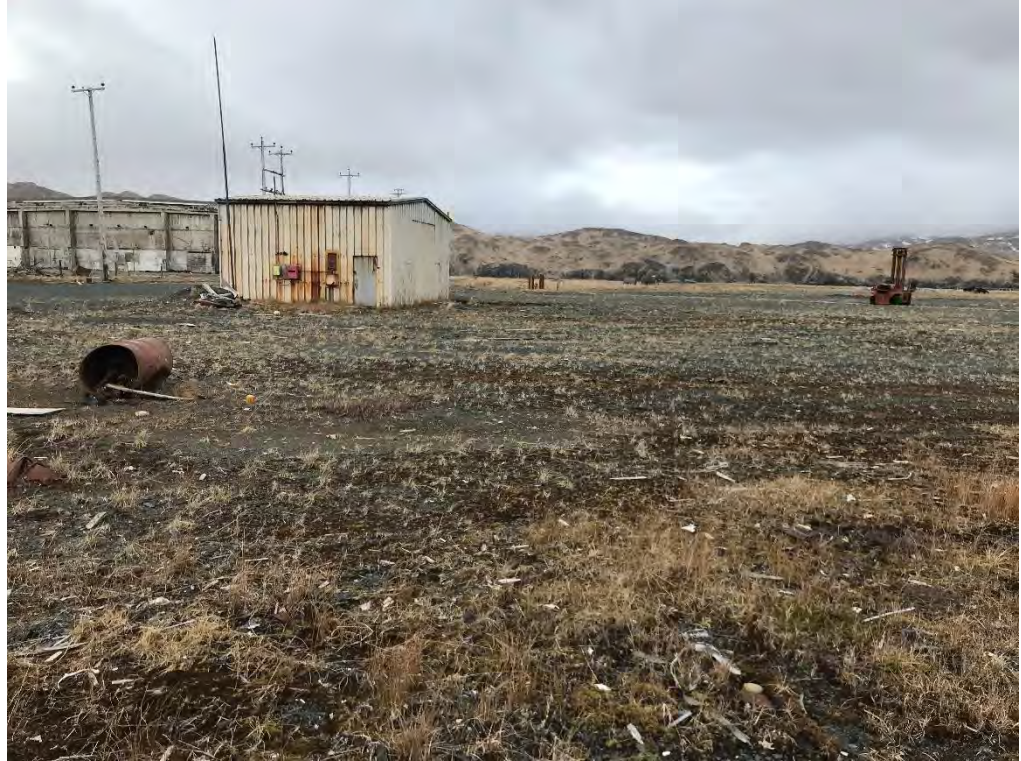
**Description:** Overview of  
SWMU 55, Waste Storage  
Area. Photo taken on  
north side of property.

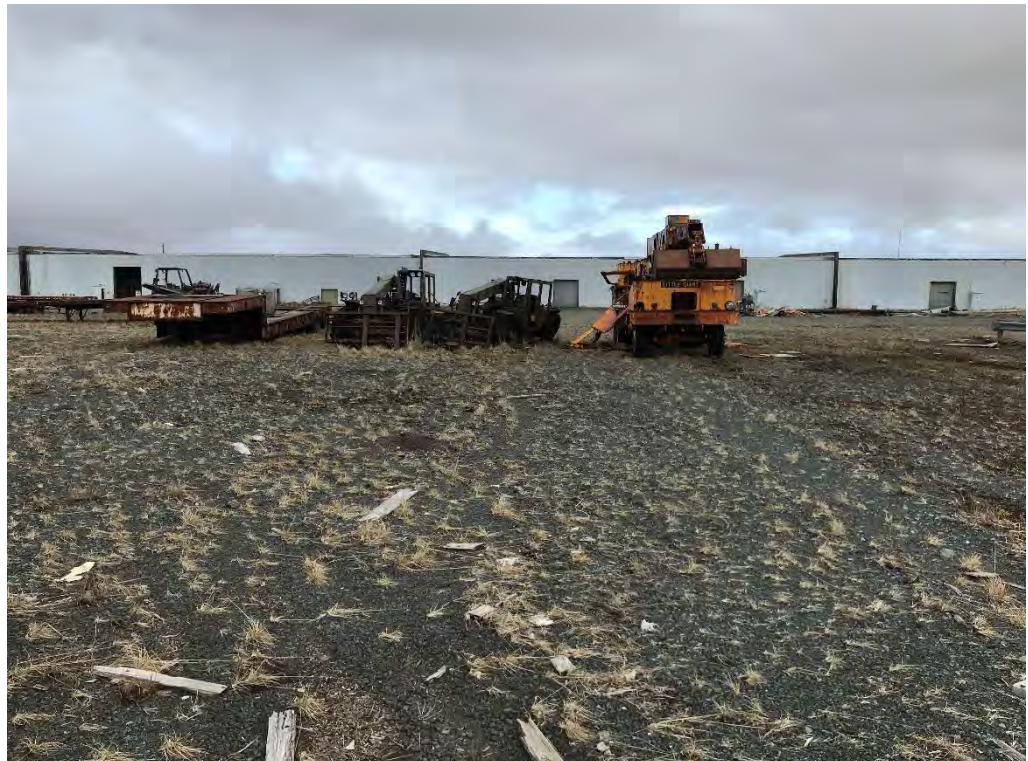
**Description:** Equipment  
storage at SWMU 55,  
Waste Storage Area on  
east side of drum storage  
building.

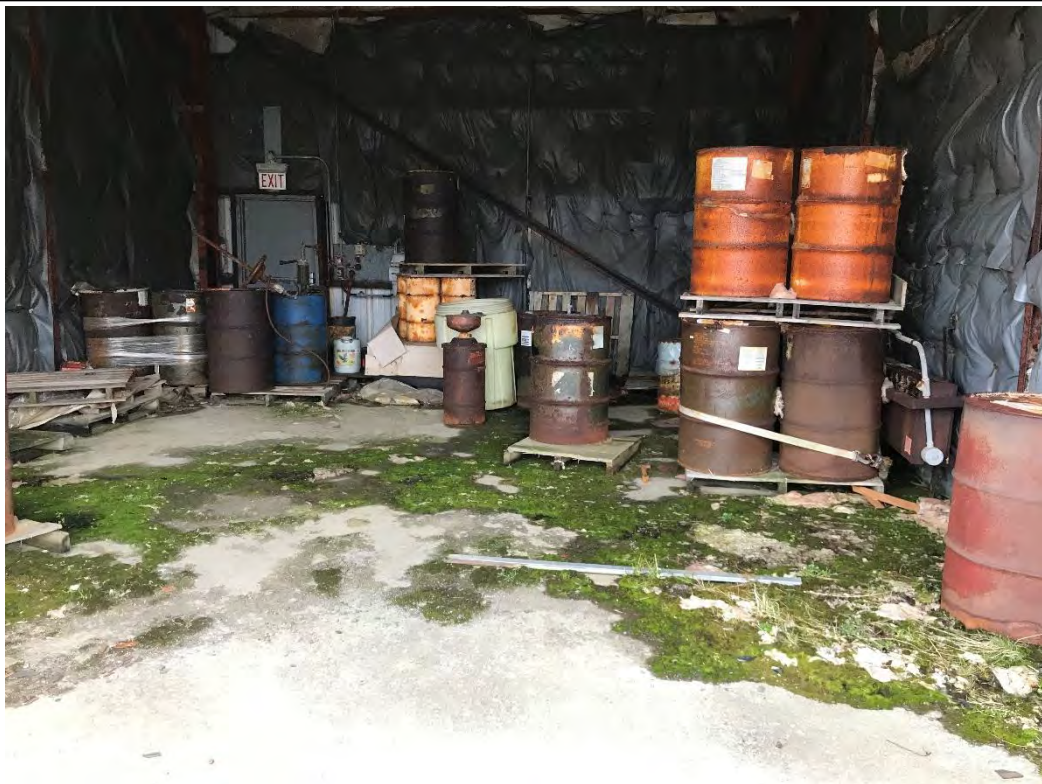
**Description:** Waste  
drums located inside  
building at SWMU 55,  
Waste Storage Area.
