# Fifth Five-Year Review Operable Units A and B-1 Former Adak Naval Complex

## **Naval Air Station Adak**

**Fifth Five-Year Review  
Operable Units A and B-1  
Former Adak Naval Complex  
NAVAL AIR STATION ADAK, ADAK ISLAND, ALASKA**

**December 2021**

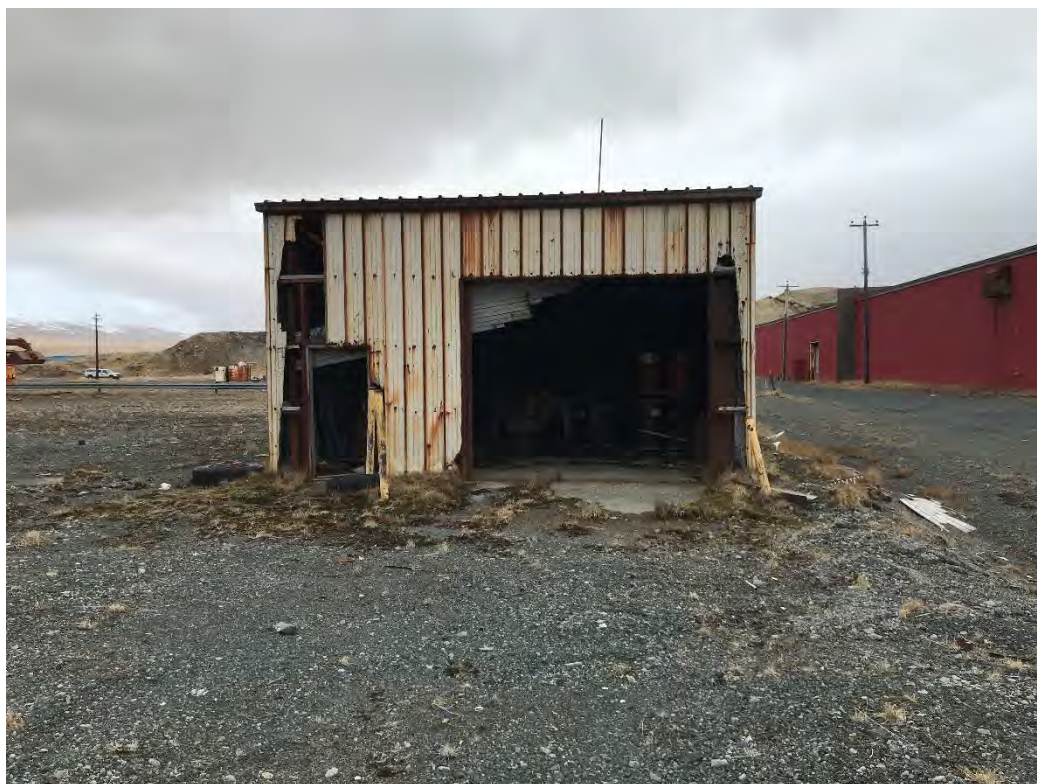
**Description:** Building  
located at SWMU 55  
Waste Storage Area. The  
building is open to  
atmosphere and contains  
waste drums.

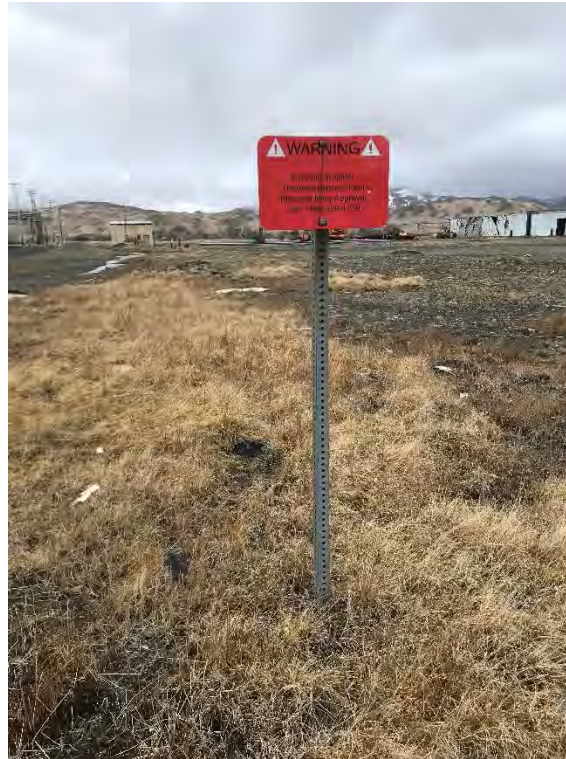
**Description:** Institutional  
control sign located at  
northeast corner of SWMU  
55, Waste Storage Area  
(sign is used for both  
SWMU 55 and SWMU  
24).

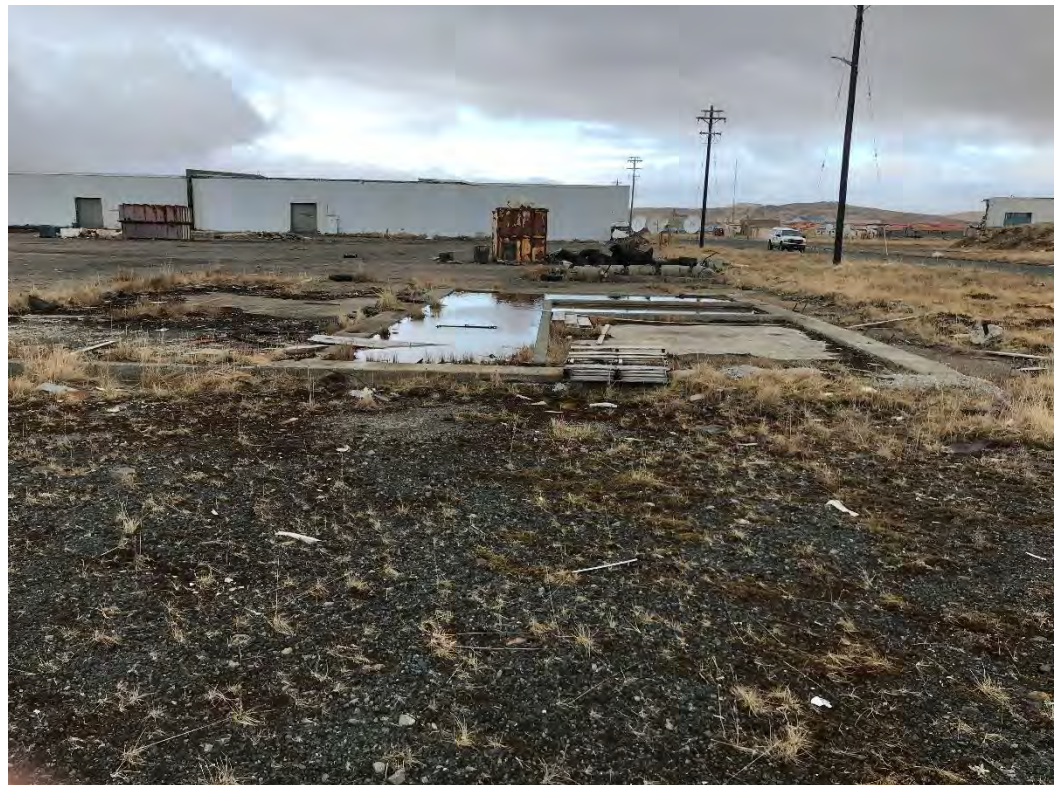
**Description:** Overview of  
SWMU 24, Hazardous  
Waste Storage Facility.  
Photo taken on east side  
of property.

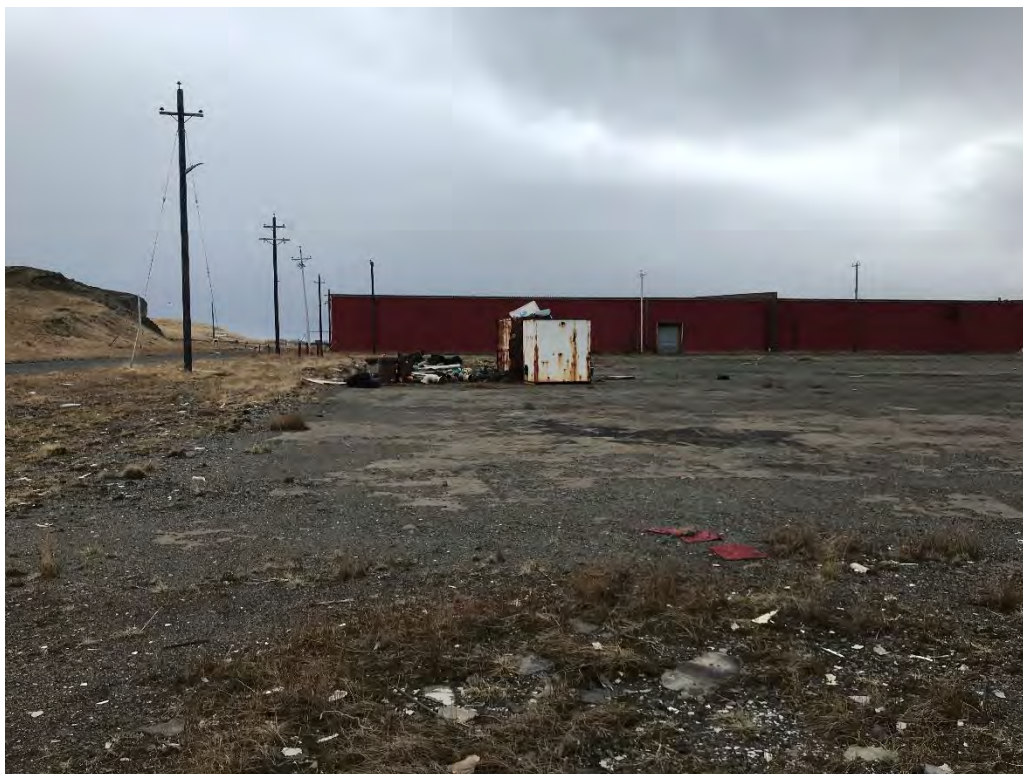
**Description:** Overview of  
SWMU 24, Hazardous  
Waste Storage Facility.  
Photo taken on west side  
of property.

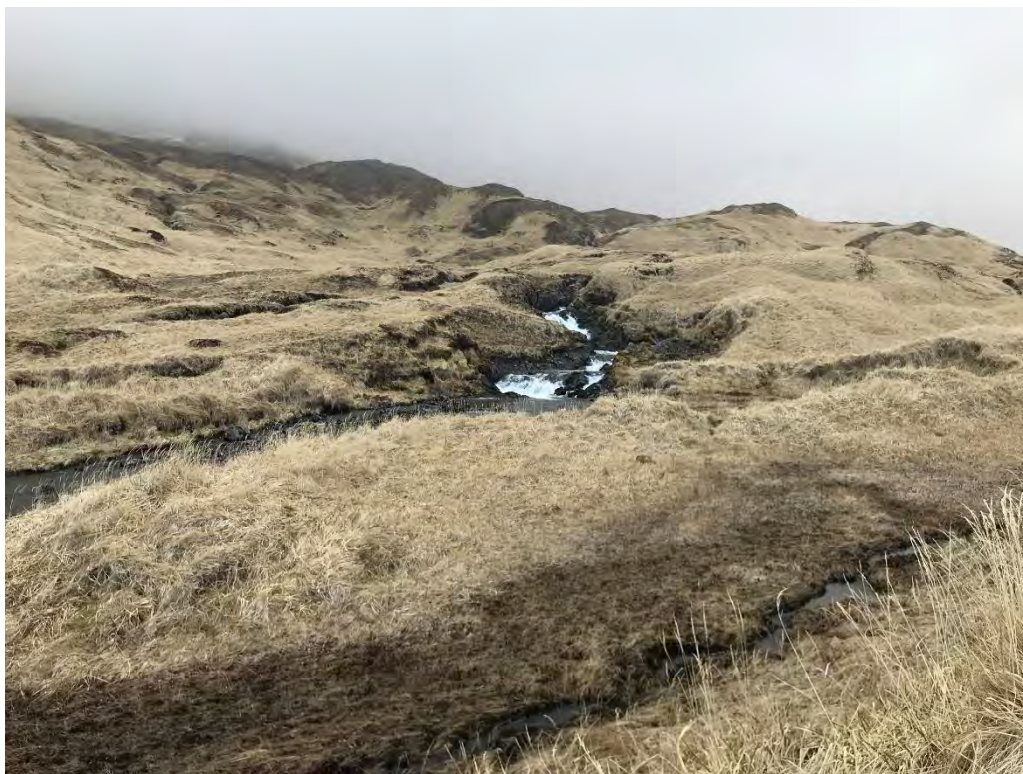
FB-02 site looking towards  
finger creek.

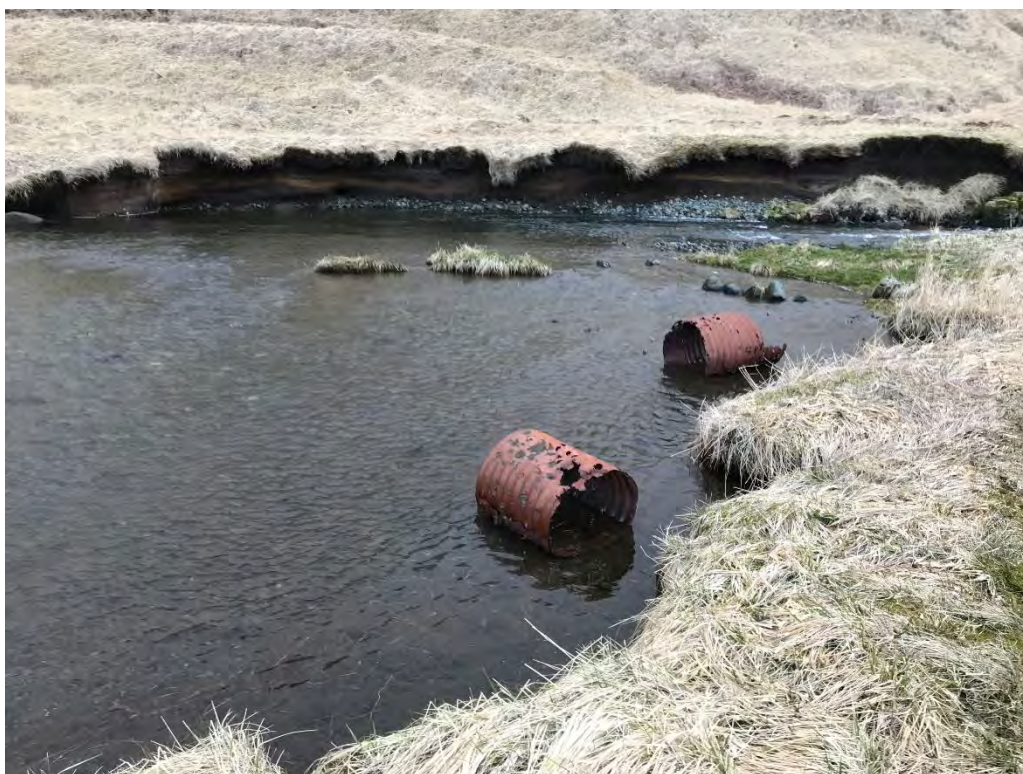
Rusted 55-gallon drums in  
finger creek near base of  
waterfall. Visual evidence  
of recreational use in area.  
Bullet holes within rusted  
drums.

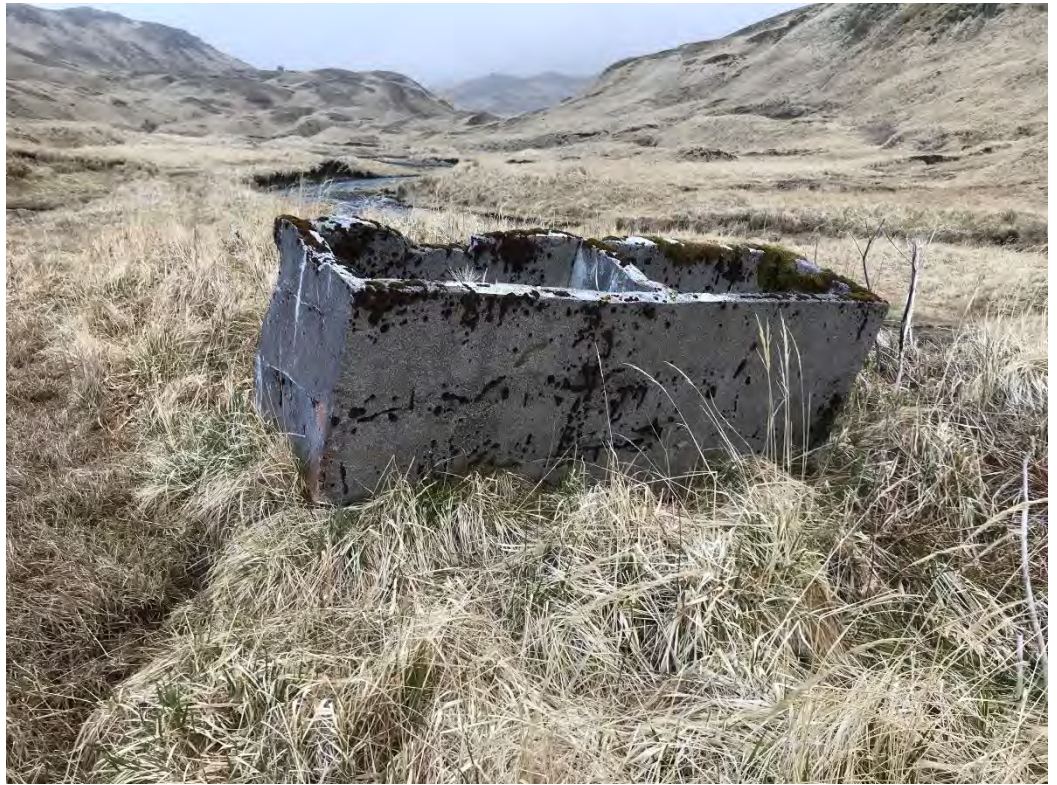
**Description:** Concrete  
debris from former  
structure near finger creek  
trail.

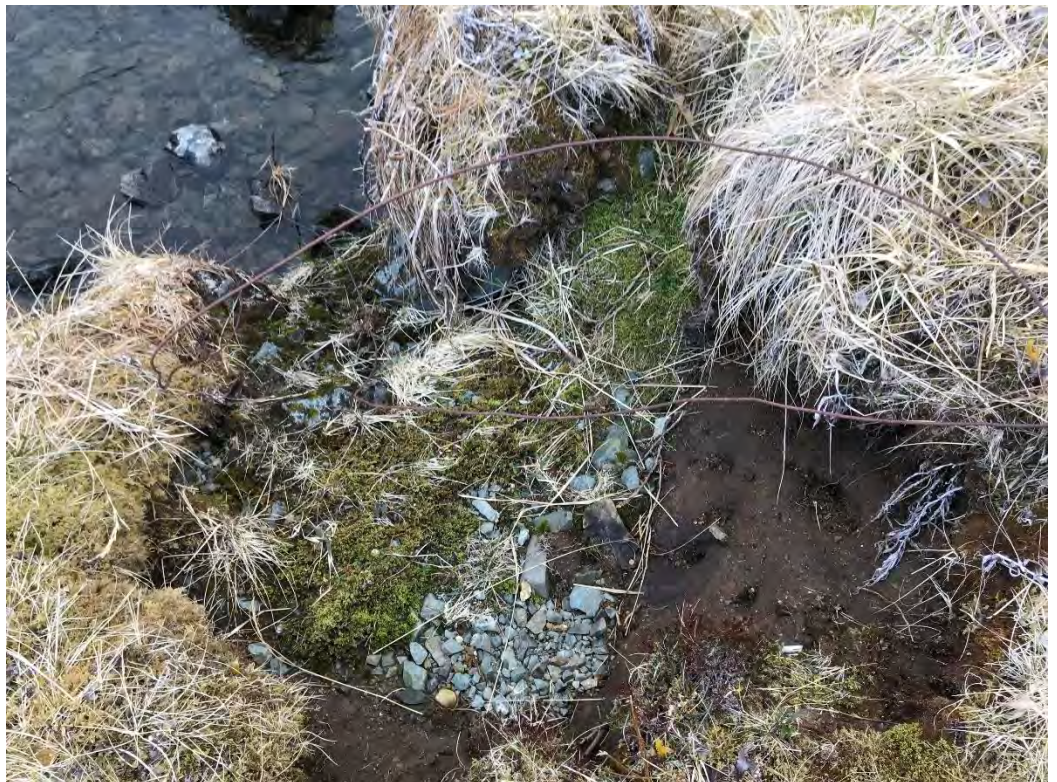
**Description:** Metallic  
debris within and along  
creek shoreline. Metal  
wire lined approximately  
100 feet of shoreline along  
finger creek trail to Lake  
Betty.

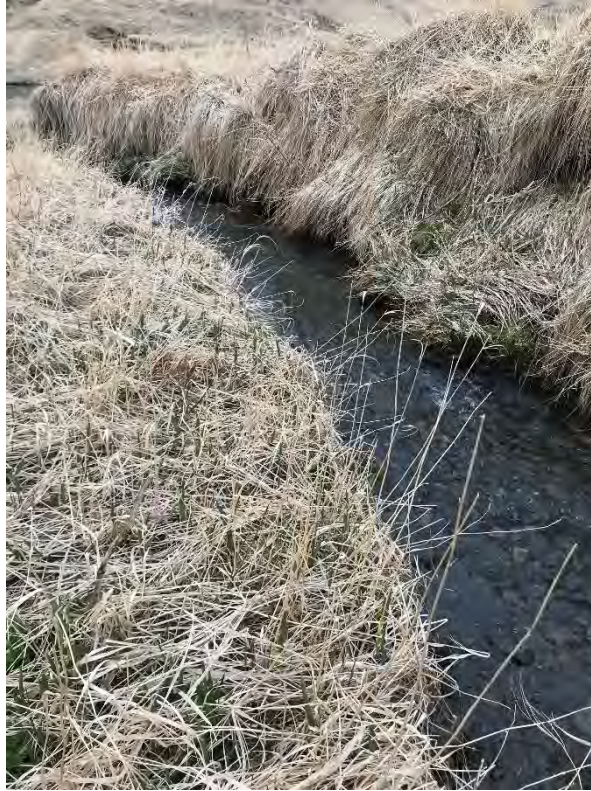
**Description:** Site  
overview from stream  
shoreline looking towards  
finger creek.

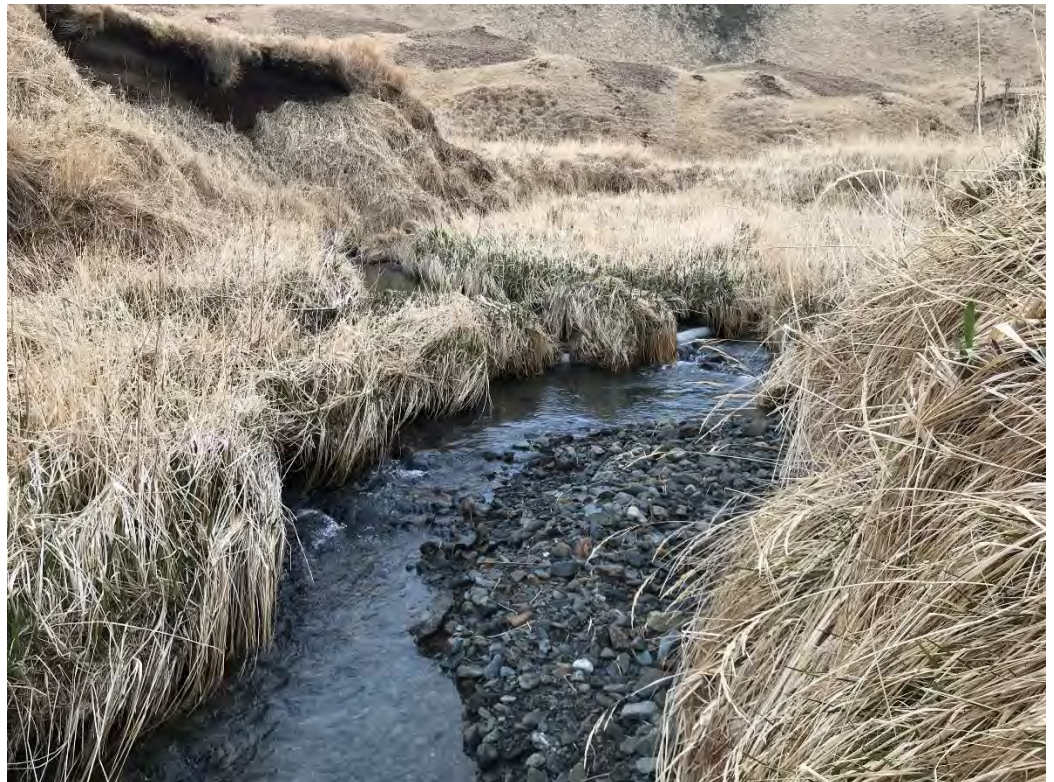
**Site Name :** FB-01

**Description:** Stream  
within site with visual  
pipeline crossing stream.

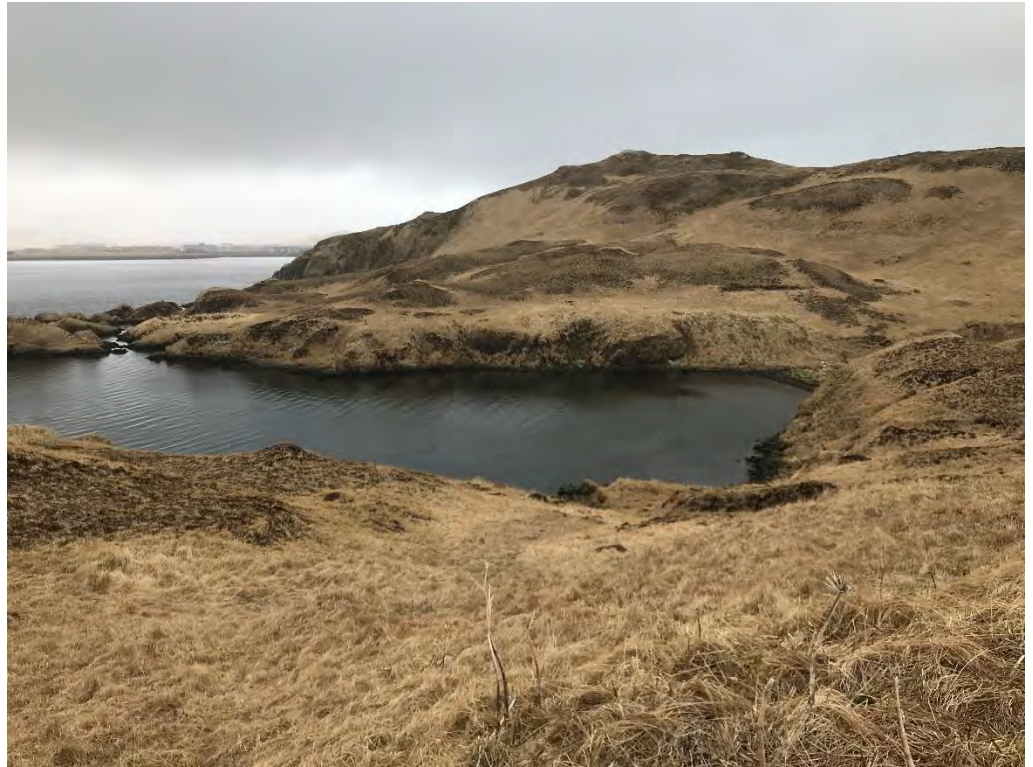
**Description:** HH-01  
looking from bluff at small  
cove, vegetated area  
throughout site.

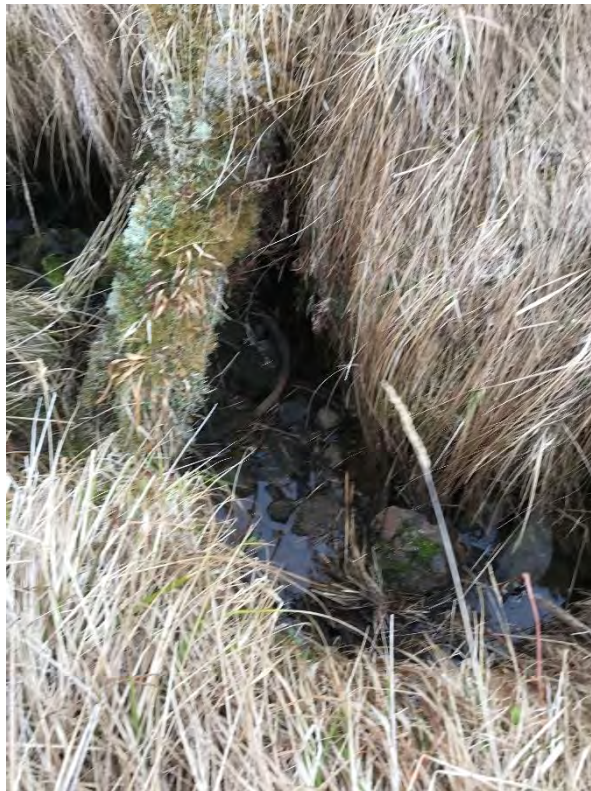
**Site Name :** HH-01

**Description:** Metallic and  
woody debris observed in  
creek gully entering into  
sweeper cove.

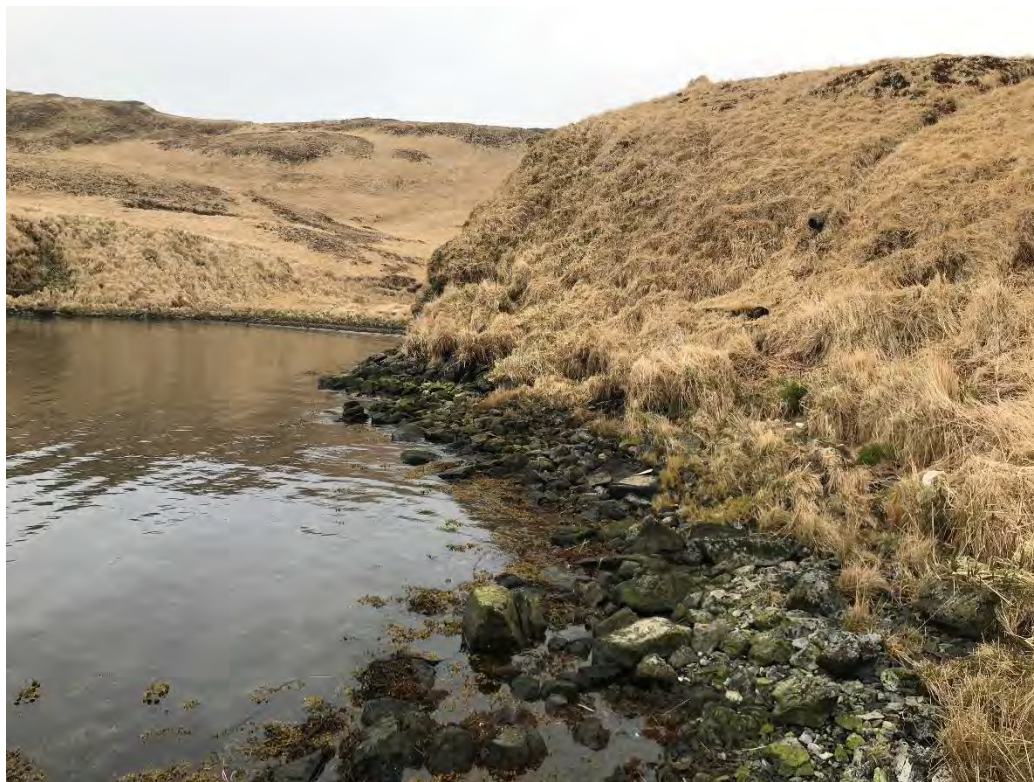
**Description:** Shoreline of  
sweeper cove within site  
area. No visual evidence  
of recreational use on site.

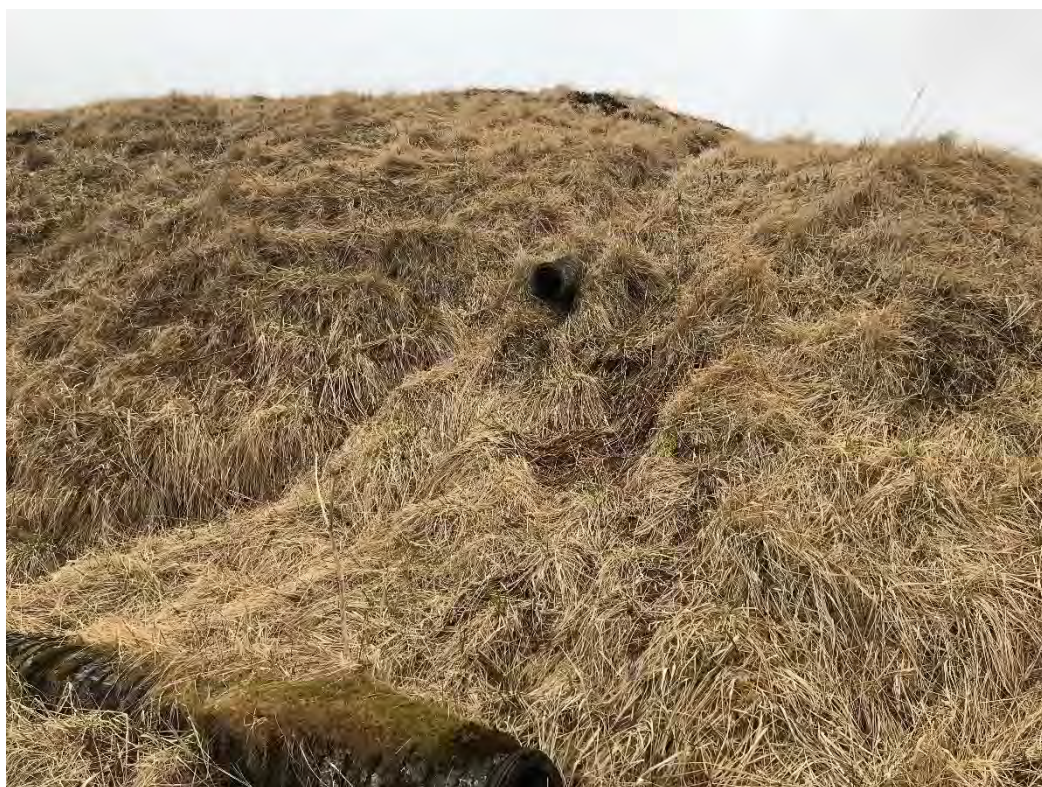
**Site Name :** HH-01

**Description:** Wire-  
wrapped wood pipeline  
surfacing from bluff with  
disconnected section  
laying in vegetation  
downgradient from bluff.

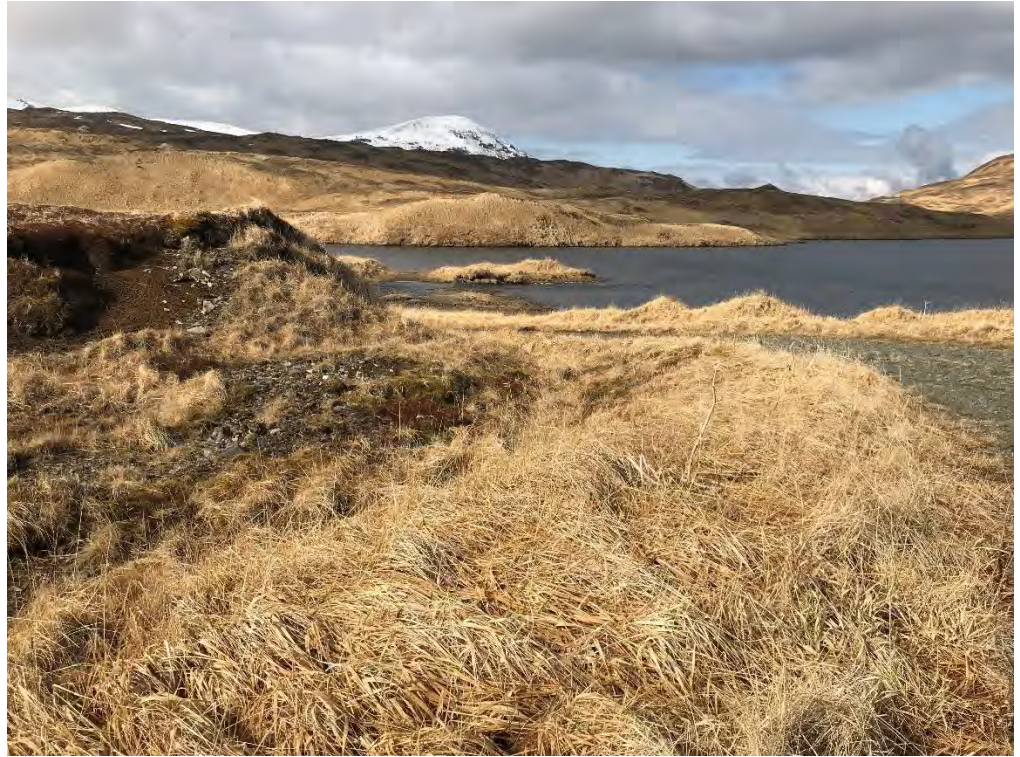
**Description:** Vegetation and gravel road within C3-01A site.

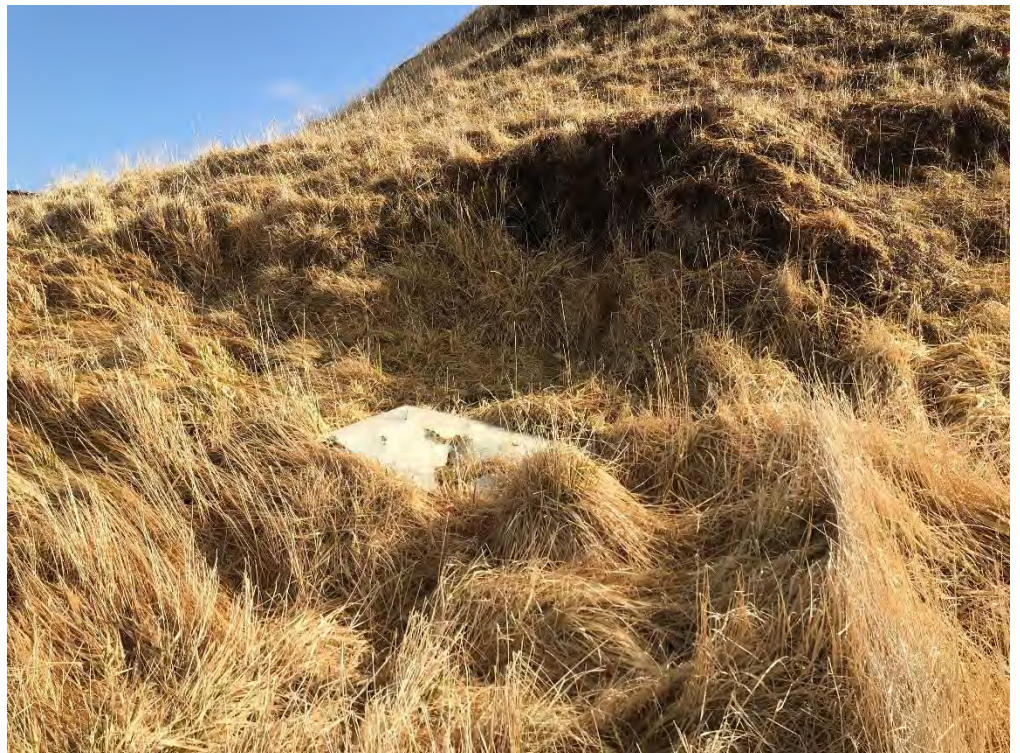
**Site Name :** OUB-1-C3-01A

**Description:** Vegetation and debris within C3-01A site.

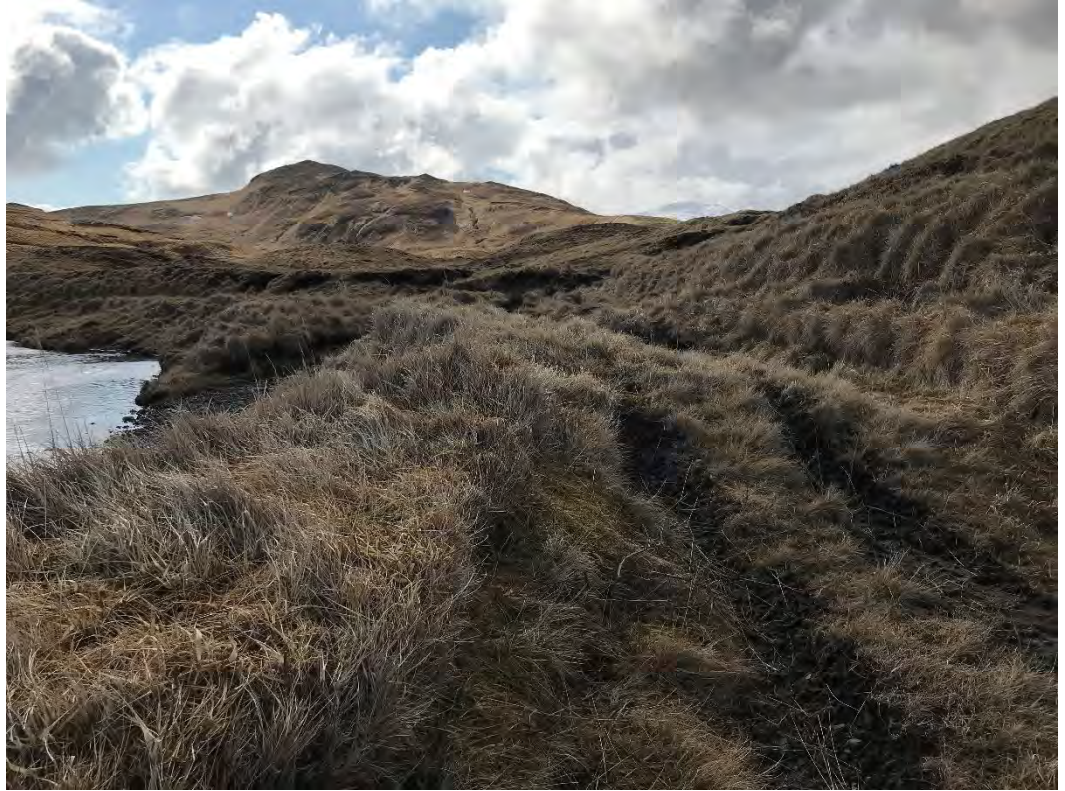
**Description:** ATV tracks present in tundra throughout site.

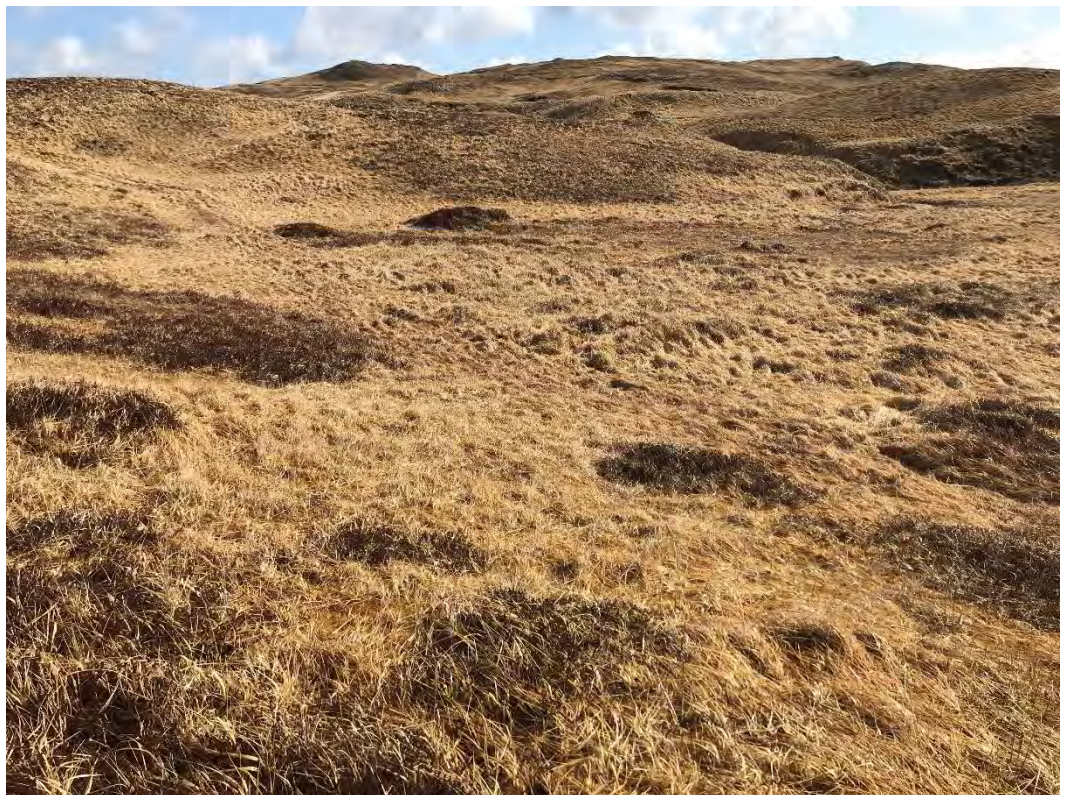
**Site Name :** OUB-1-C3-01B

**Description:** Vegetated tundra throughout site.

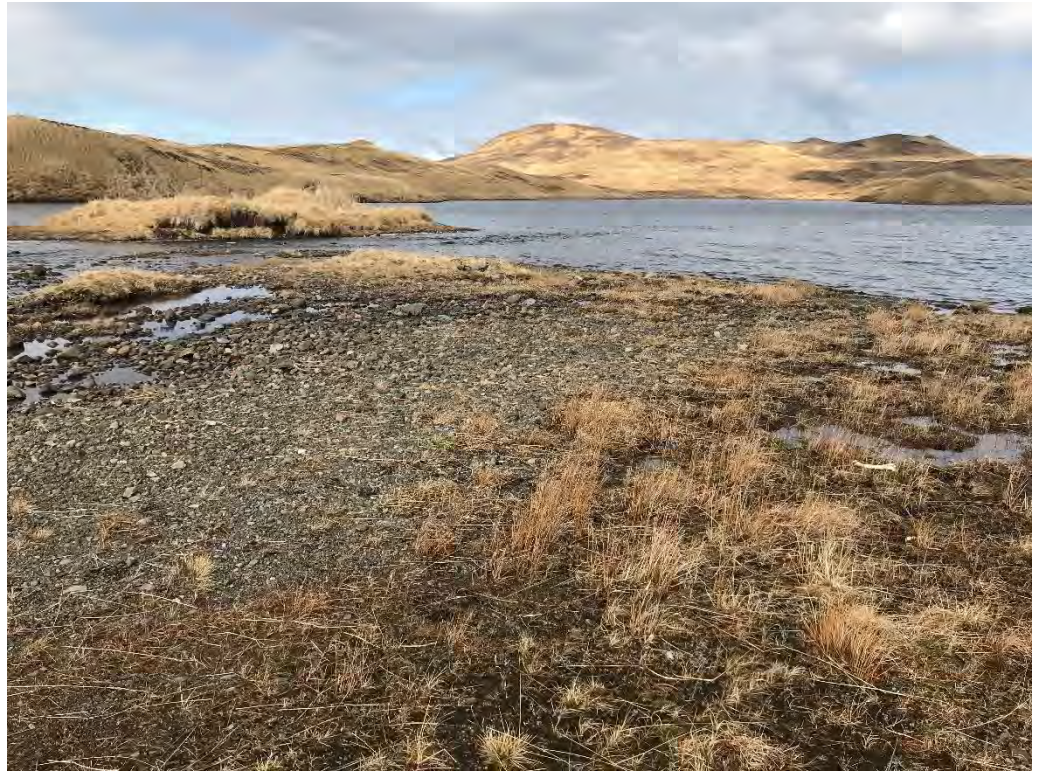
**Description:** Shoreline of Heart Lake within C3-01C site.

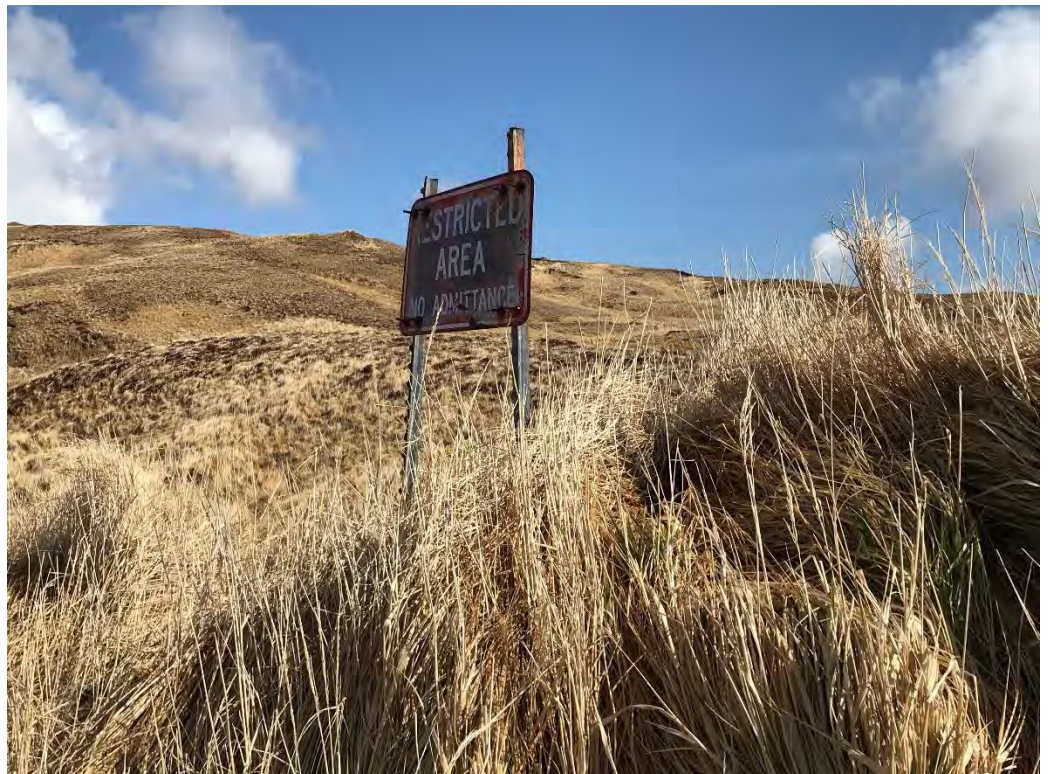
**Site Name :** OUB-1-C3-01C

**Description:** Vegetated tundra within C3-01C, restricted access sign properly installed.

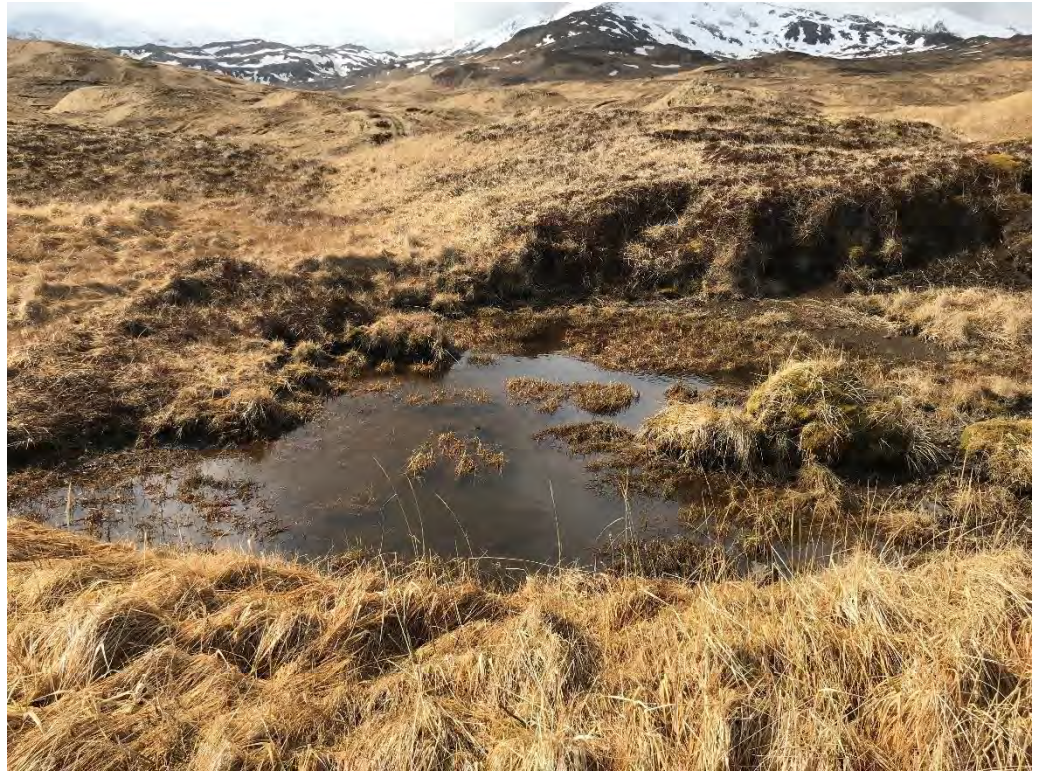
**Description:** Vegetated tundra and pooling within site.

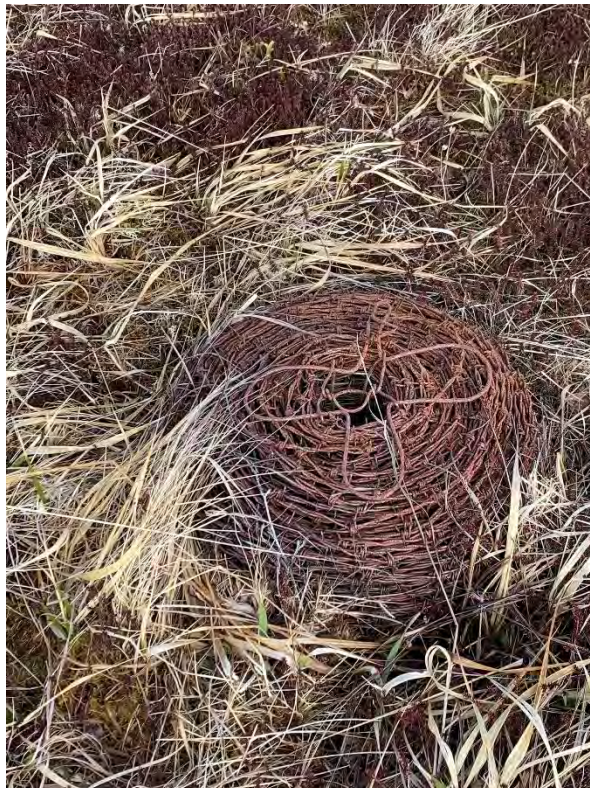
**Site Name :** OUB-1-C3-01D

**Description:** Barbed wire roll within tundra of site.

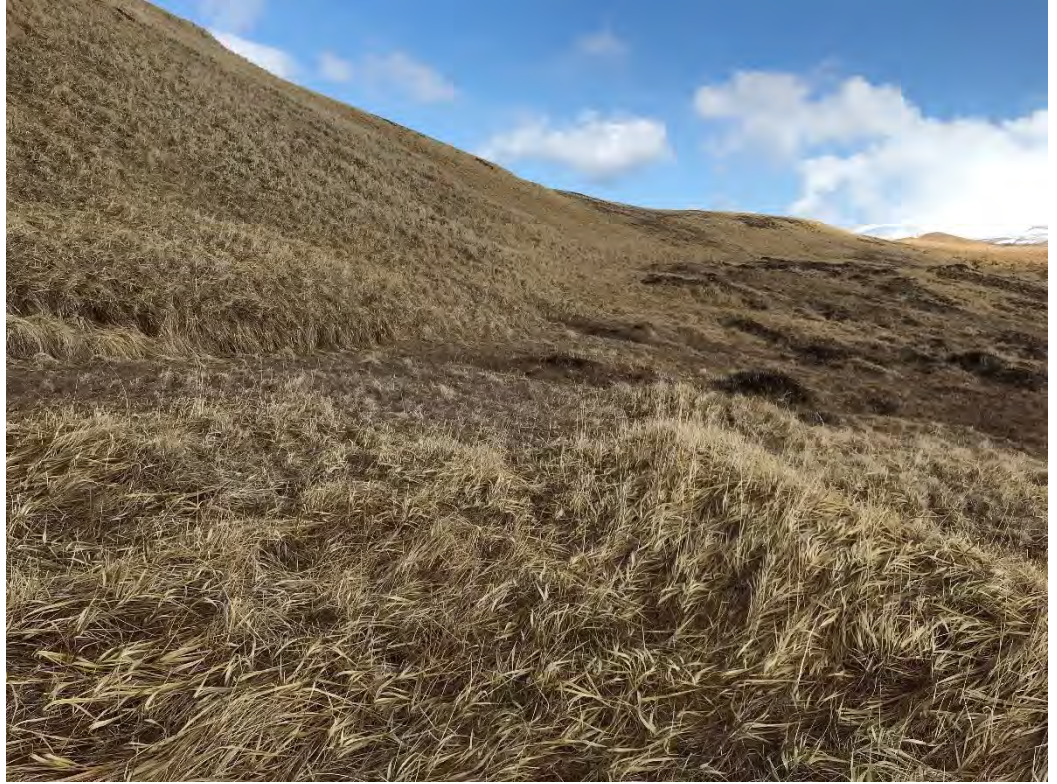
**Description:** Stressed vegetation in hillside of site.

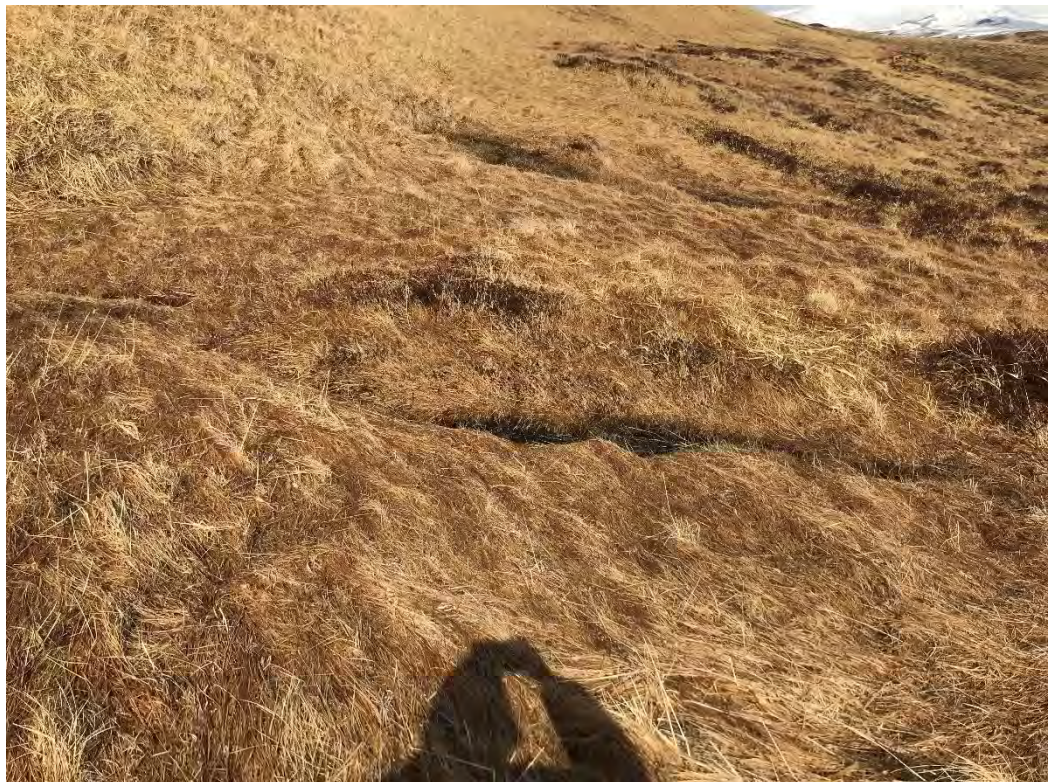
**Site Name :** OUB-1-C3-01E

**Description:** ATV tracks within tundra of site.

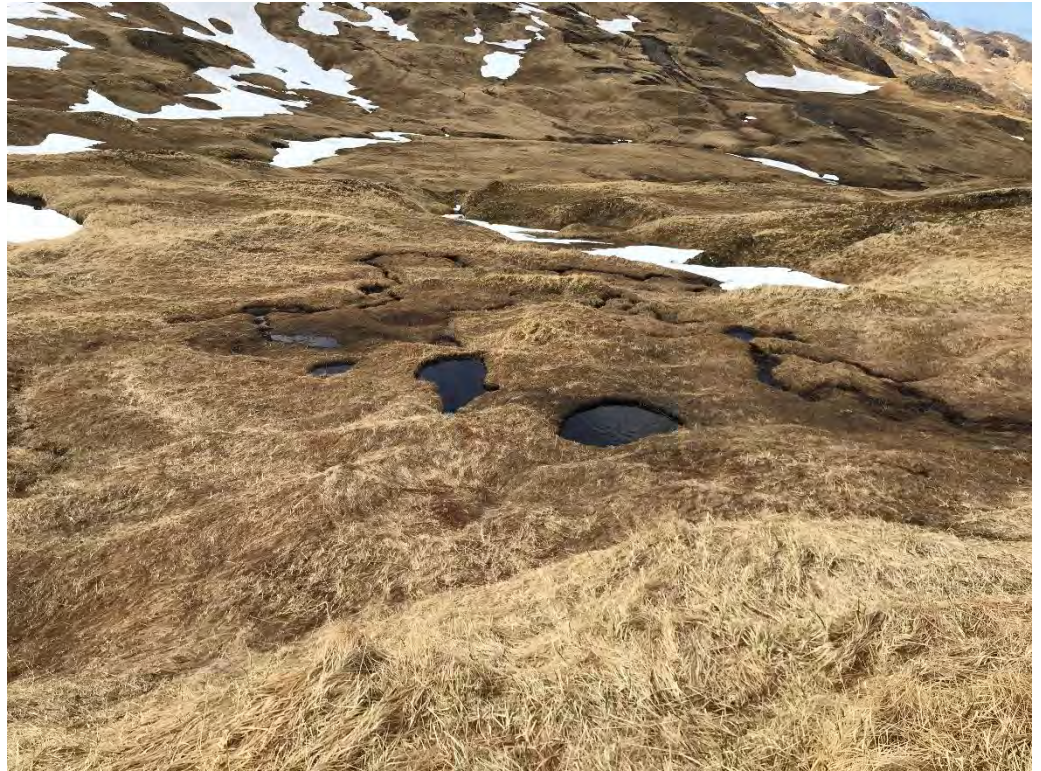
**Description:** Site  
overview looking west  
towards site from hillside  
across valley.

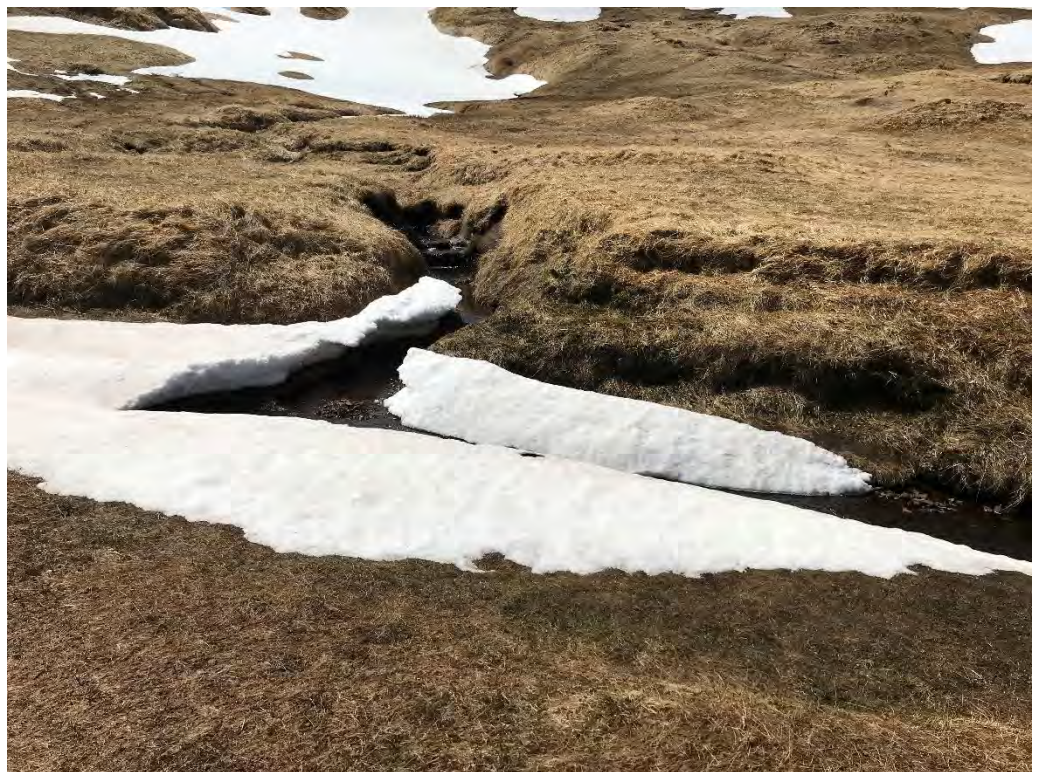
**Site Name :** OUB-1-ML-01

**Description:** Stream  
divert from Lake Bonnie  
Rose upgradient.

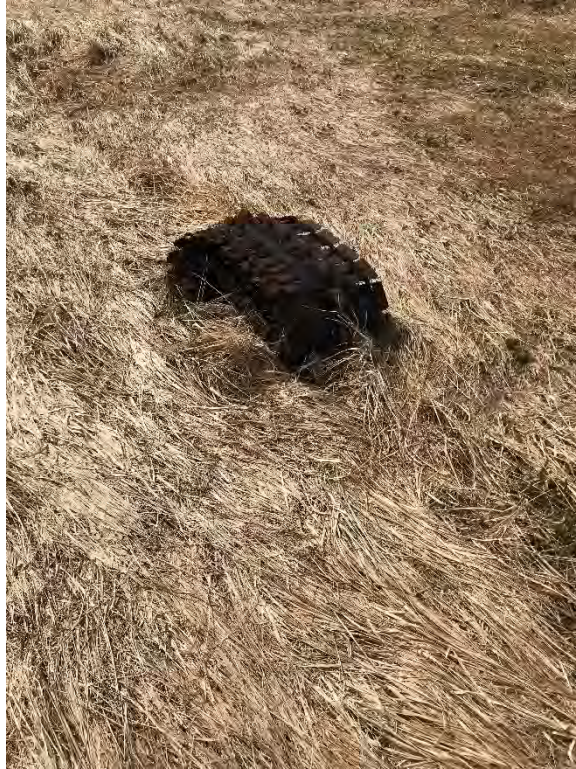
**Description:** Metallic  
debris observed within  
site. Damaged ARGO tire  
treads.

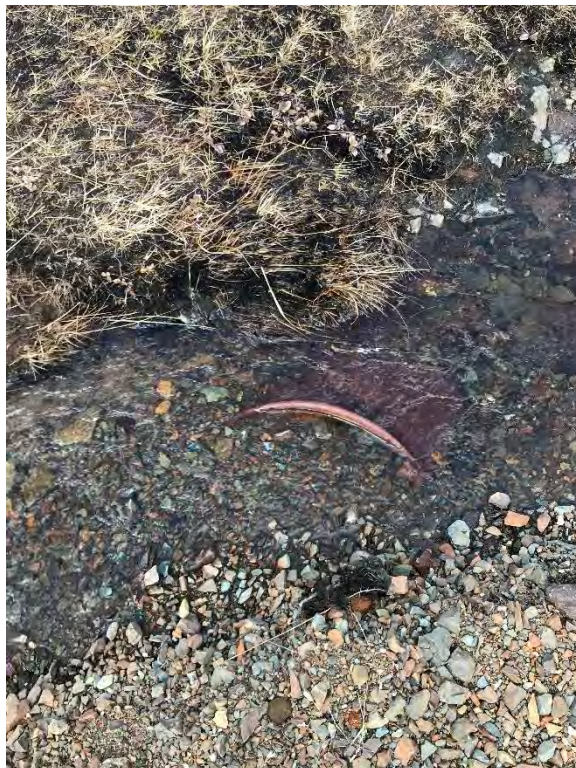
**Site Name :** OUB-1-ML-01

**Description:** Rusty 55-  
gallon drum within stream  
on site.

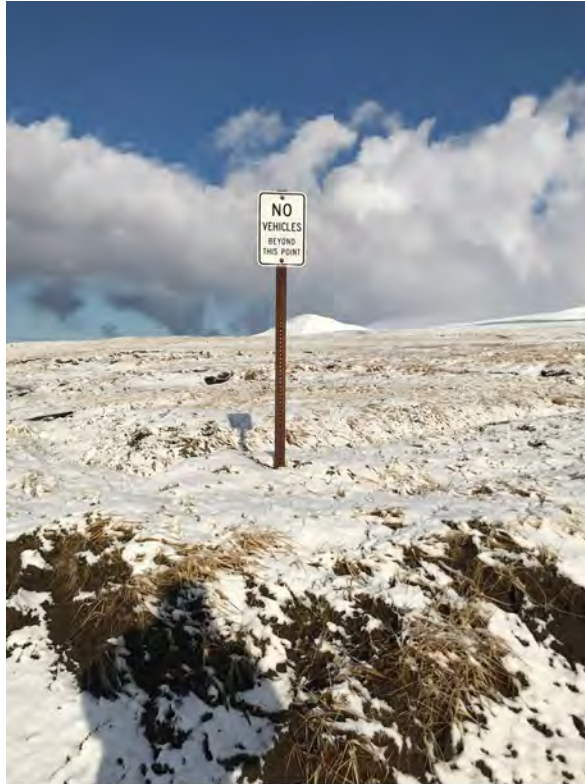
**Description:** No vehicles  
beyond this point sign  
adjacent to the parking lot.

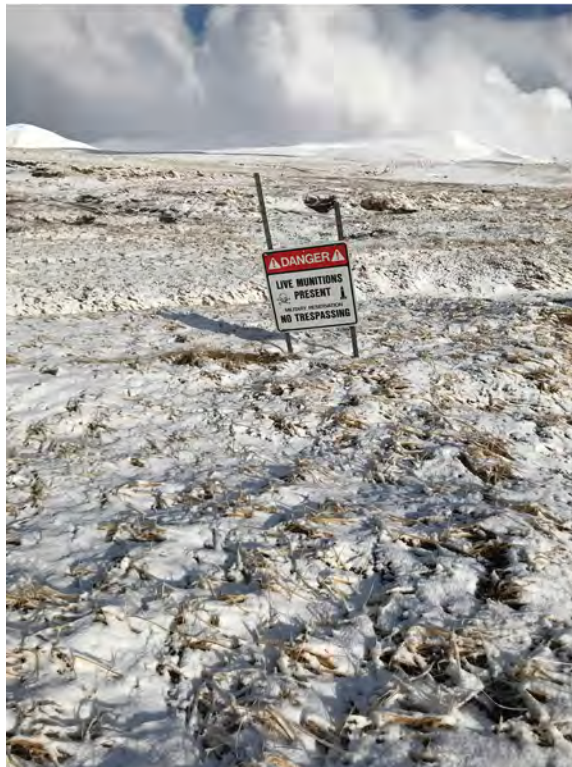
**Site Name:** OUB-1-MM

**Description:** Photo of no  
trespassing sign for MM.

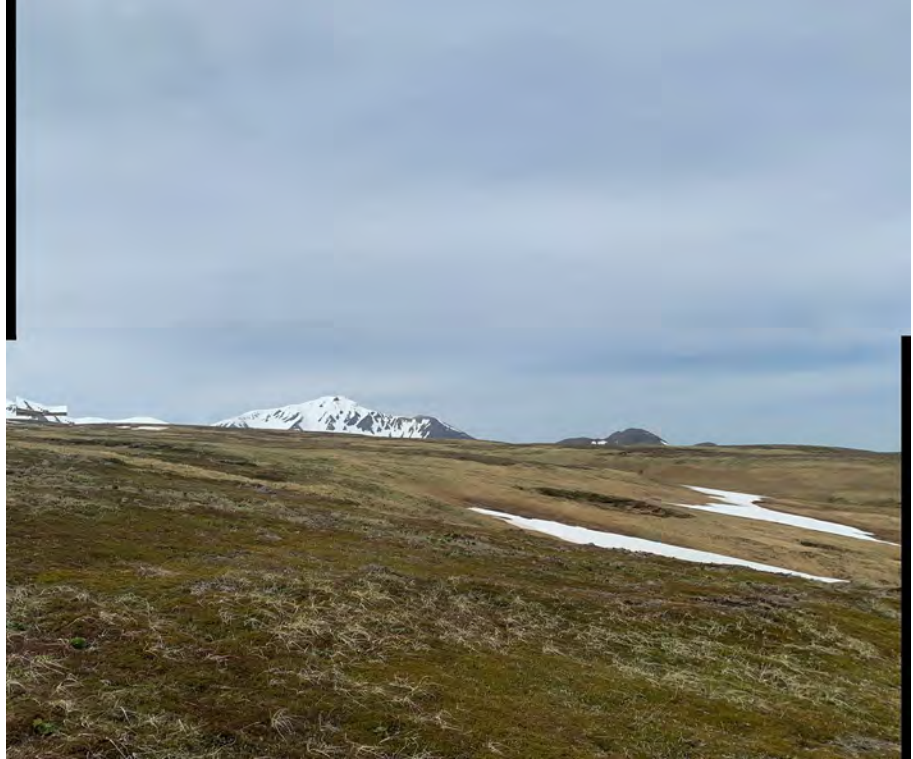
**Description:** Overview of  
Mt Moffett, no signs of  
recent activity.
