# Fifth Five-Year Review Operable Units A and B-1 Former Adak Naval Complex

## **Naval Air Station Adak**

**Fifth Five-Year Review  
Operable Units A and B-1  
Former Adak Naval Complex  
NAVAL AIR STATION ADAK, ADAK ISLAND, ALASKA**

**December 2021**

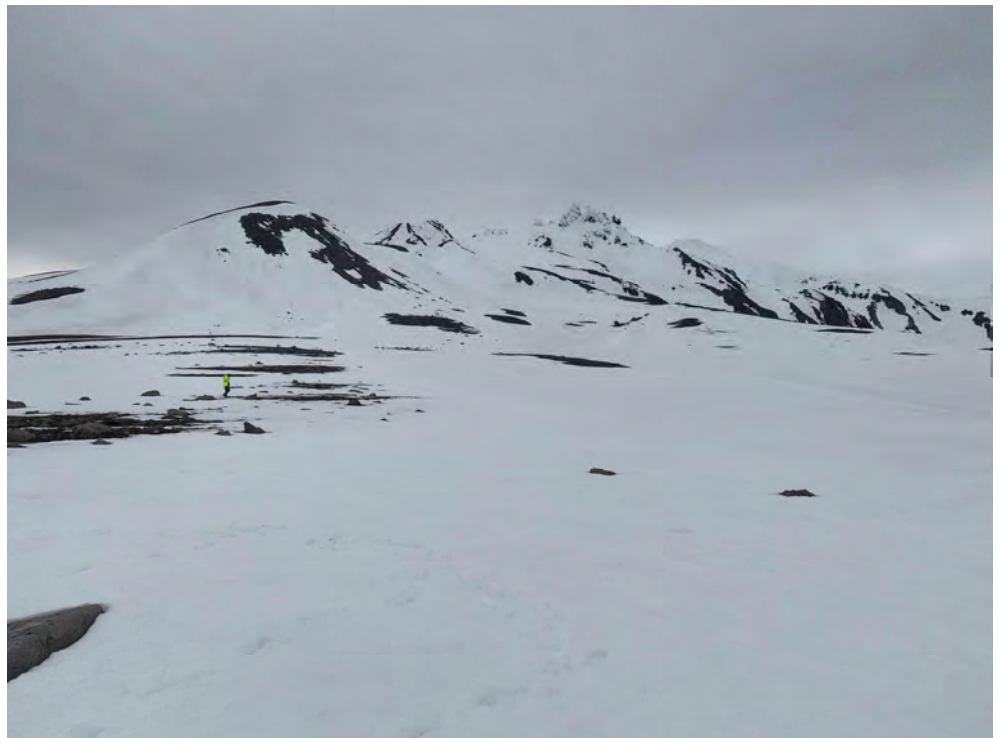
**Site Name:** OUB-1-MM

**Description:** Overview of  
Mt Moffett, no signs of  
recent activity.
