Naval Facilities Engineering Systems Command Washington Washington, D.C.

Comprehensive Fourth Five-Year Review Report

Former Naval Surface Warfare Center White Oak Silver Spring, Maryland

June 2022

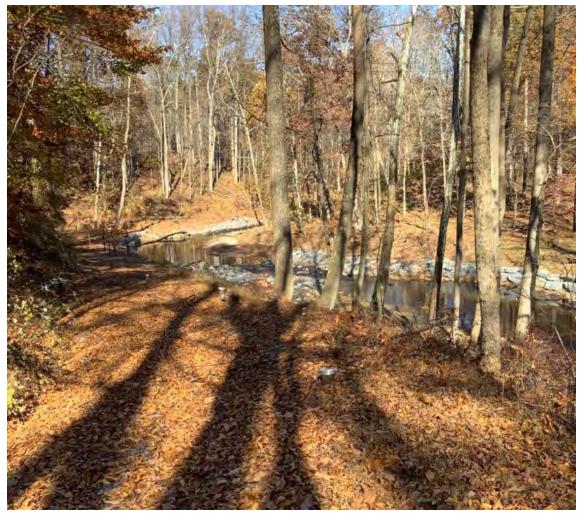
Looking north toward former perimeter road that crossed Paint Branch. Area recently renovated.

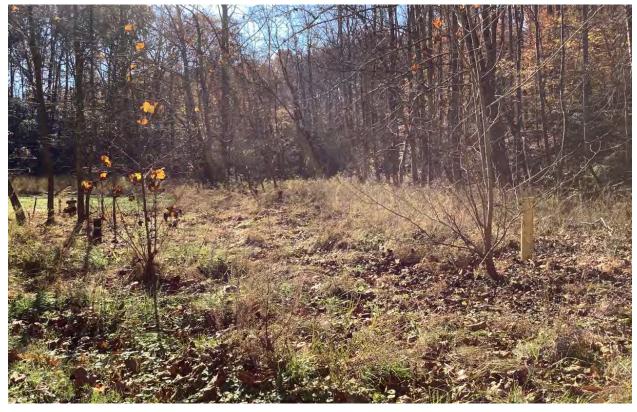
Looking south at SWMU 87.

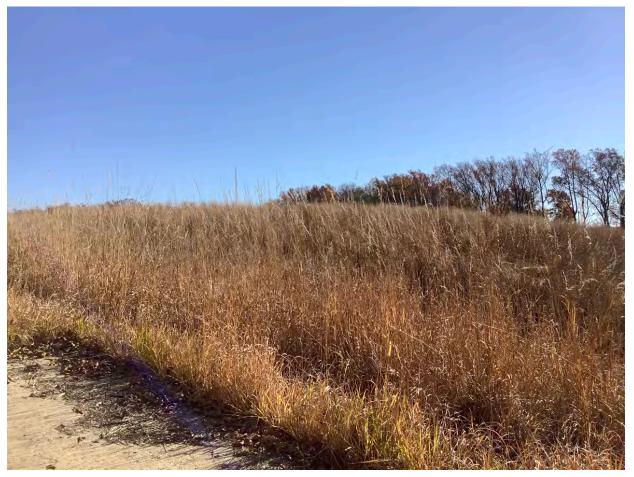
OU2 Photos

Looking southeast from Perimeter Road at OU2.
