Naval Facilities Engineering Command Southwest BRAC PMO West San Diego, CA

Second Five-Year Review

Former Naval Station Treasure Island, CA

August 5, 2020

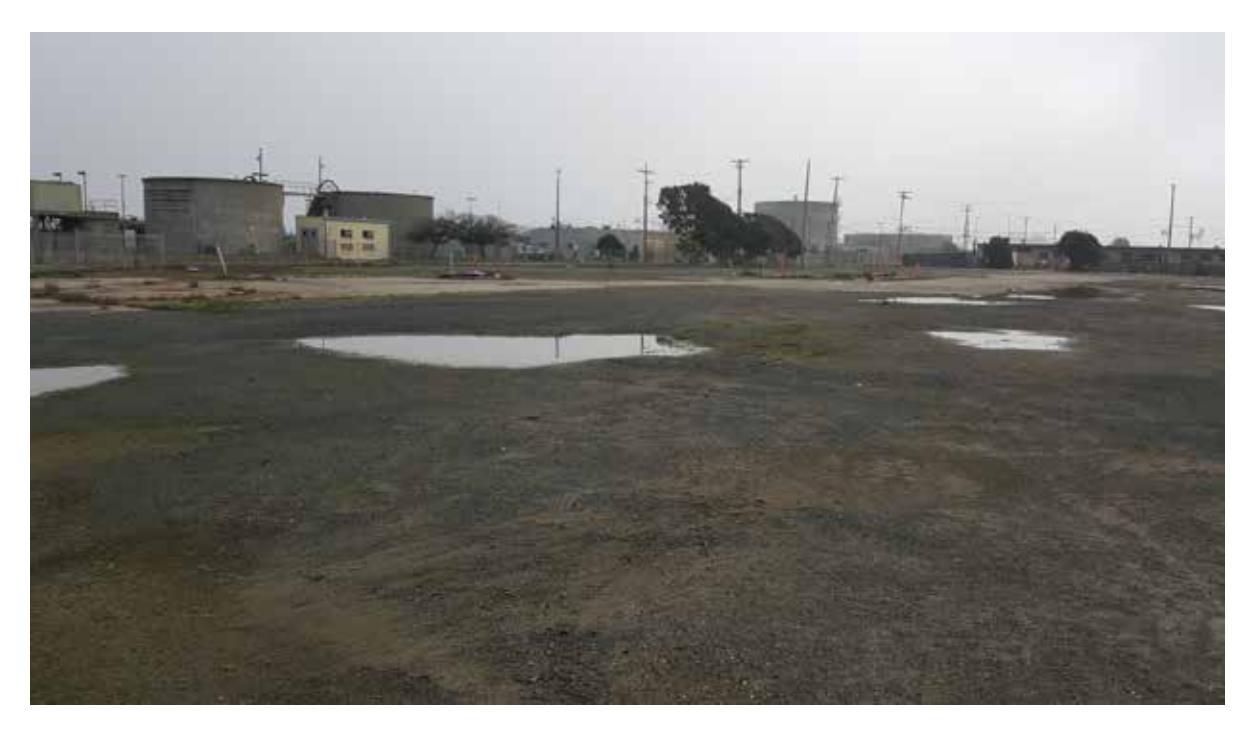
Photograph 1: View of Site 6 from south corner of Building 461, looking southeast (1/10/2019).

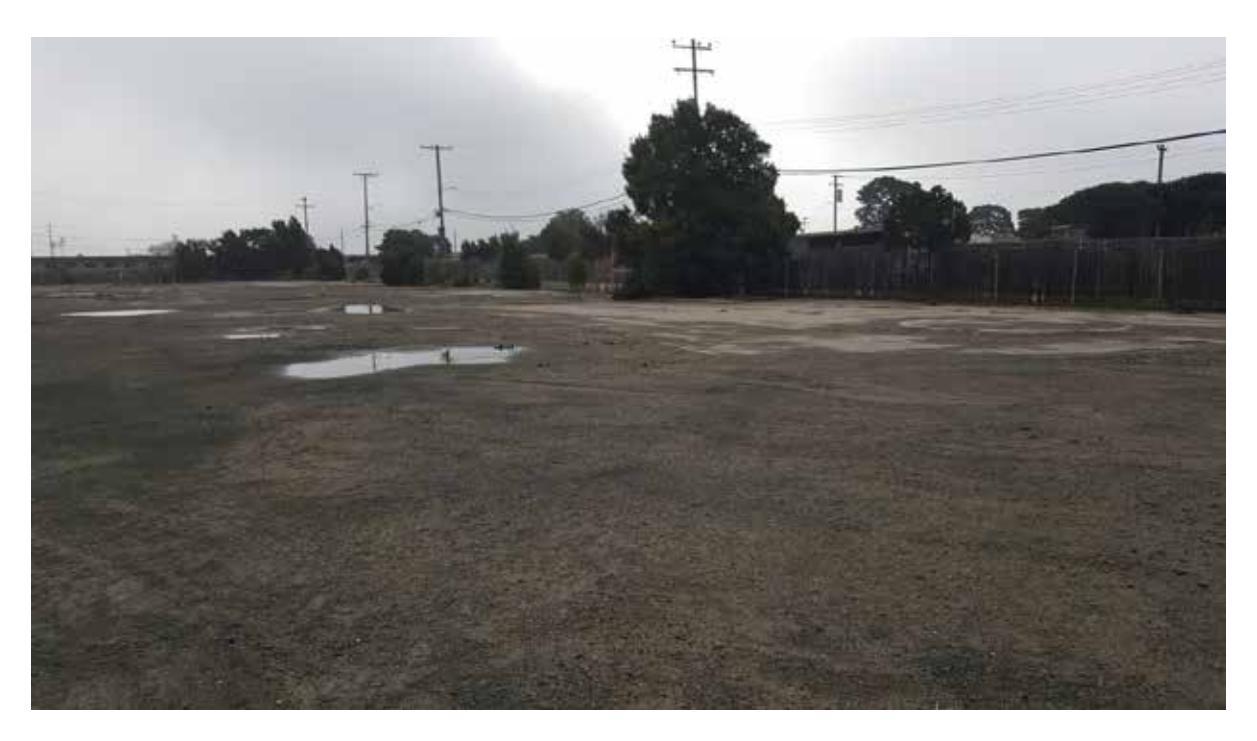
Photograph 2: View of Site 6 from south corner of Building 461, looking southwest (1/10/2019).

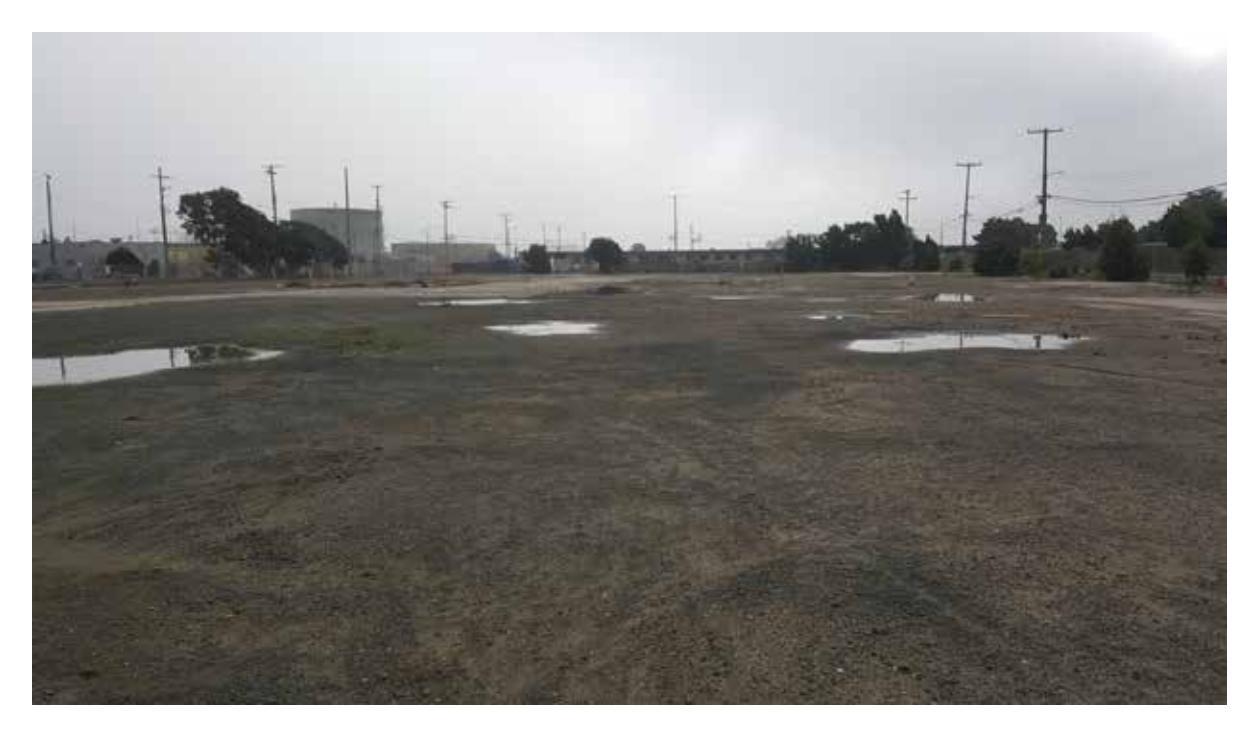
Photograph 3: View of Site 6 from south corner of Building 461, looking south (1/10/2019).

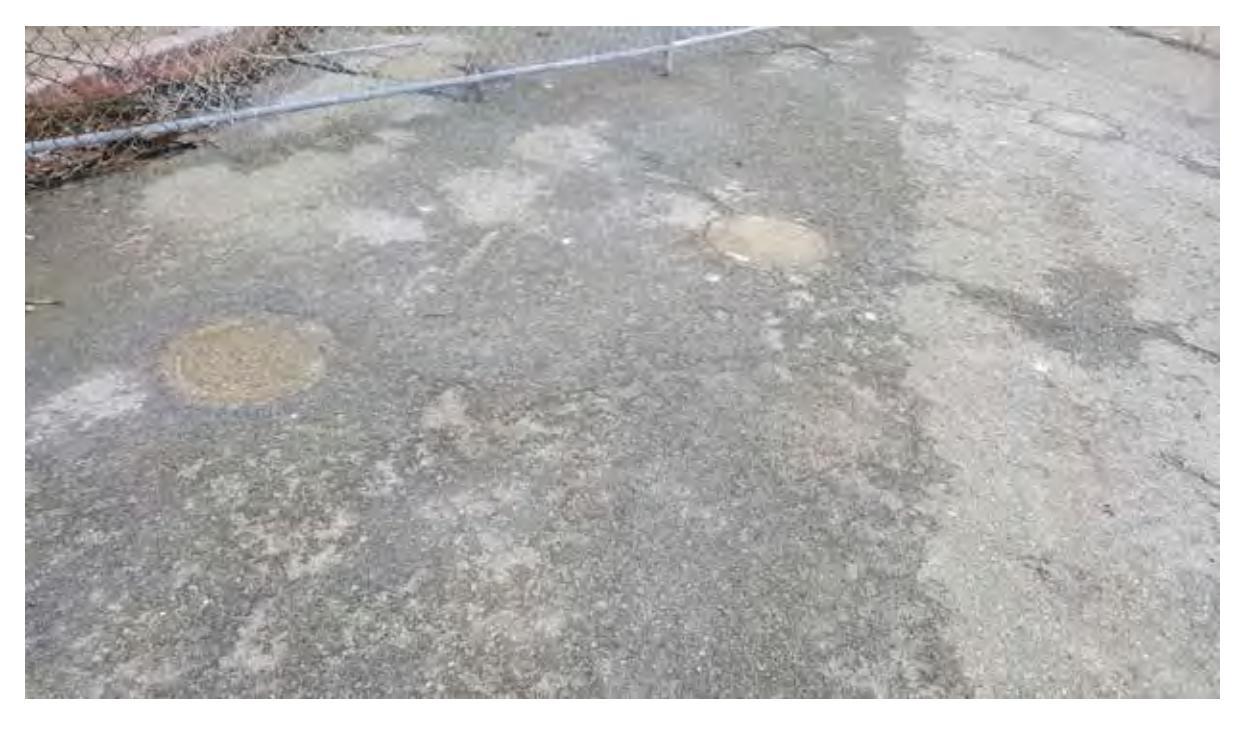
Photograph 4: View of former monitoring well locations near well 06-MW25 at Site 6 (1/10/2019).

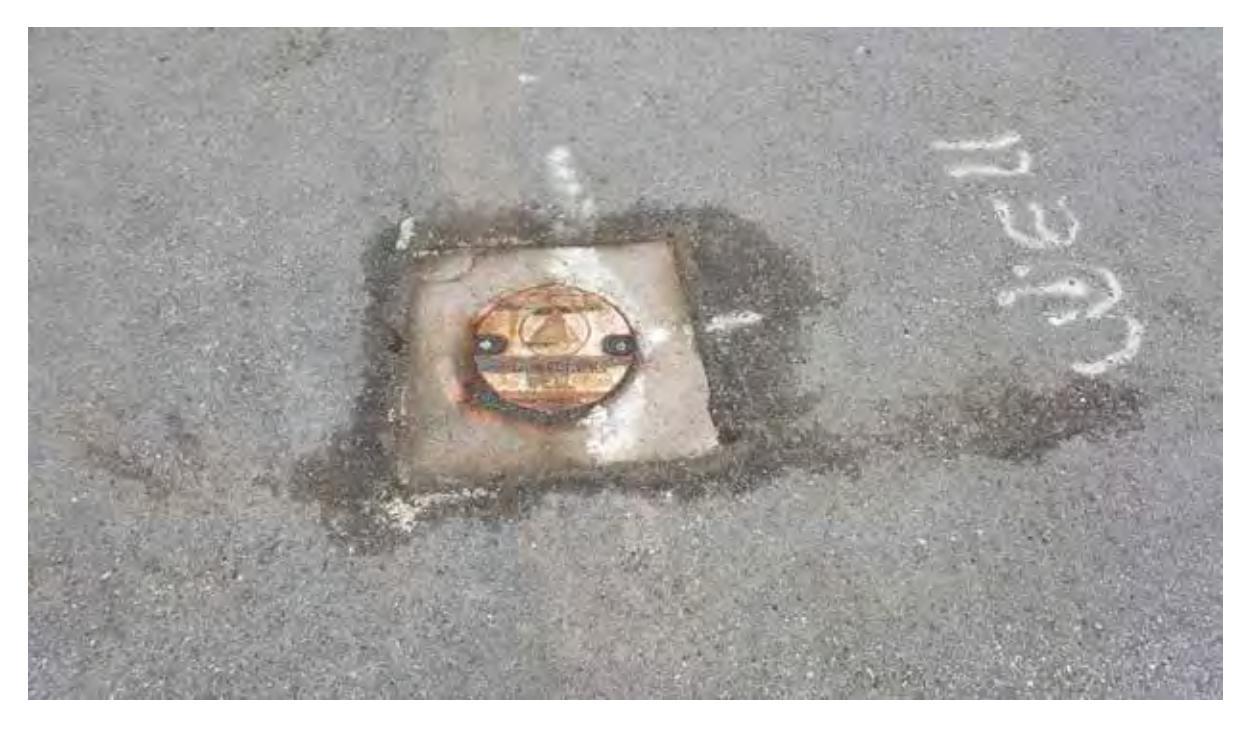
Photograph 6: View of well 06-MW25 at Site 6 (1/10/2019).

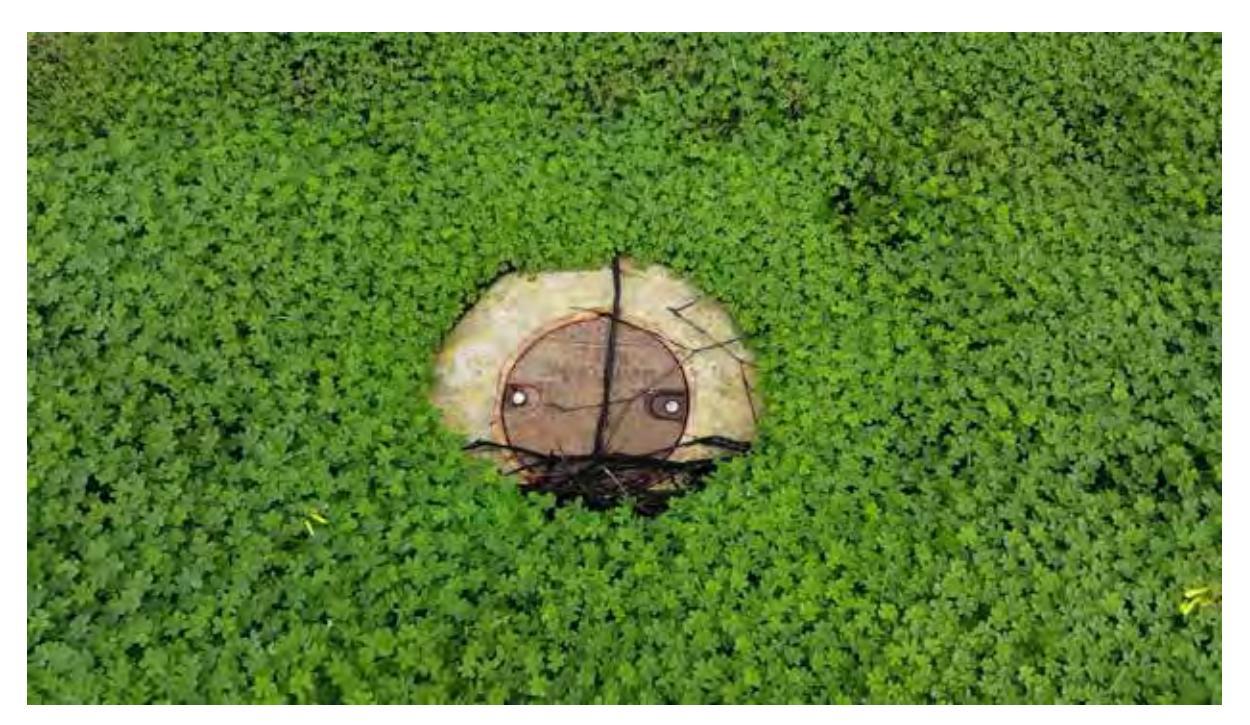
Photograph 7: View of well 06-MW26 at Site 6 (1/10/2019).

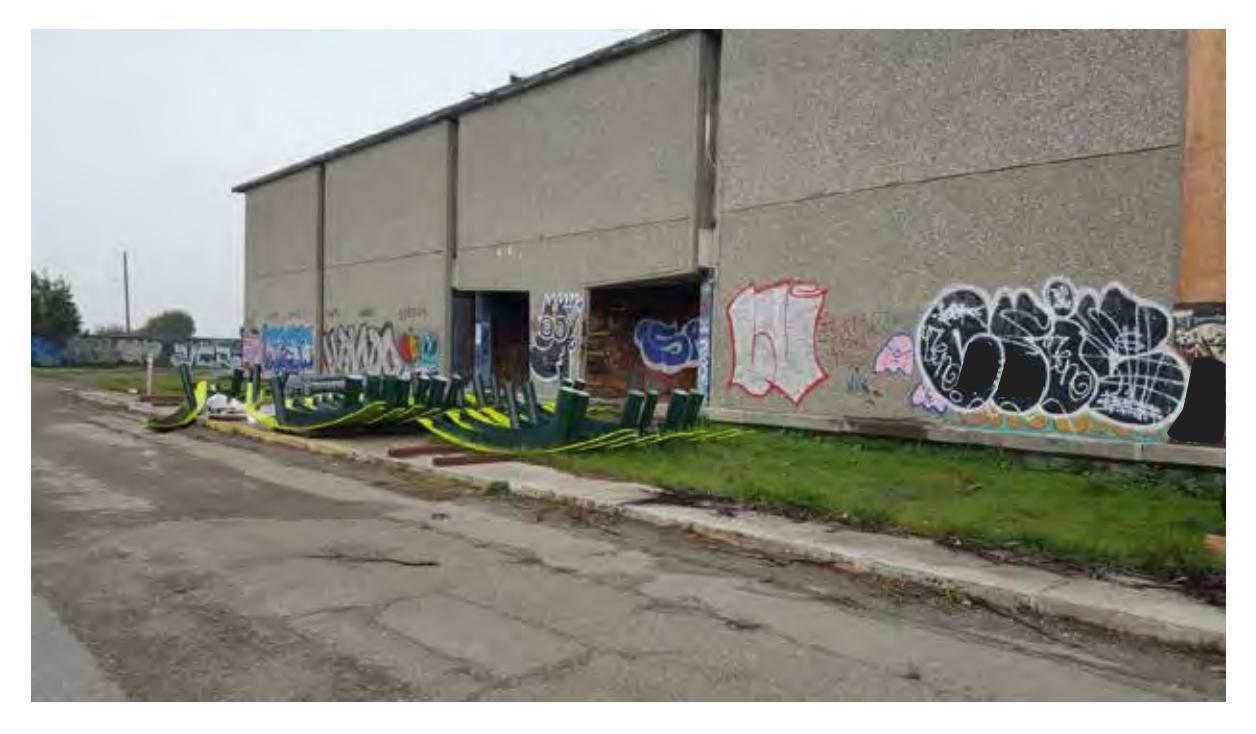
Photograph 8: View of south wall of Building 461, looking west (1/10/2019).

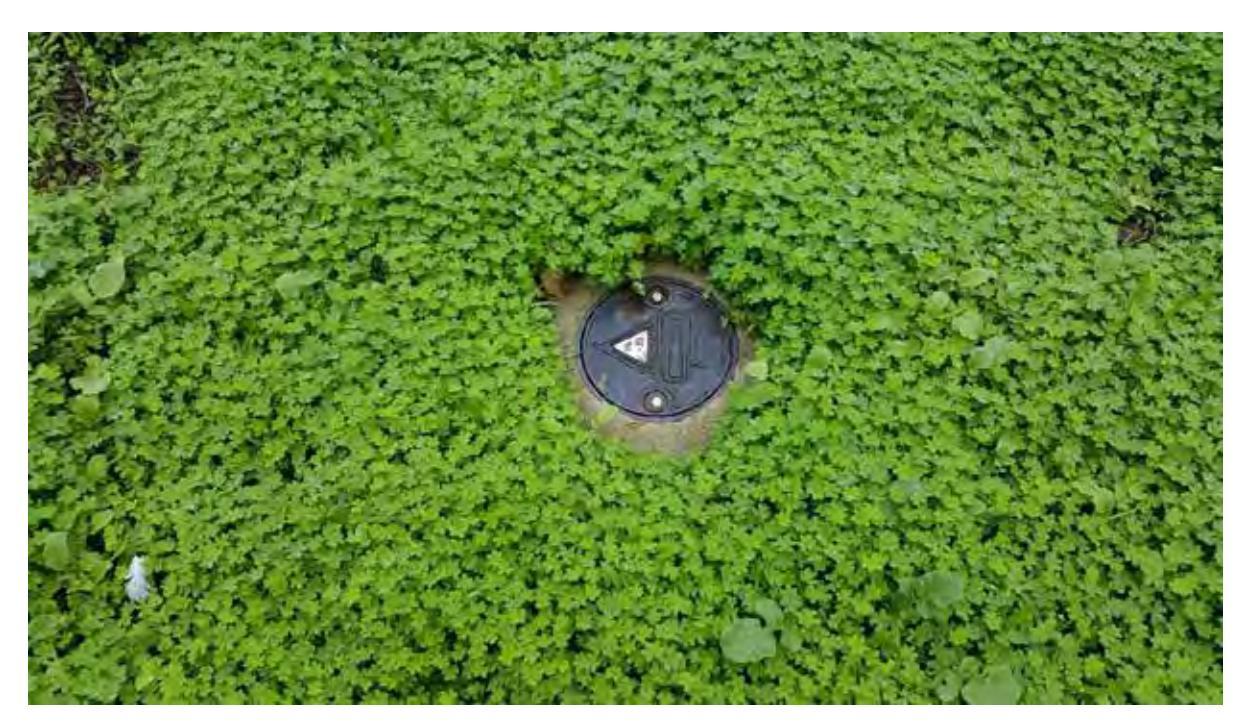
Photograph 9: View of well 06-MW33 at Site 6 (1/10/2019).

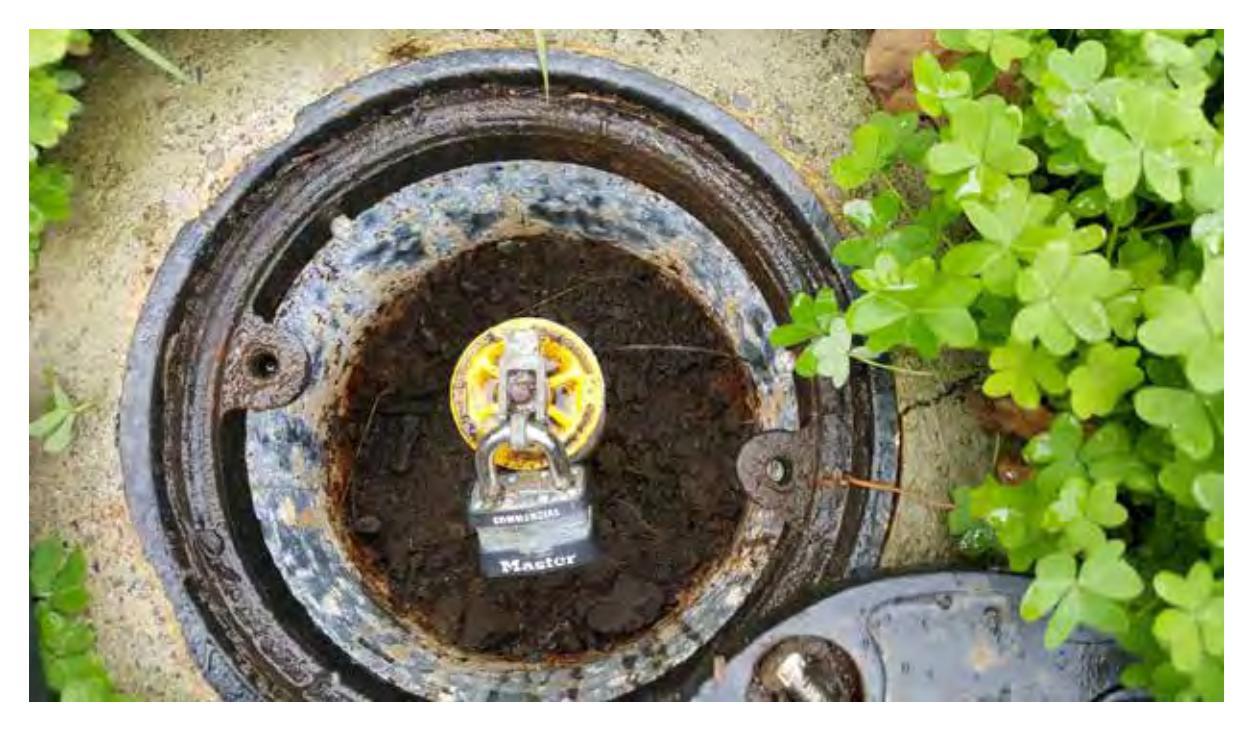
Photograph 10: View of well box interior of well 06-MW33 at Site 6 (1/10/2019).

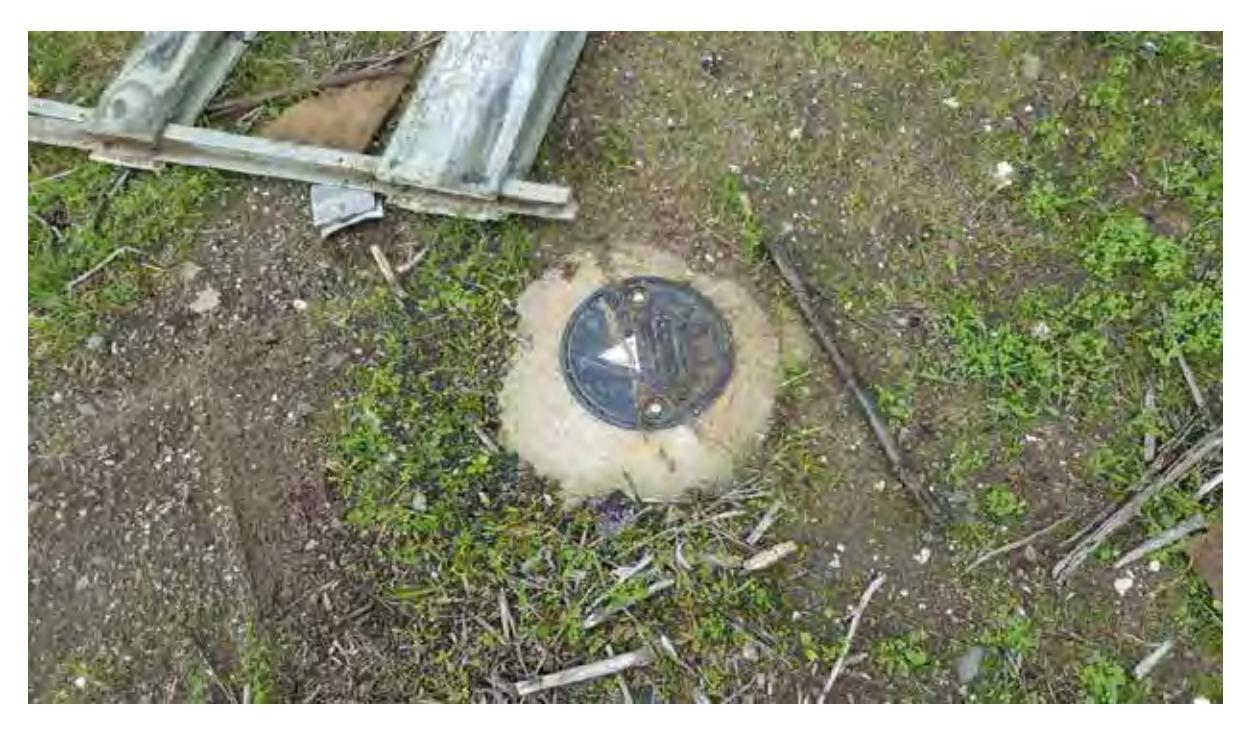
Photograph 11: View of well 06-MW32 at Site 6 (1/10/2019).

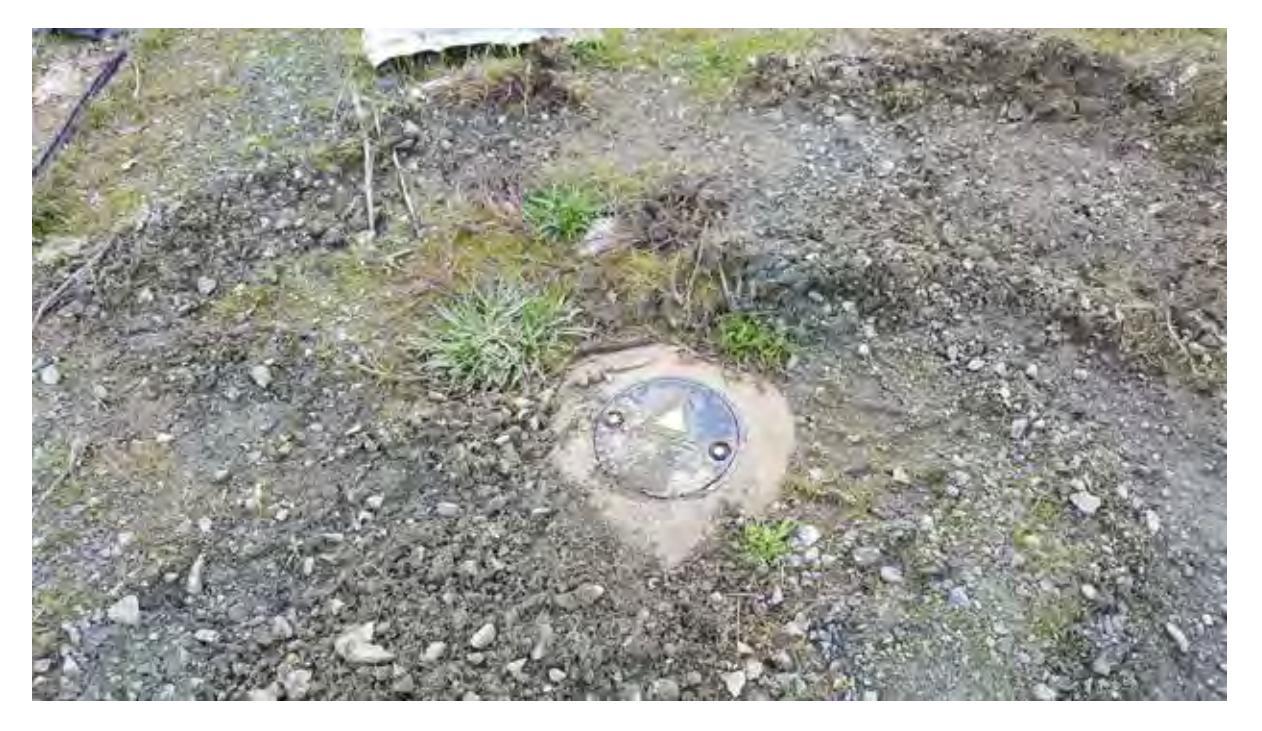
Photograph 12: View of well 06-MW35 at Site 6 (1/10/2019).

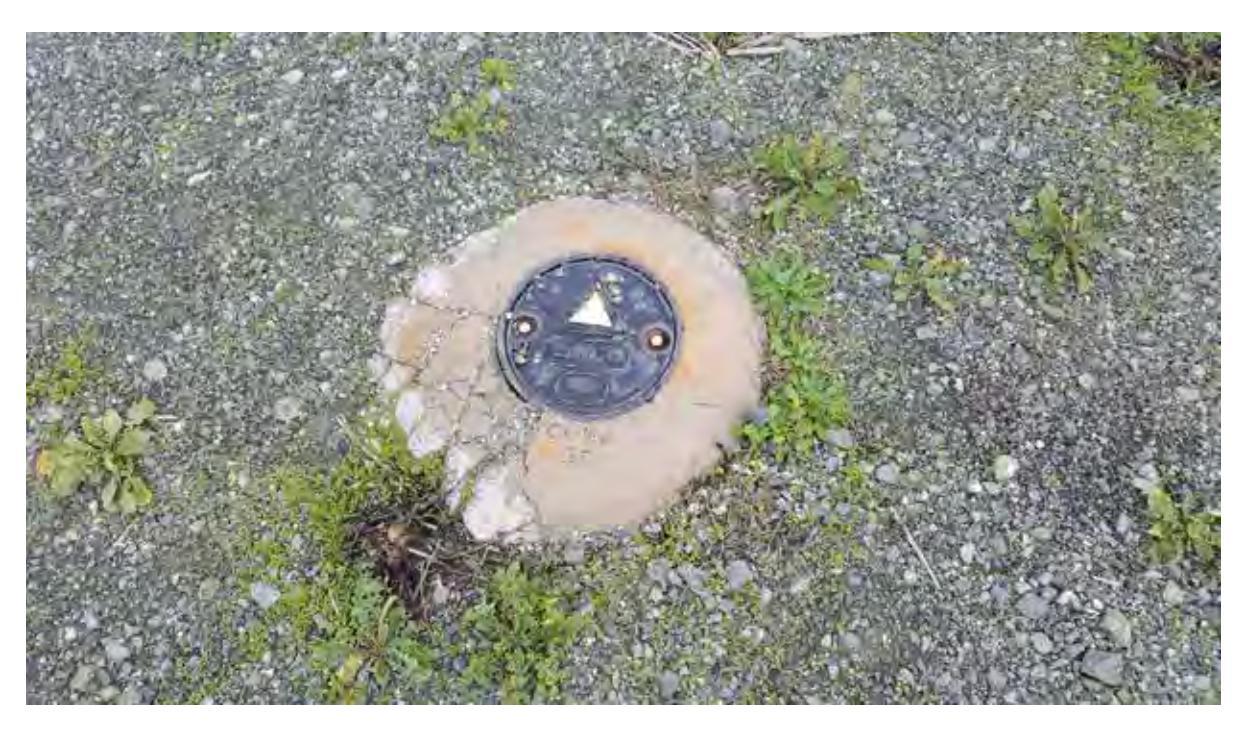
Photograph 13: View of well 06-MW34 at Site 6 (1/10/2019).

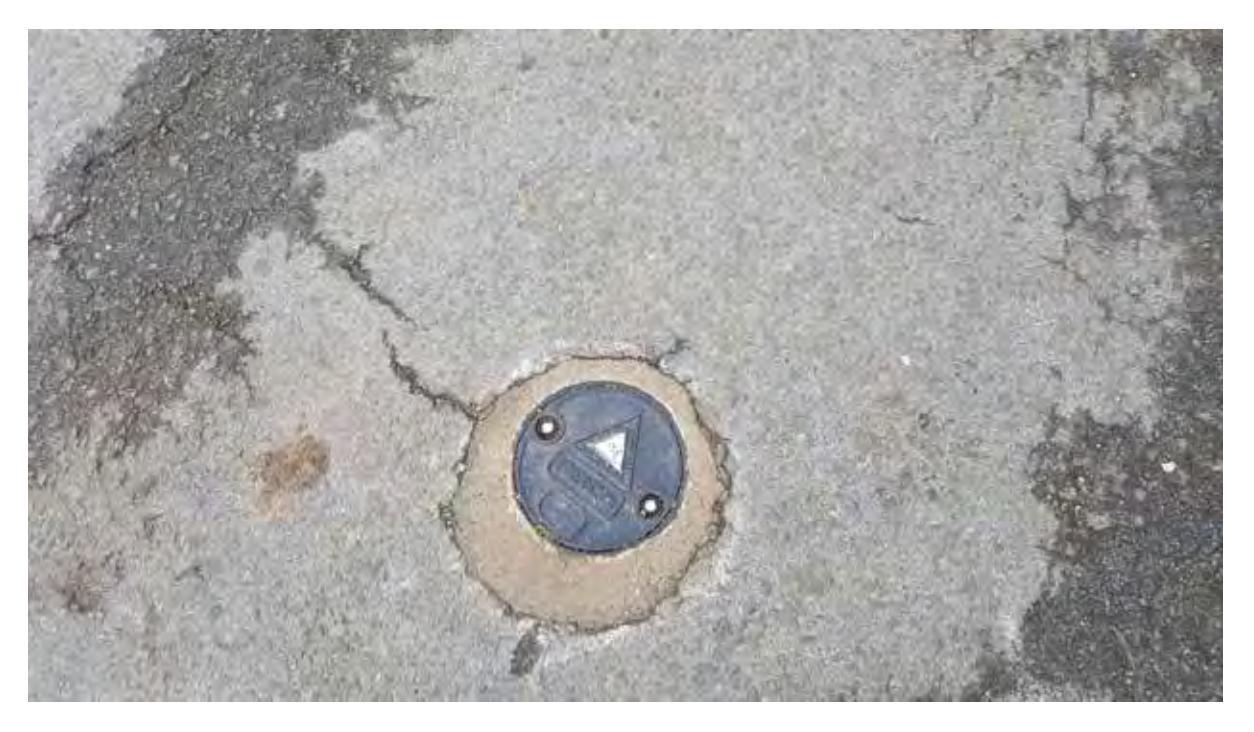
Photograph 14: View of well 06-MW36 at Site 6 (1/10/2019).

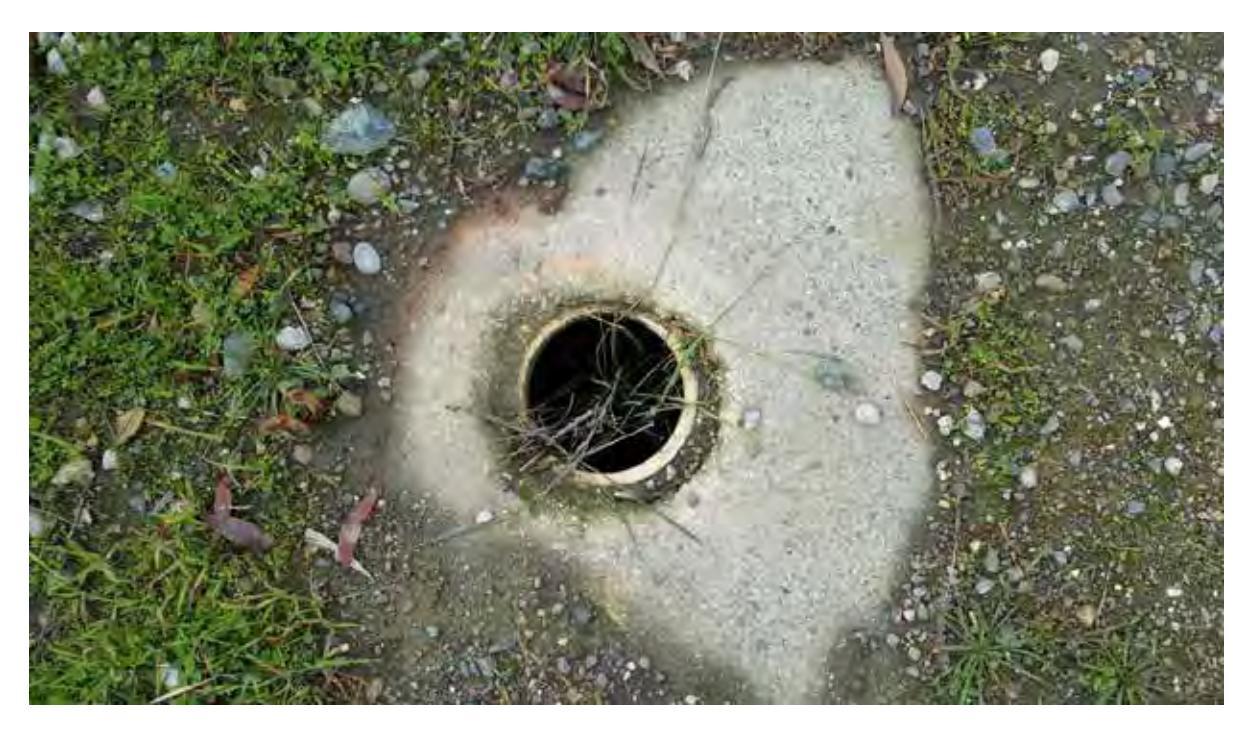
Photograph 15: View of uncapped former well or similar structure adjacent to well 06-MW36 at Site 6 (1/10/2019).

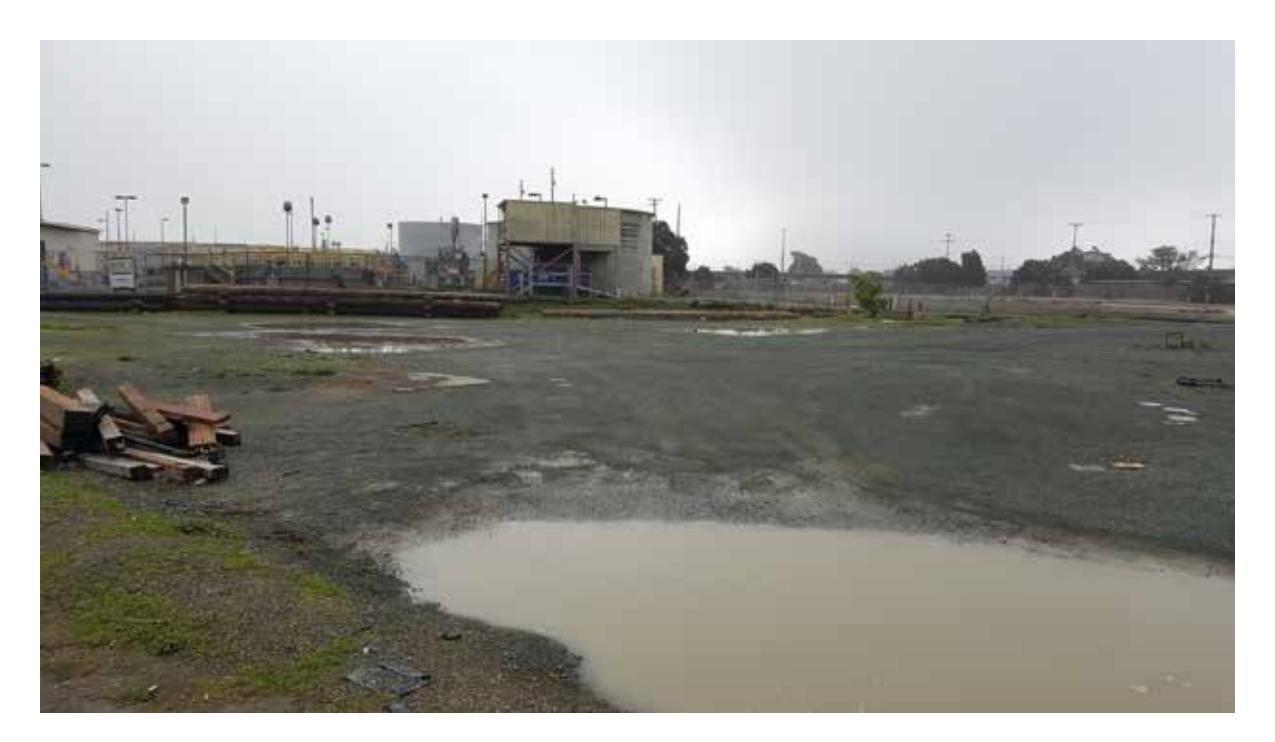
Photograph 18: View of Site 6 from northeast boundary, looking southwest (1/10/2019).

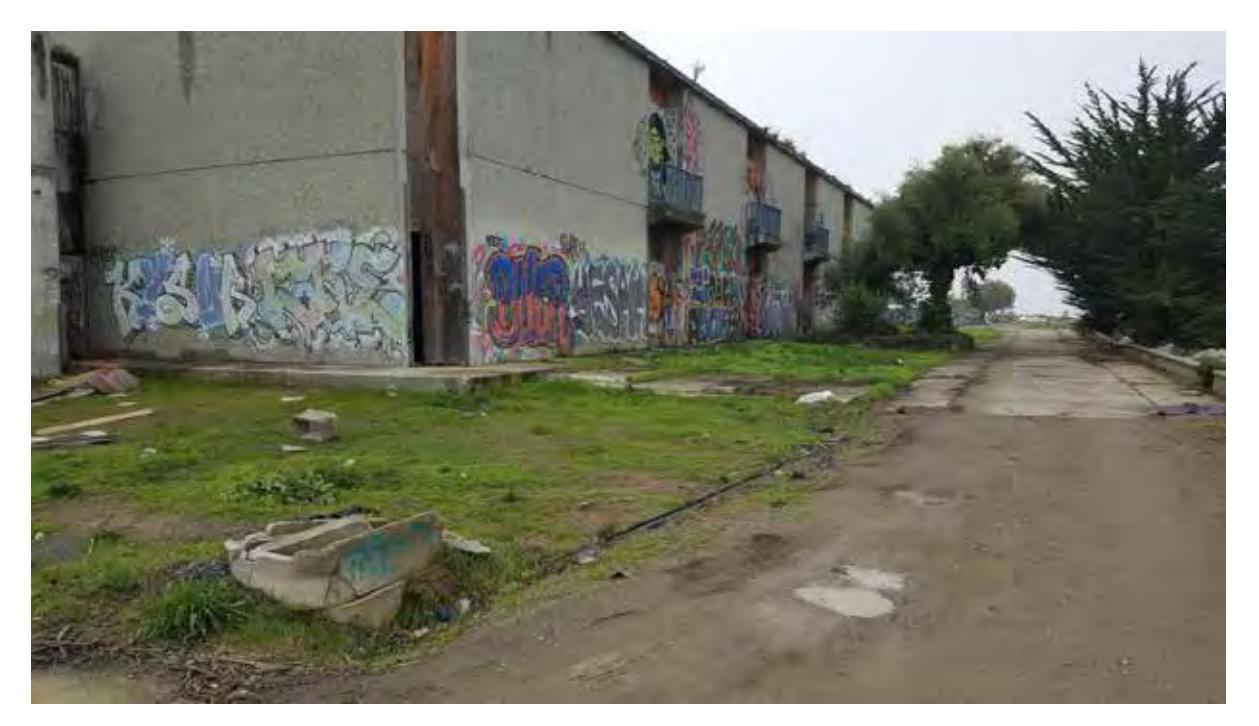
Photograph 19: View of vehicle accessway adjacent to Site 6 northeast boundary from northeast corner of Building 461, looking northwest (1/10/2019).

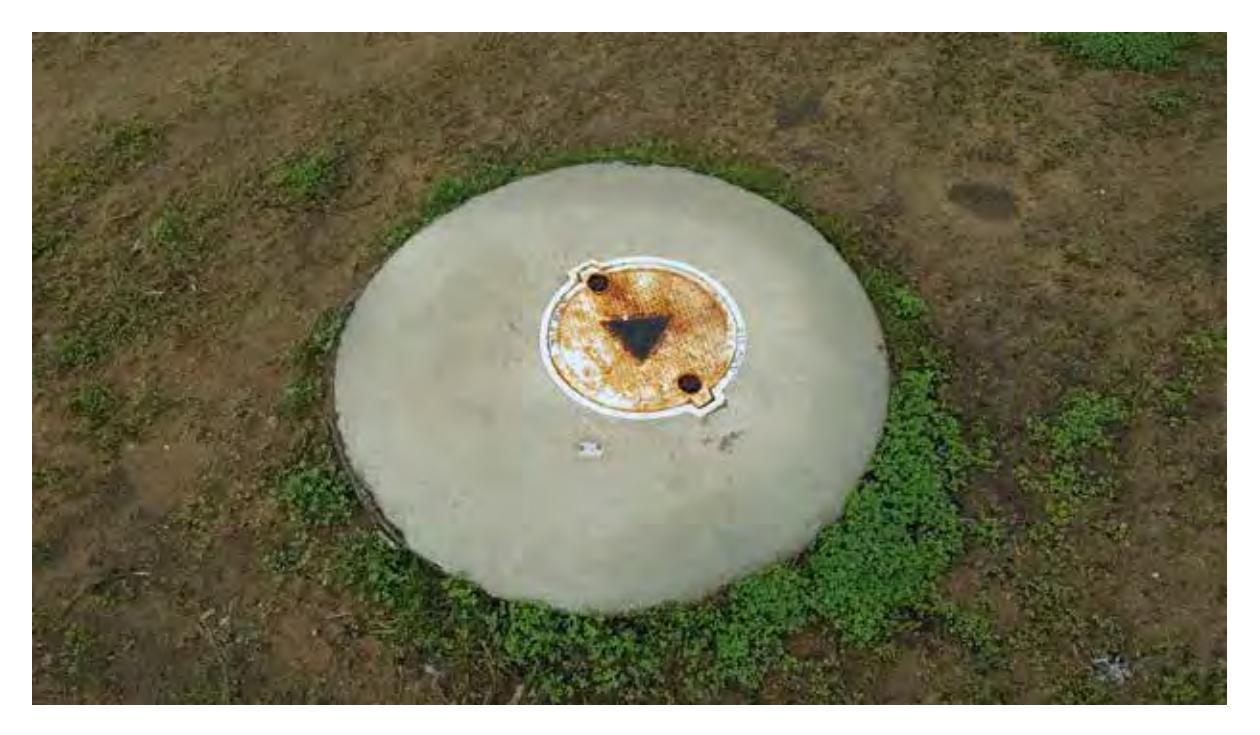
Photograph 1: View of well 12-MW21R at Site 12 Gateview Petroleum Area (1/10/2019).

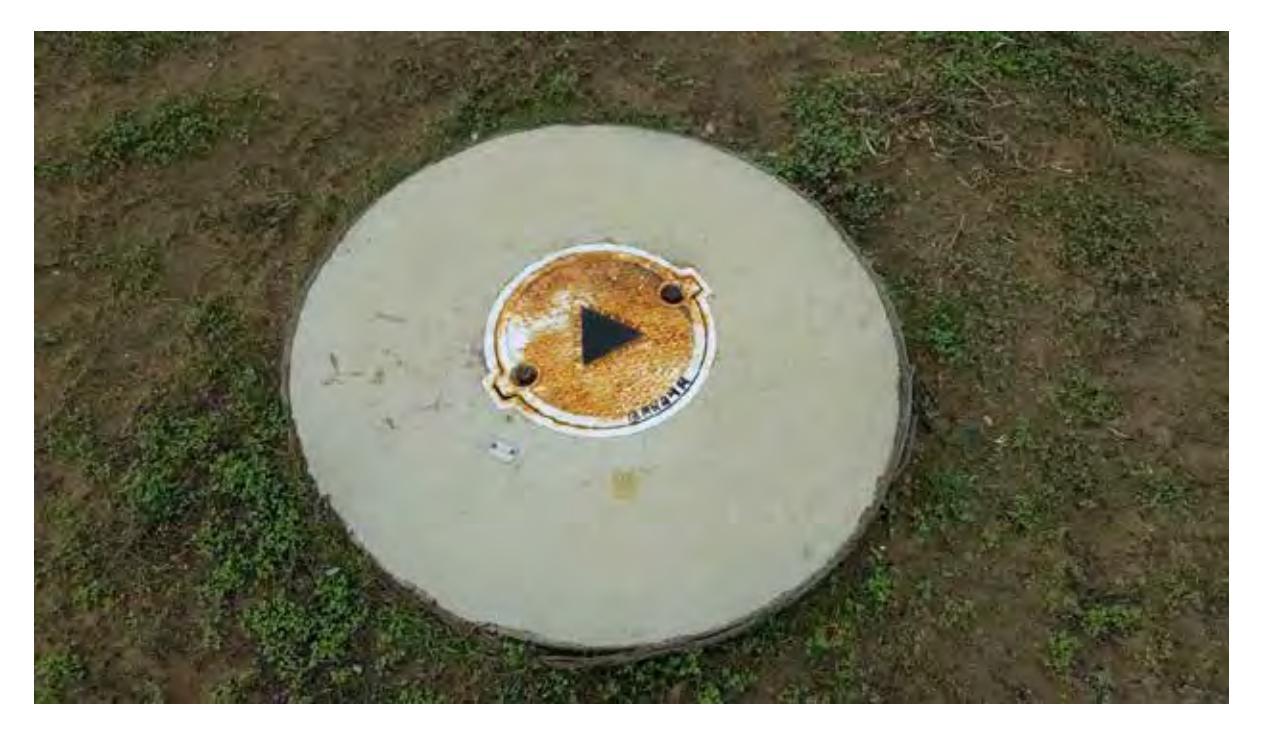
Photograph 2: View of well 12-MW24R at Site 12 Gateview Petroleum Area (1/10/2019).

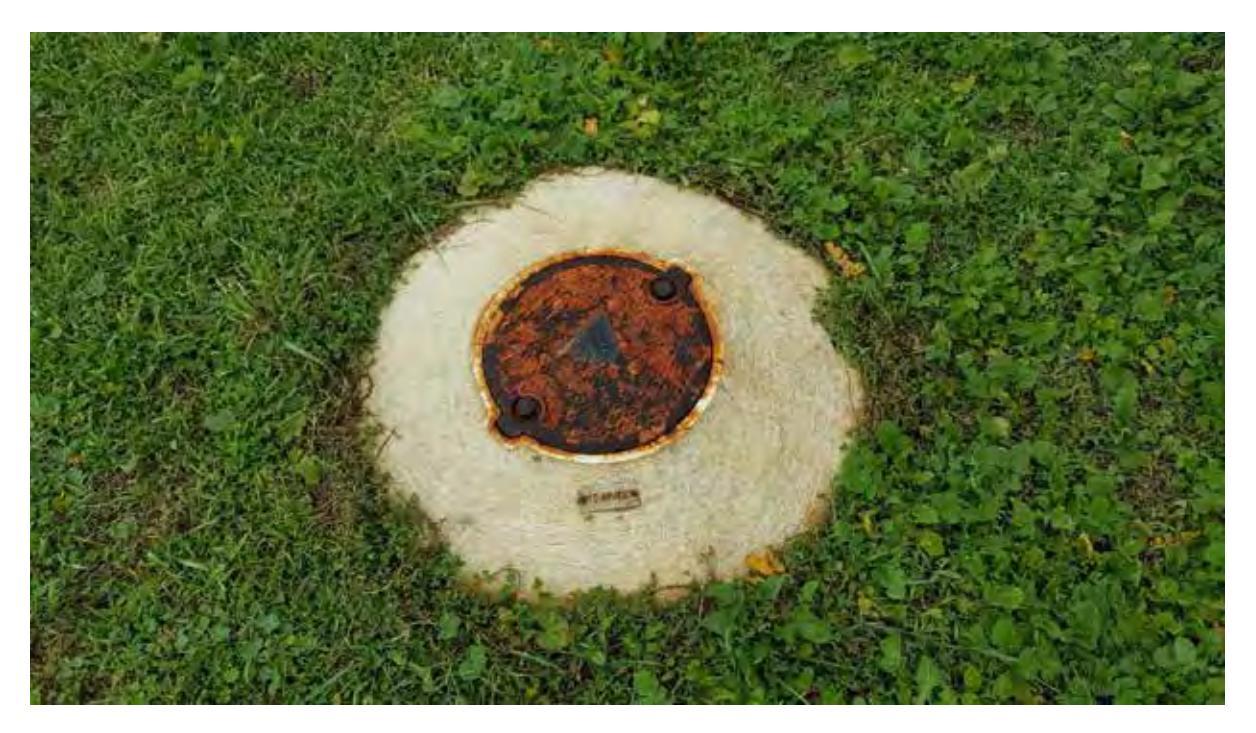
Photograph 3: View of well 12-MW23 at Site 12 Gateview Petroleum Area (1/10/2019).

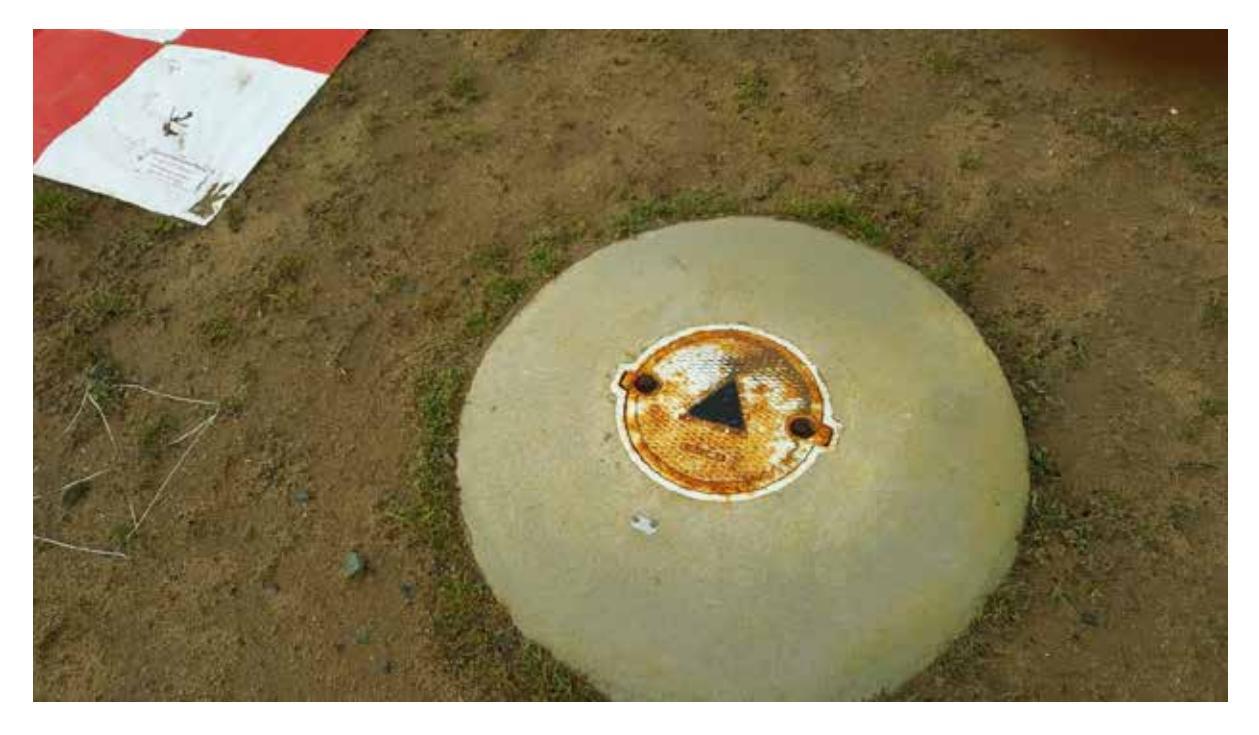
Photograph 4: View of well 12-MW22R at Site 12 Gateview Petroleum Area (1/10/2019).

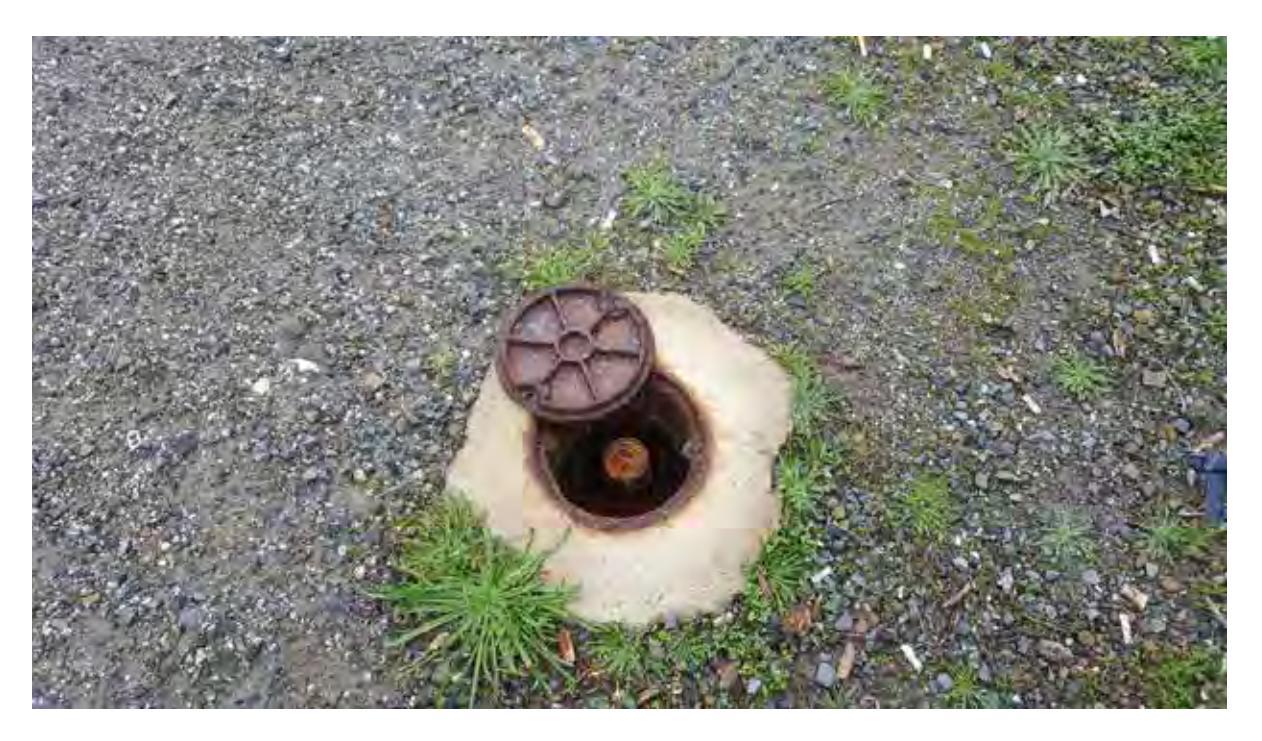
Photograph 10: View of dry well box of well 12-MW36 at Site 12 Gateview Petroleum Area (1/10/2019).

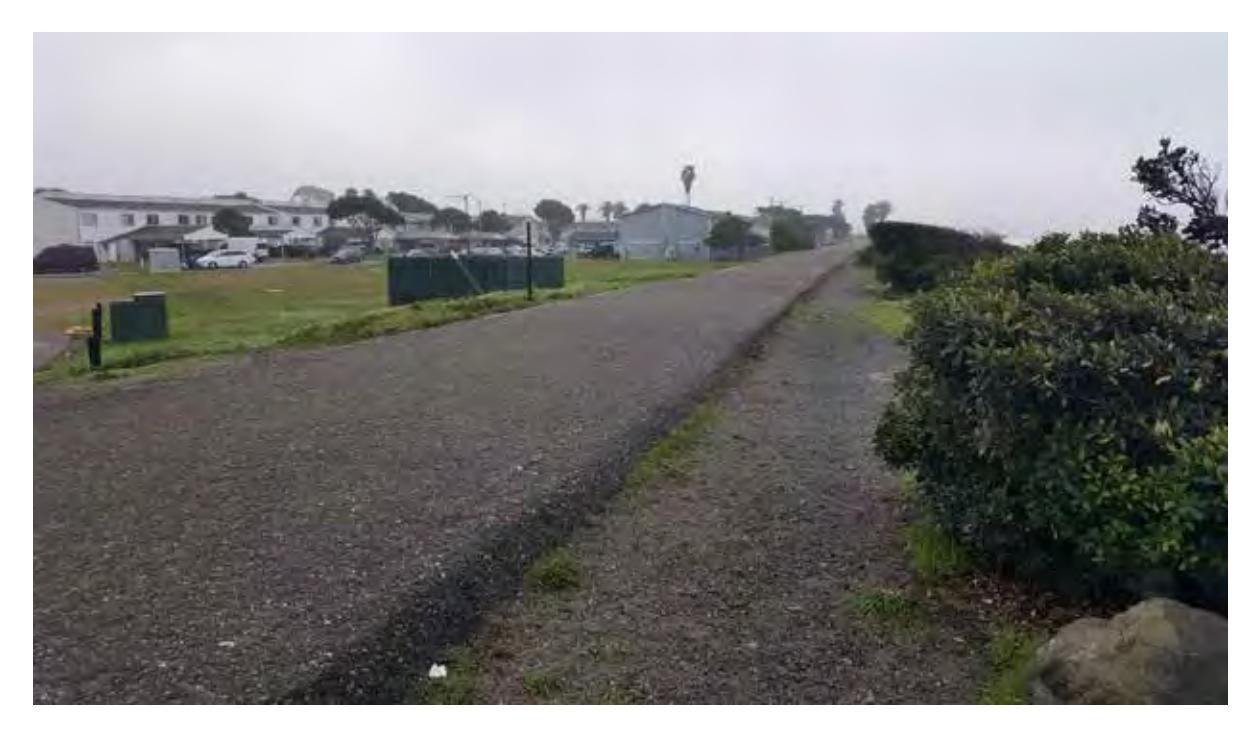
Photograph 13: View of Perimeter Road at western boundary of Site 12 Gateview Petroleum Area, looking south (1/10/2019).

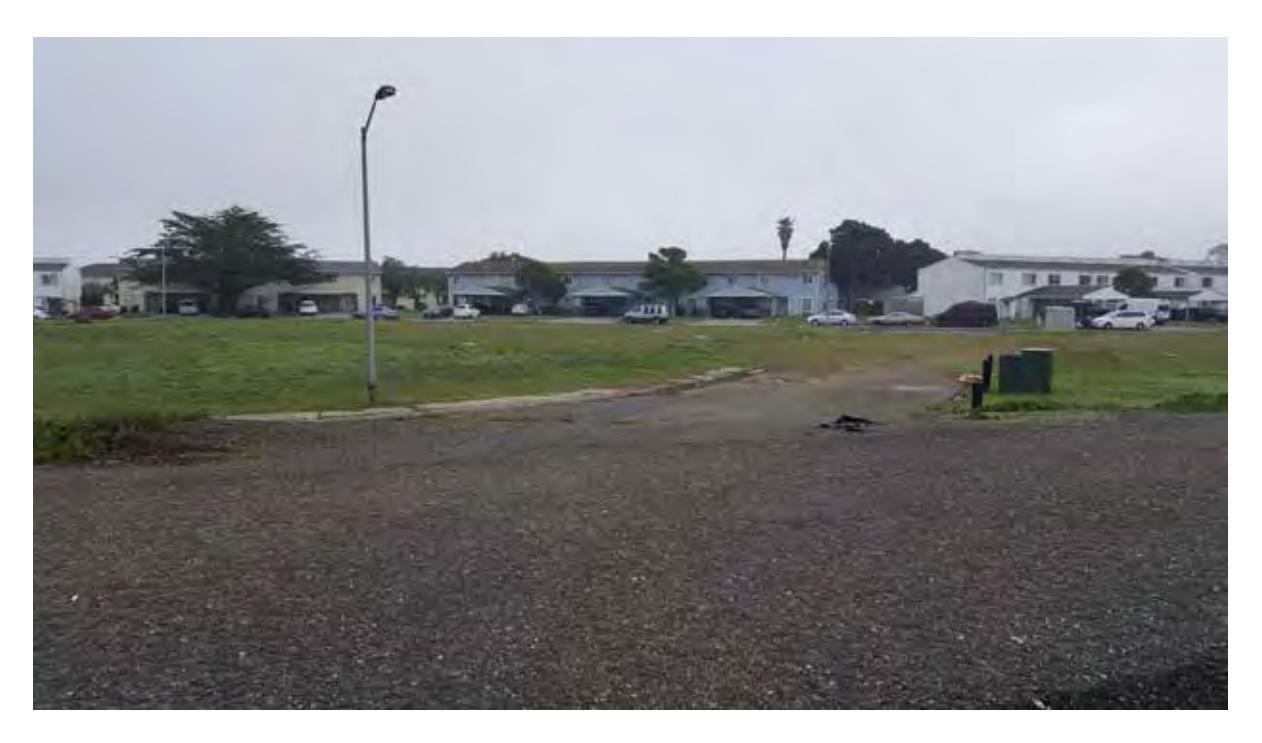
Photograph 14: View of Site 12 Gateview Petroleum Area from public footpath at western boundary, looking east (1/10/2019).

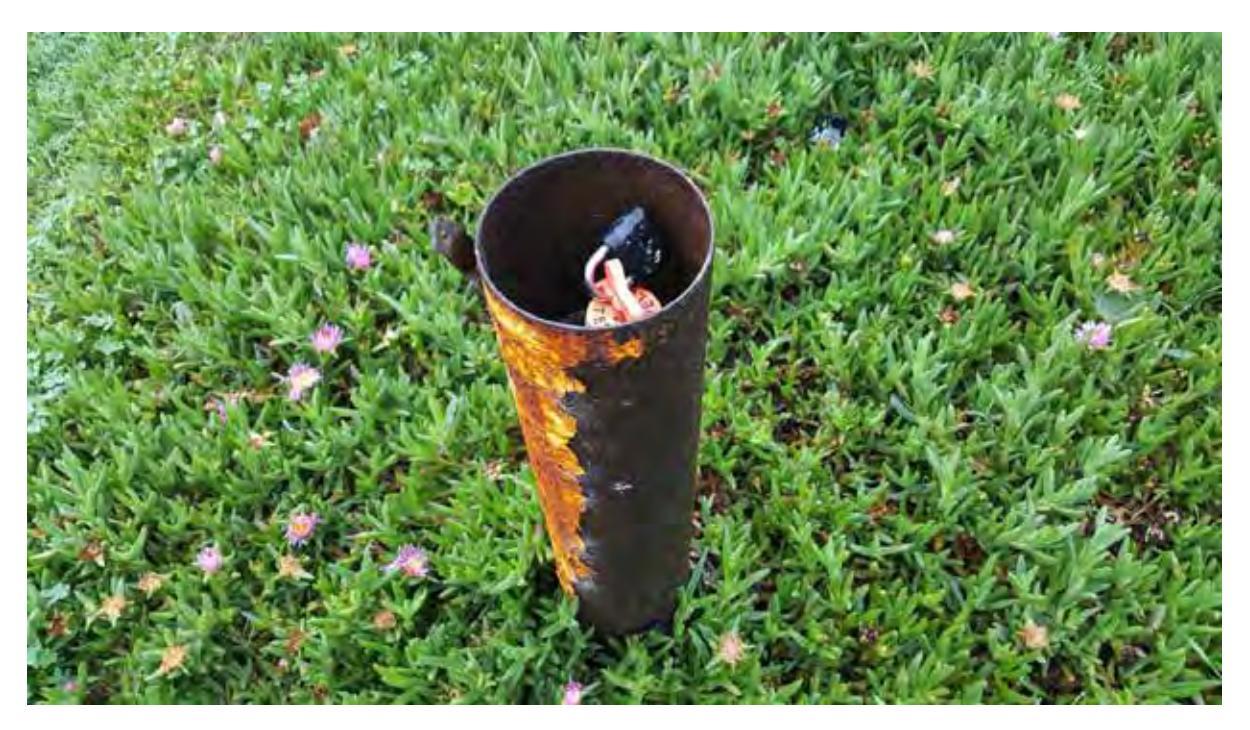
Photograph 15: View of well 12-MW20R at Site 12 Gateview Petroleum Area (1/10/2019).
