Naval Facilities Engineering Command Southwest BRAC PMO West San Diego, CA

Second Five-Year Review

Former Naval Station Treasure Island, CA

August 5, 2020

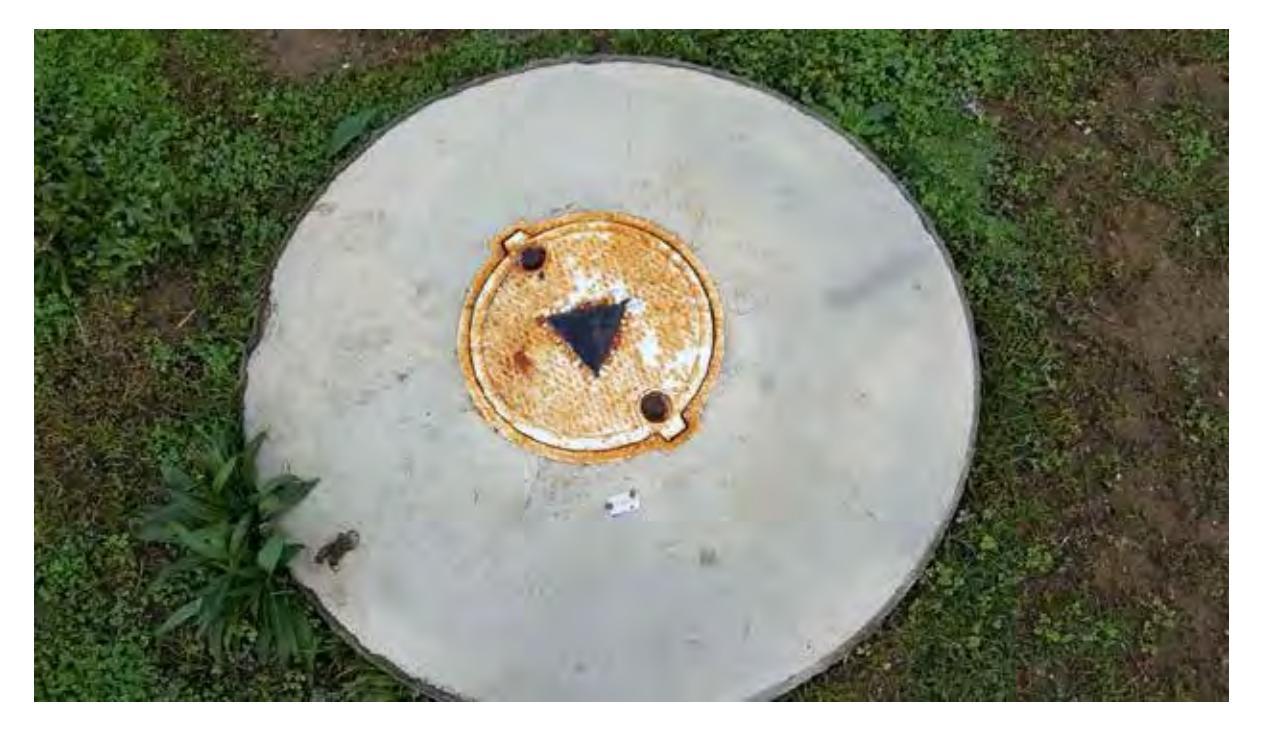
Photograph 16: View of well 12-MW20R at Site 12 Gateview Petroleum Area (1/10/2019).

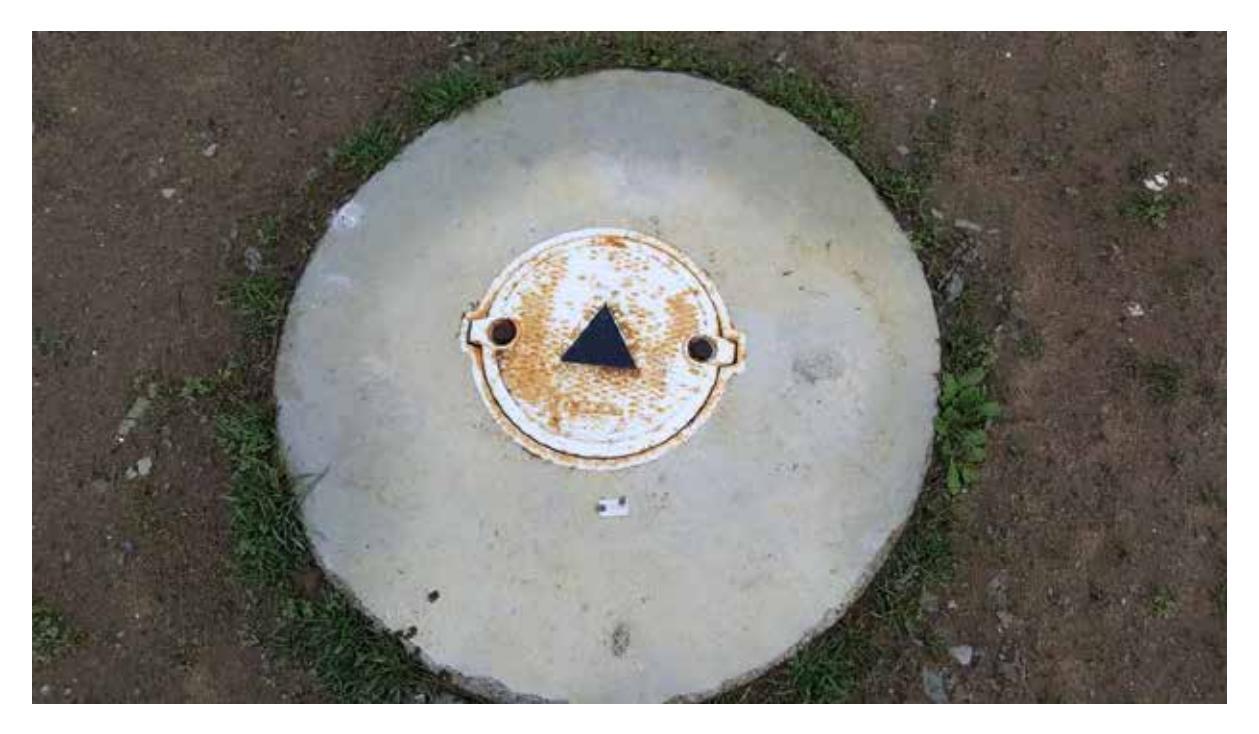
Photograph 17: View of well 12-MW38R at Site 12 Gateview Petroleum Area (1/10/2019).

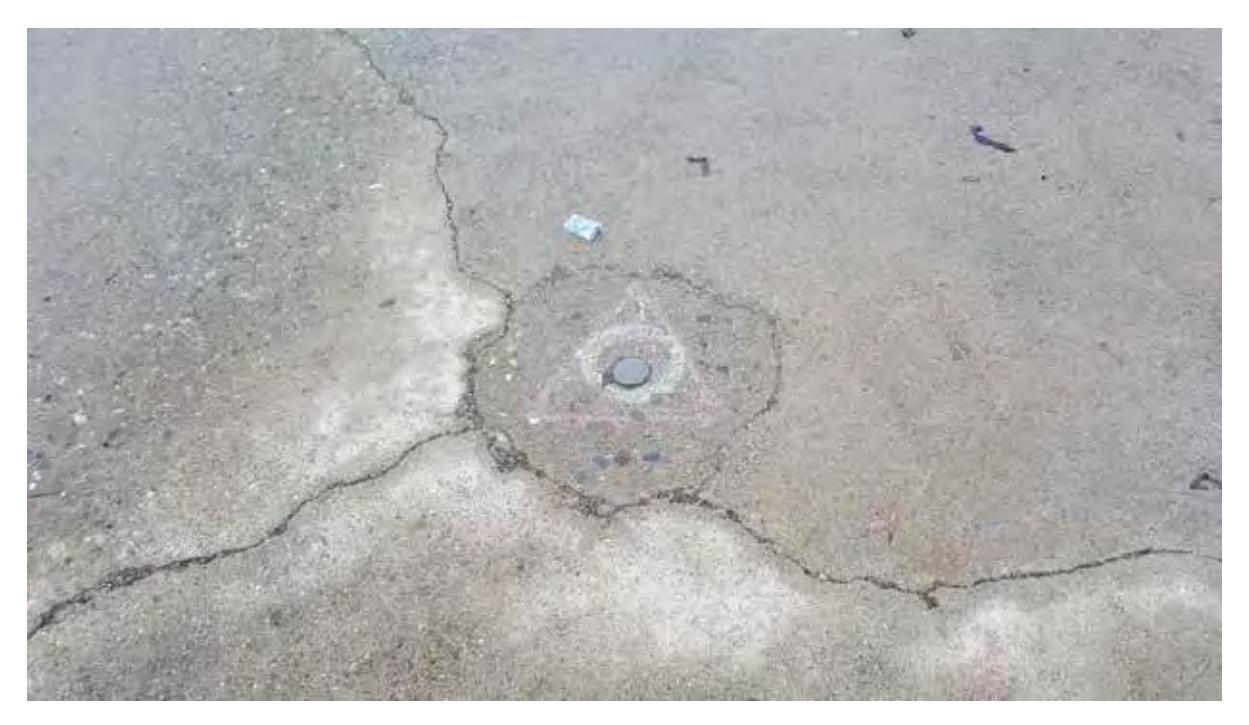
Photograph 1: View of well 21-SG20 at Site 21 (1/8/2019).

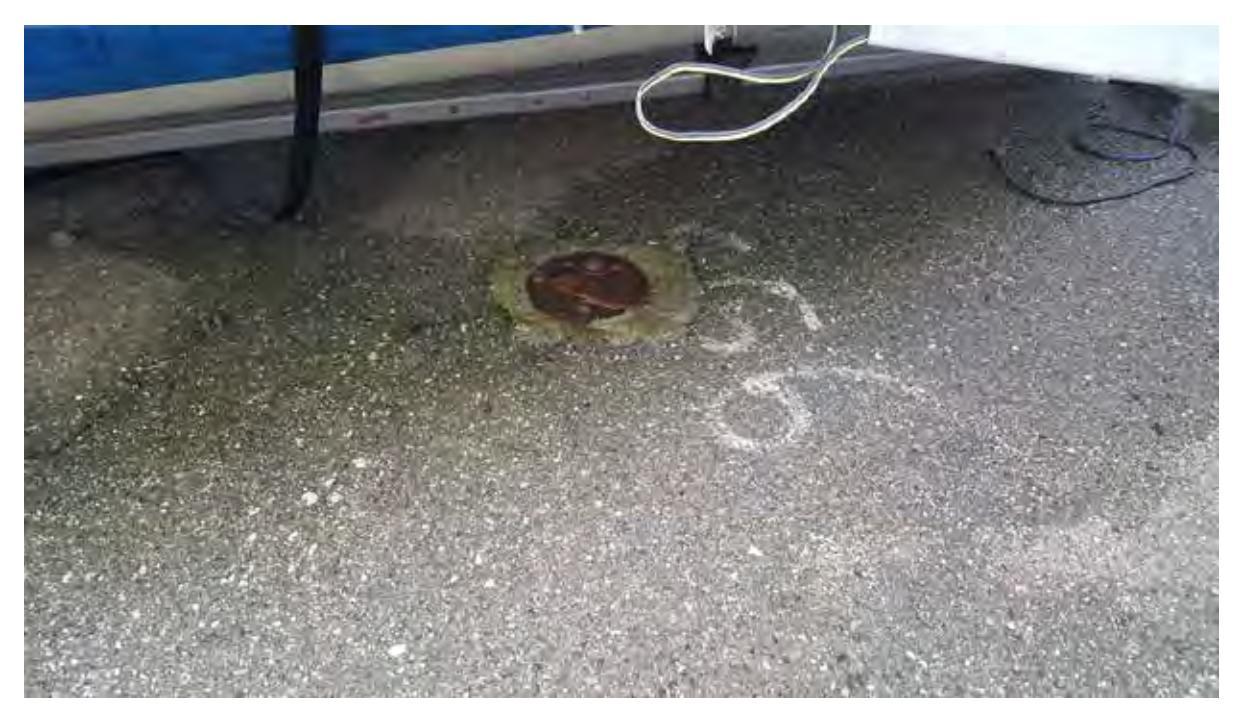
Photograph 2: View of well 21-SG06 at Site 21 (1/8/2019).

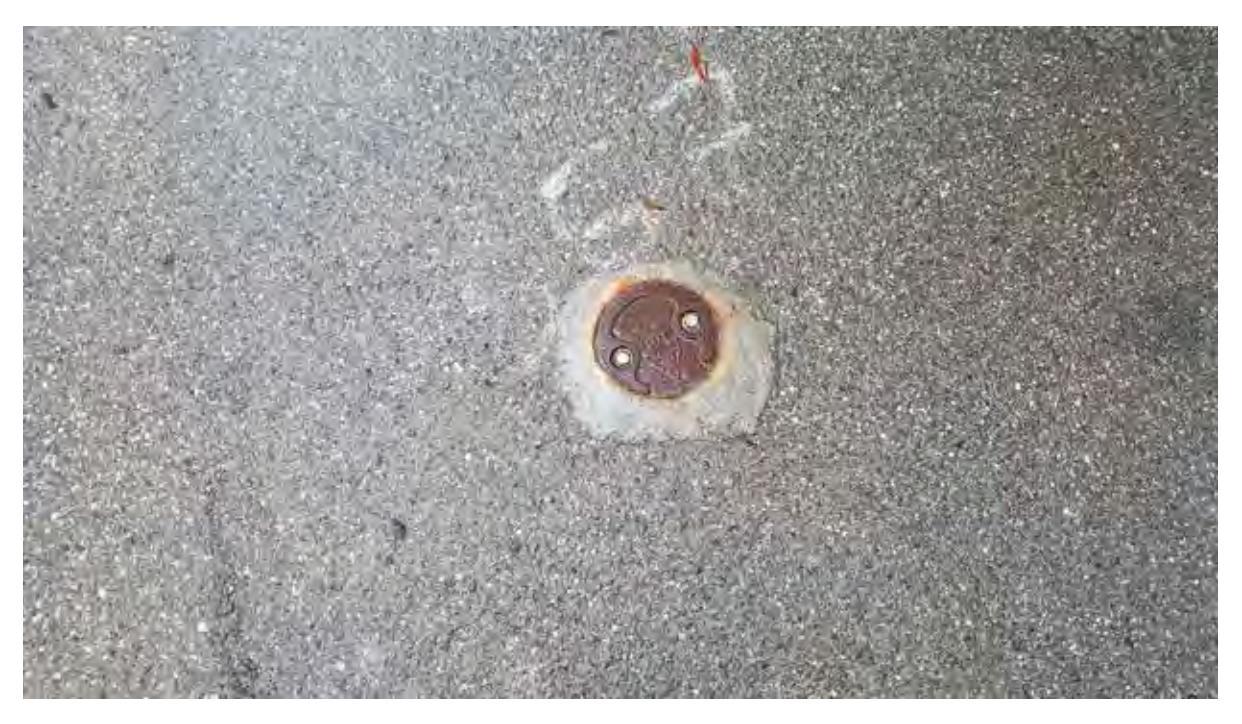
Photograph 3: View of well 21-SG07 at Site 21 (1/8/2019).

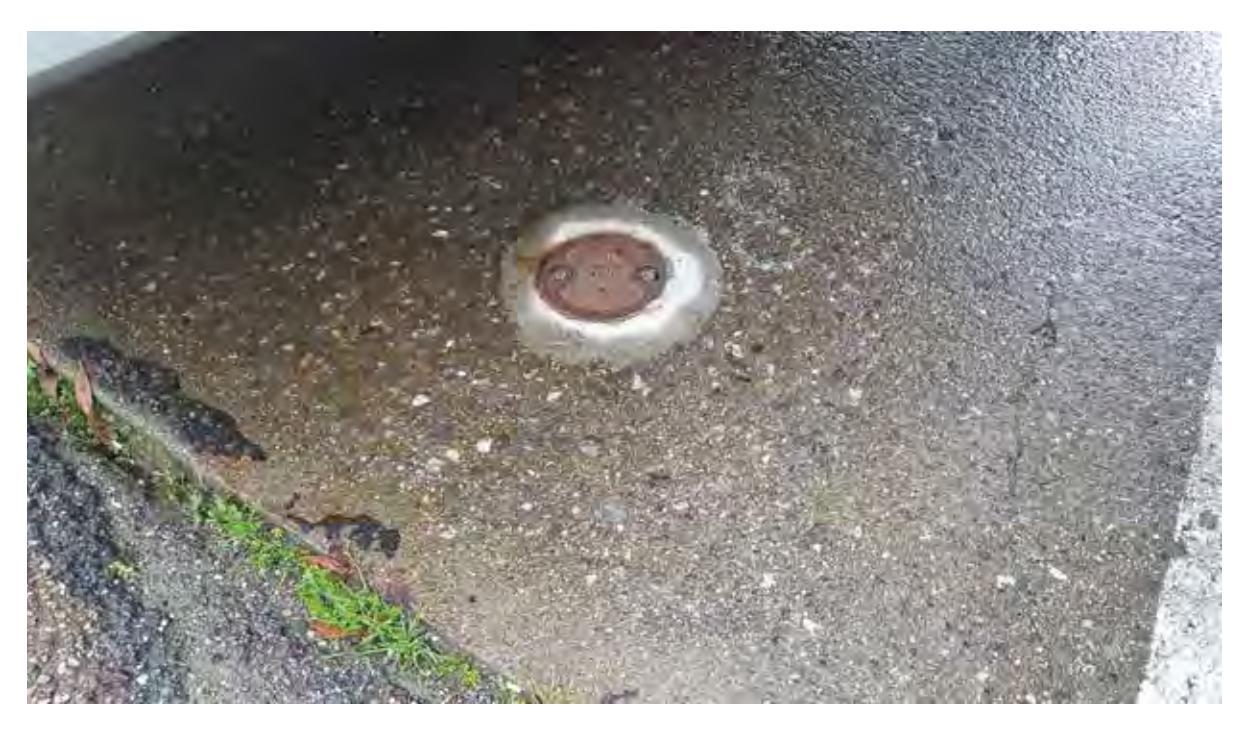
Photograph 4: View of well 21-SG08 at Site 21 (1/8/2019).

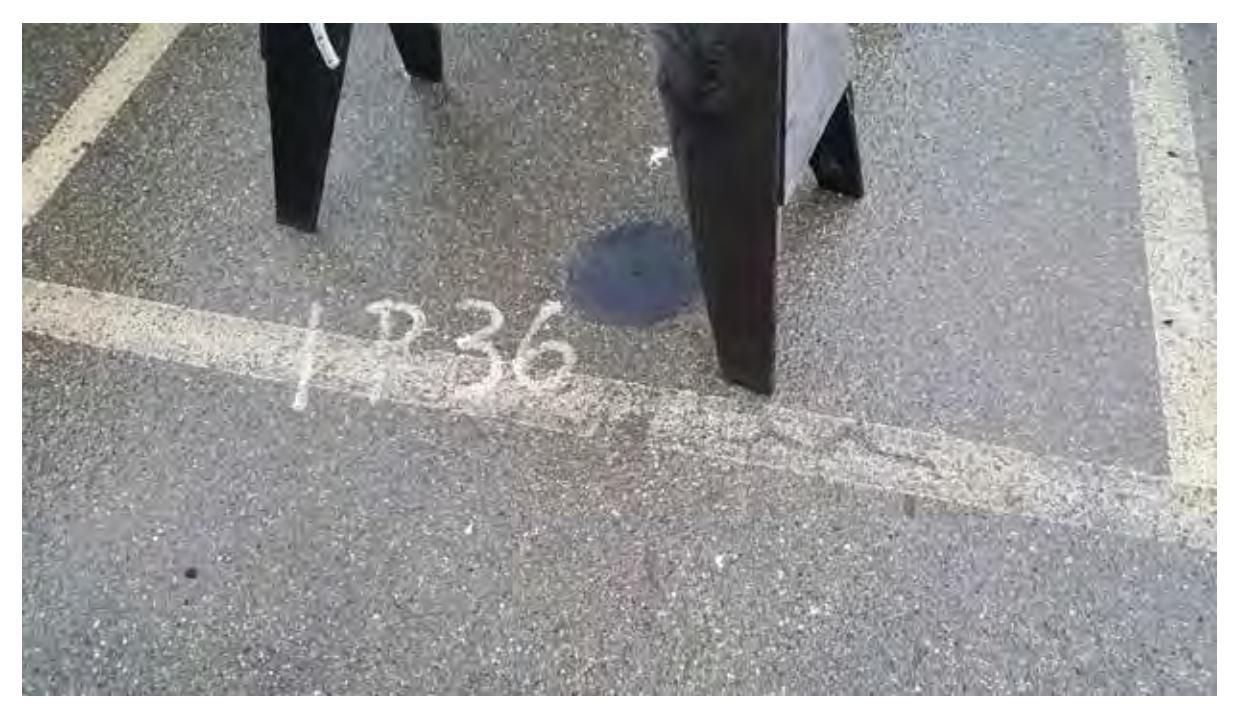
Photograph 5: View of former monitoring well location at Site 21 (1/8/2019).

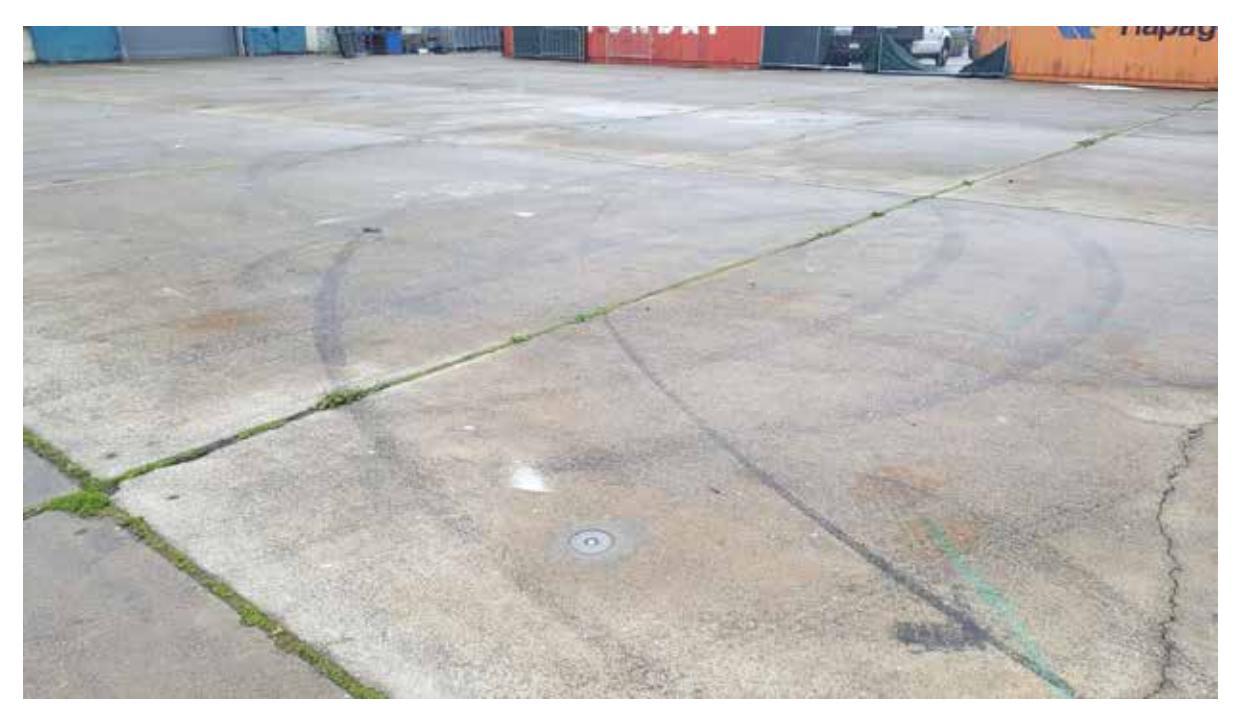
Photograph 6: View of former monitoring well location at Site 21 (1/8/2019).

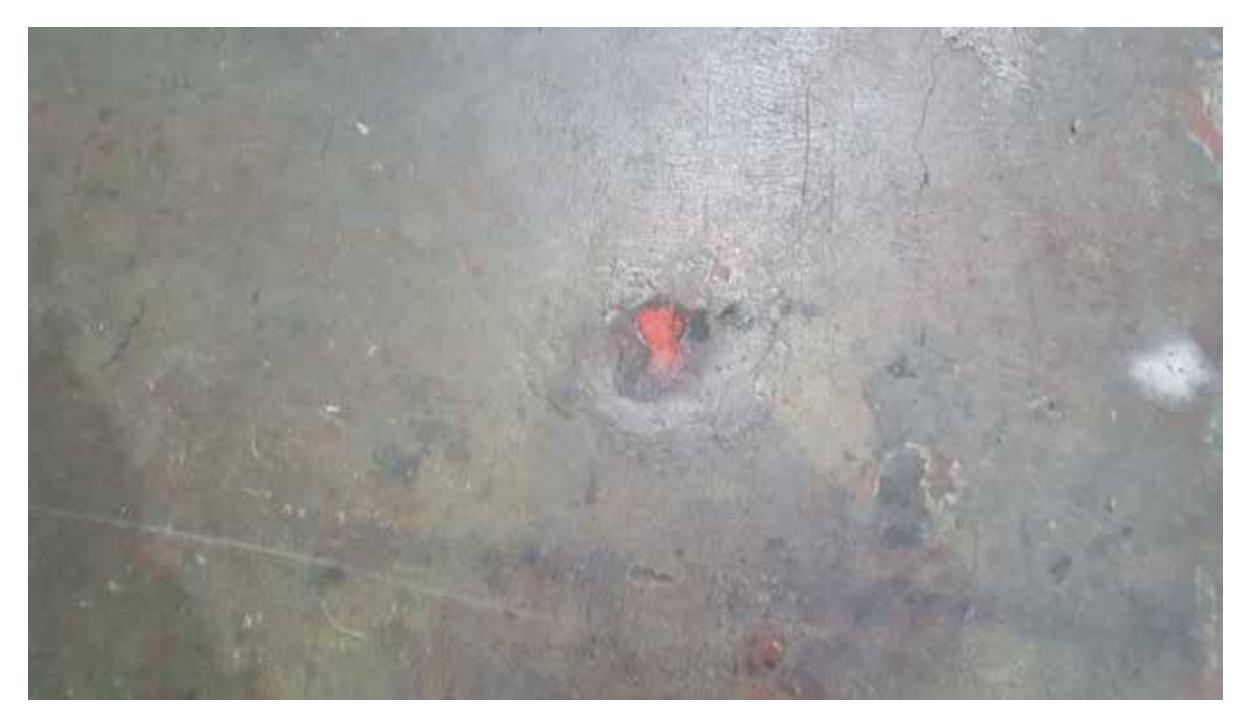
Photograph 7: View of well 21-SG19 at Site 21 (1/8/2019).

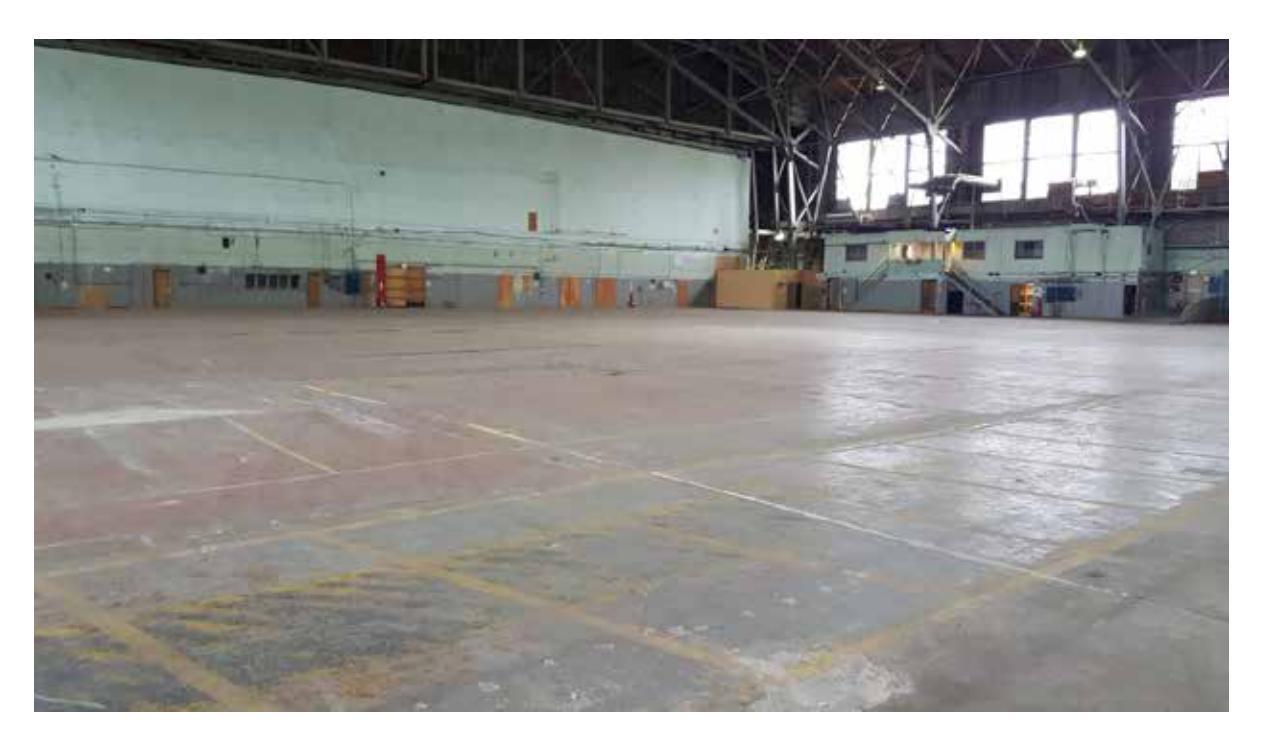
Photograph 9: View of Site 21 Building 3 hangar interior, looking northwest from approximate centerpoint (1/8/2019).

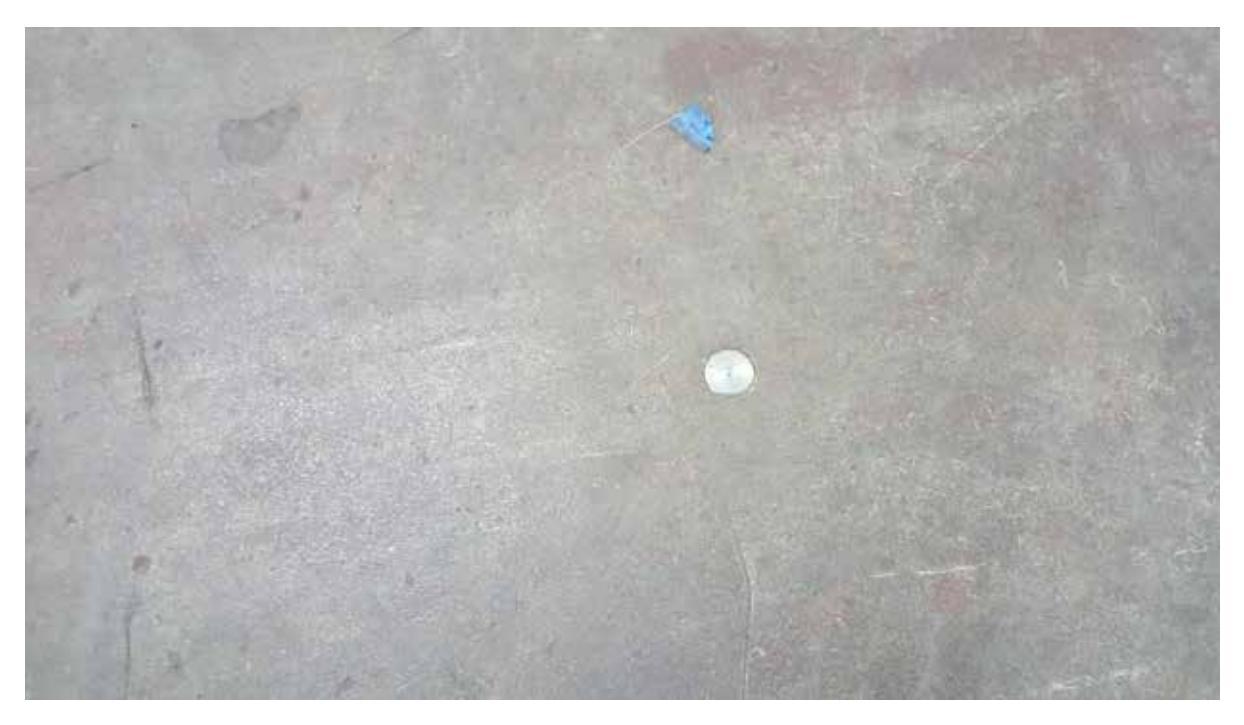
Photograph 10: View of Site 21 Building 3 hangar interior, looking southwest from approximate centerpoint (1/8/2019).

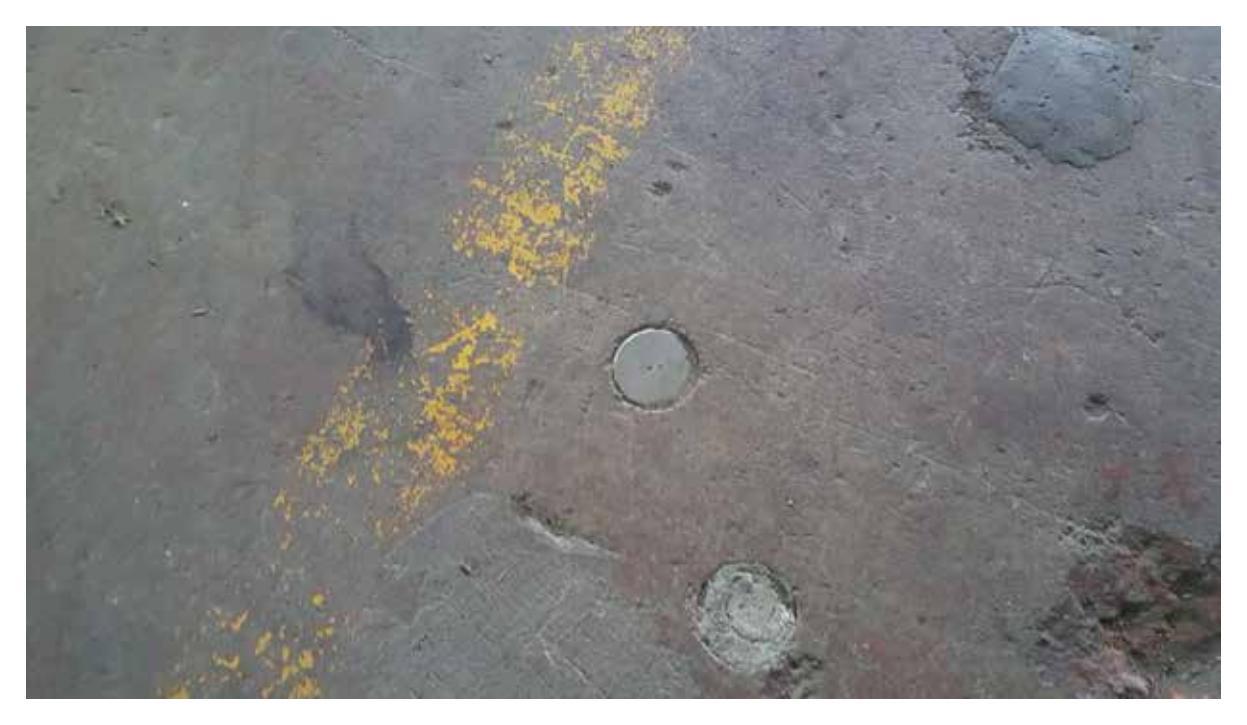
Photograph 11: View of well 21-SG09 at Site 21 (1/8/2019).

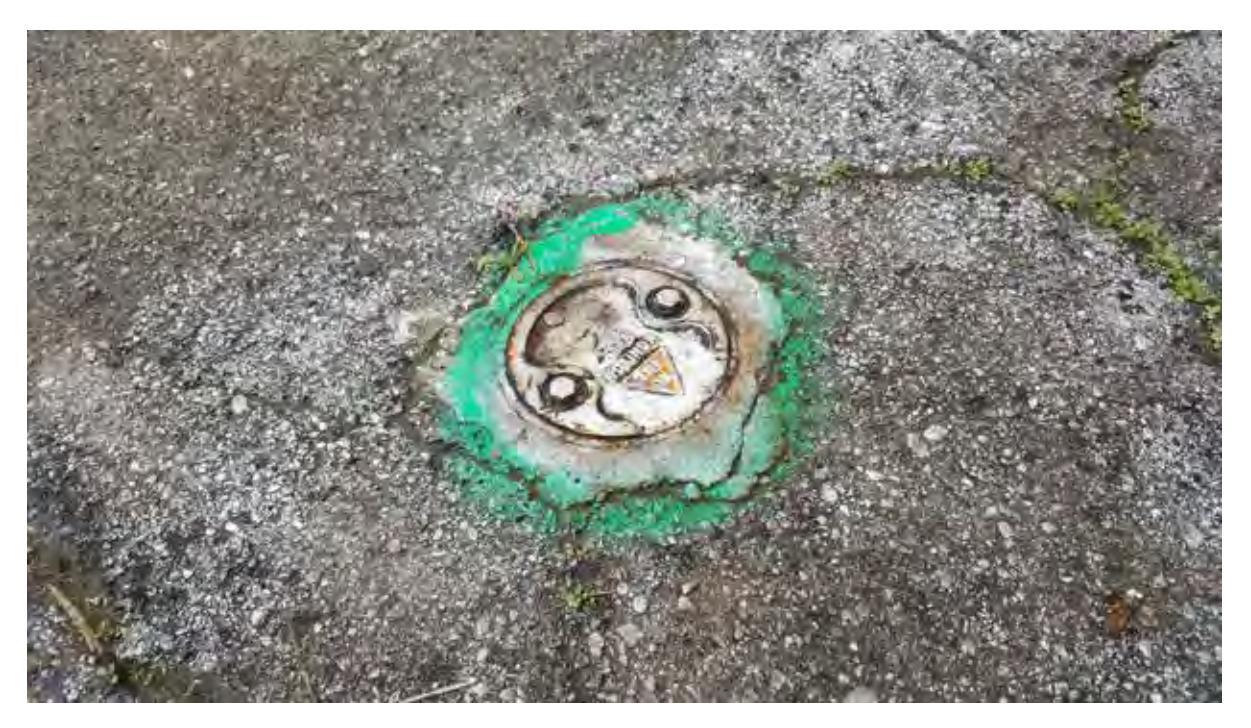
Photograph 12: View of well 21-SG10 at Site 21 (1/8/2019).

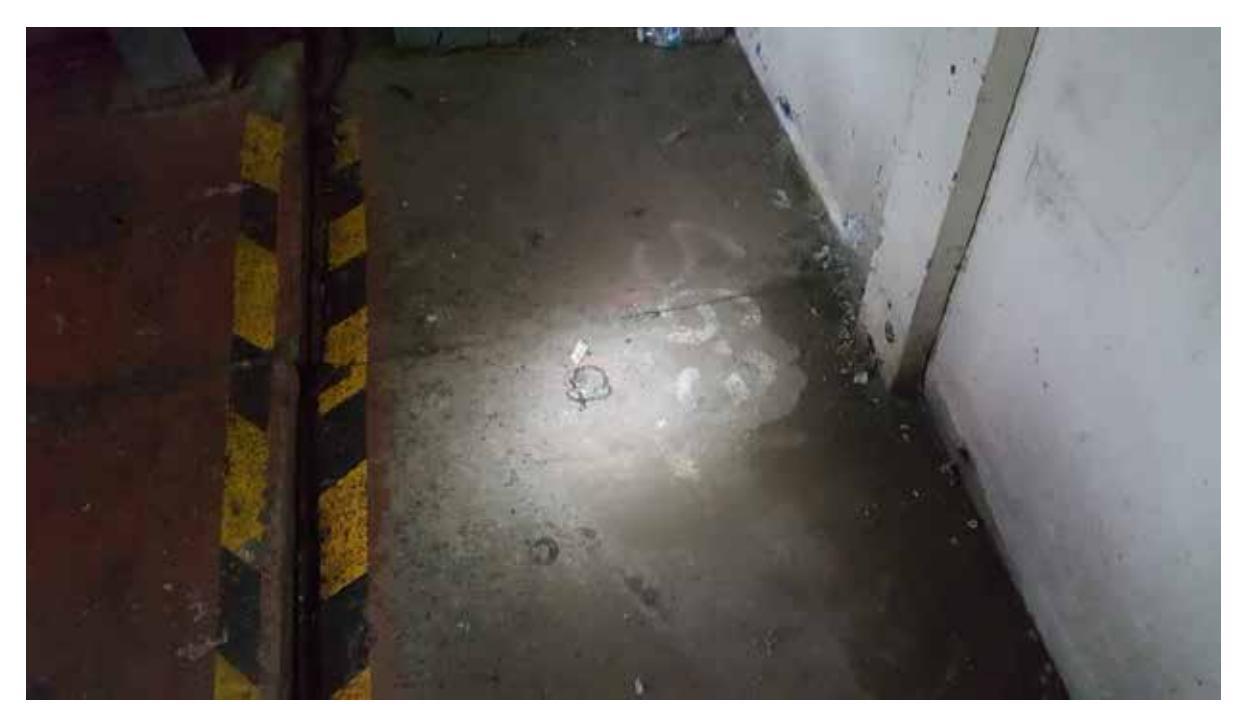
Photograph 17: View of well 21-IP12 at Site 21. Note missing bolt (1/8/2019).

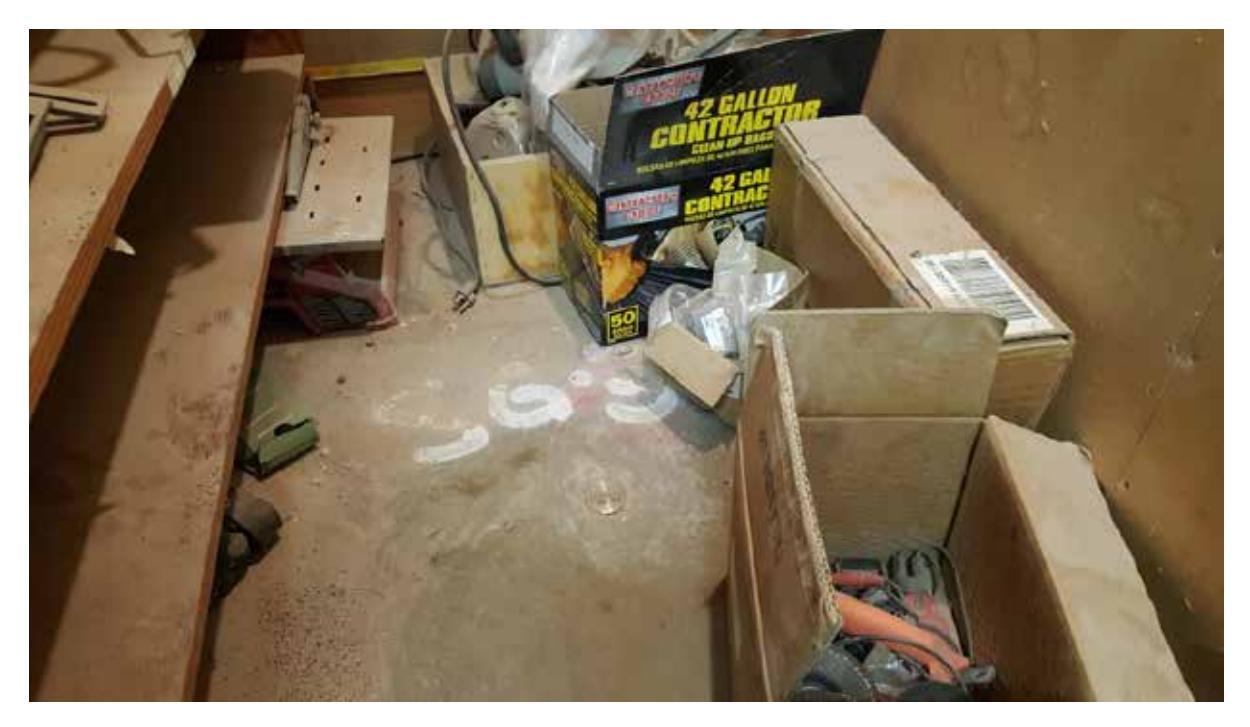
Photograph 19: View of well 21-SG27 at Site 21 (1/8/2019).

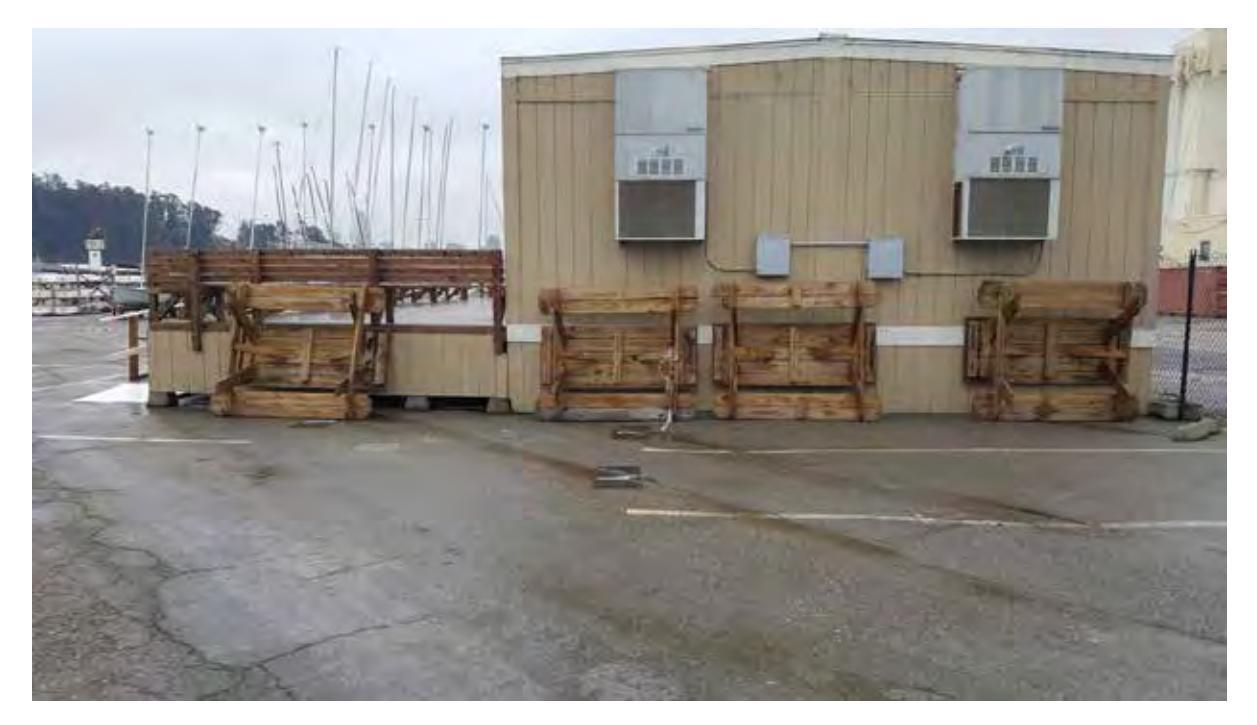
Photograph 20: View of well 21-SG30 at Site 21 (1/8/2019).

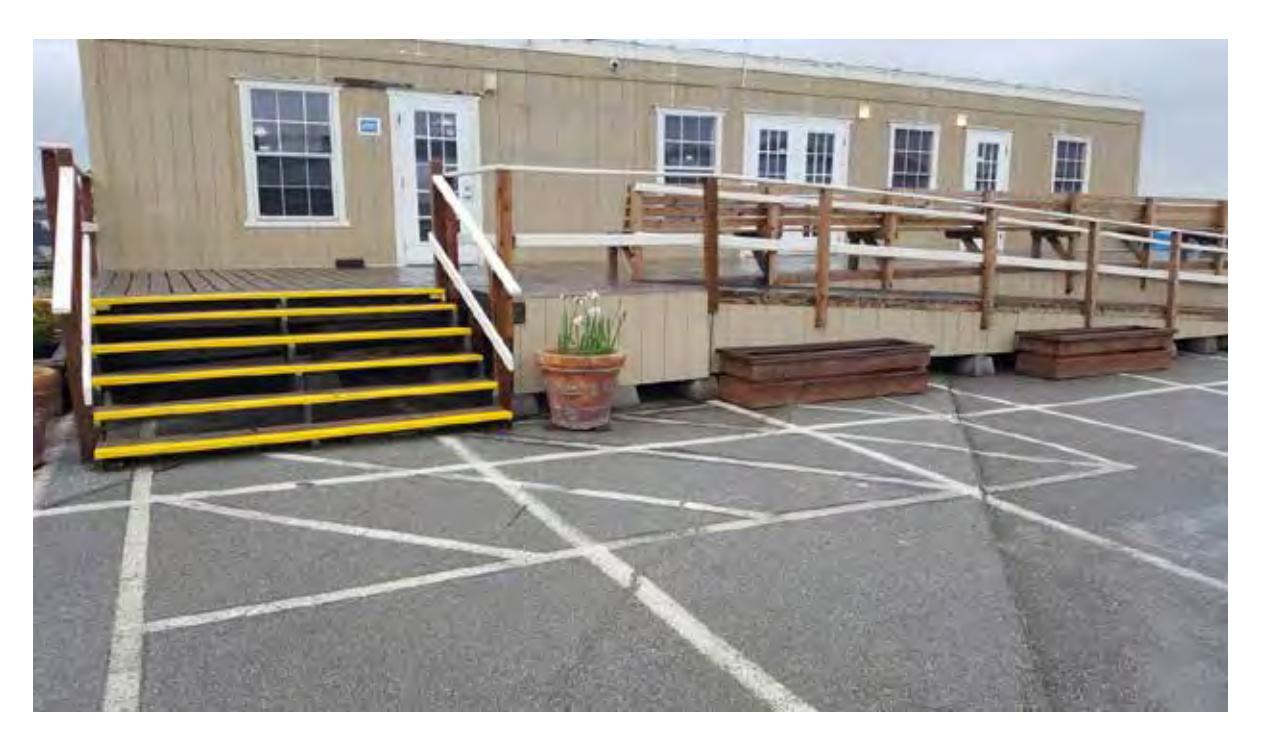
Photograph 21: View of east end of TI Sailing Center administration trailer at Site 21, looking west (1/8/2019).

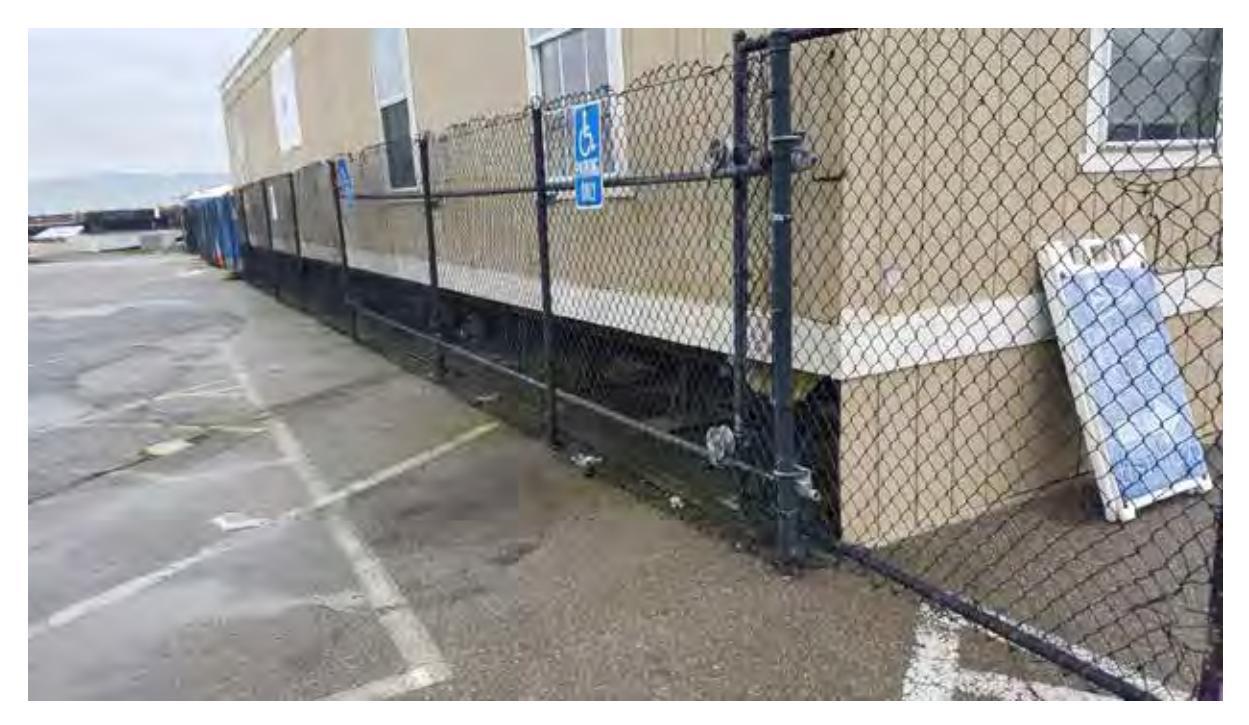
Photograph 22: View of front side of TI Sailing Center administration trailer at Site 21, looking north (1/8/2019).

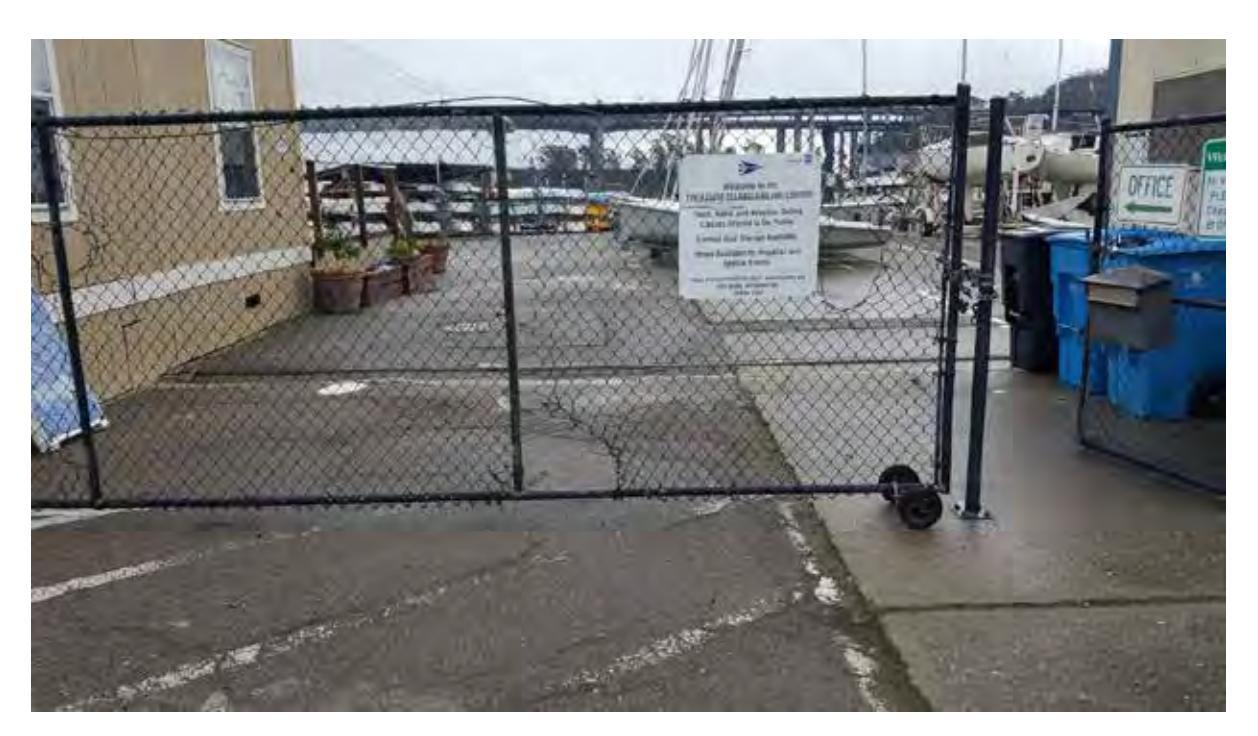
Photograph 23: View of back of TI Sailing Center administration trailer at Site 21, looking southeast from entrance gate. Wells 21-IP26, 21-IP27, 21-IP33, and 21-IP34 are inaccessible beneath trailer (1/8/2019).

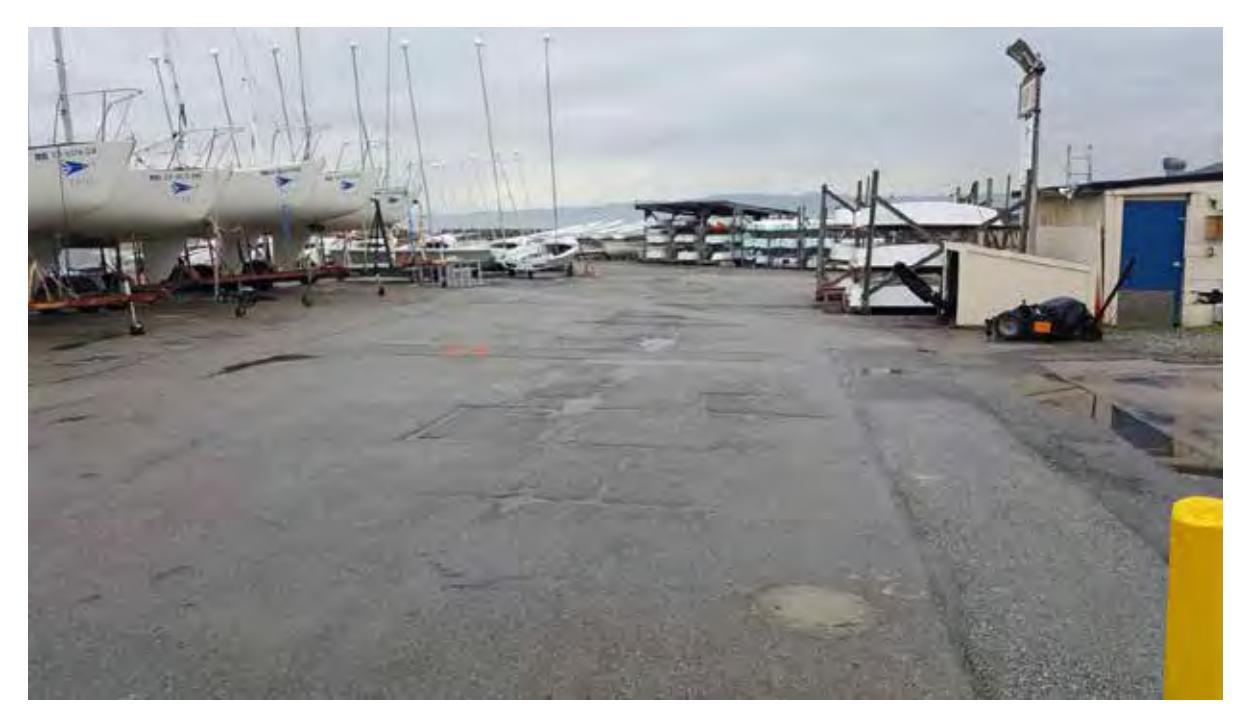
Photograph 24: View of TI Sailing Center main entrance gate, looking west (1/8/2019).

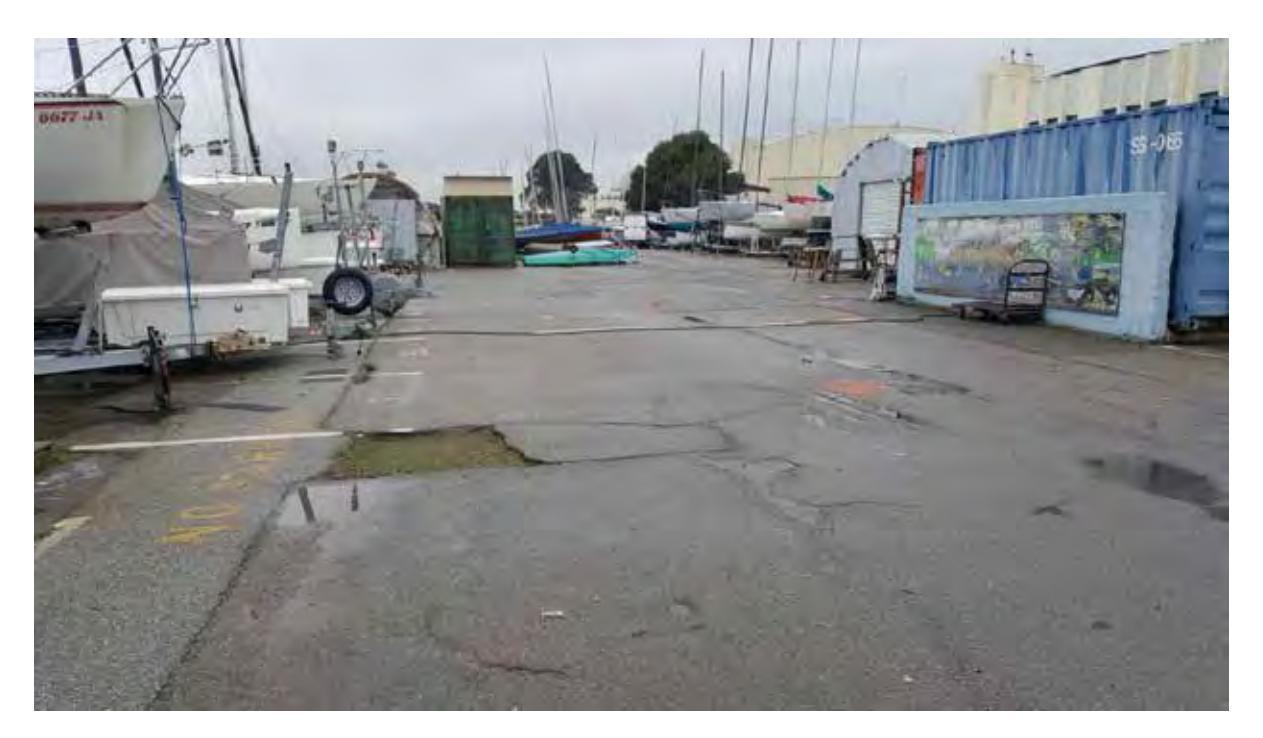
Photograph 25: View of TI Sailing Center yard from northwest corner of administration trailer, looking west. Note former monitoring well location in foreground (1/8/2019).

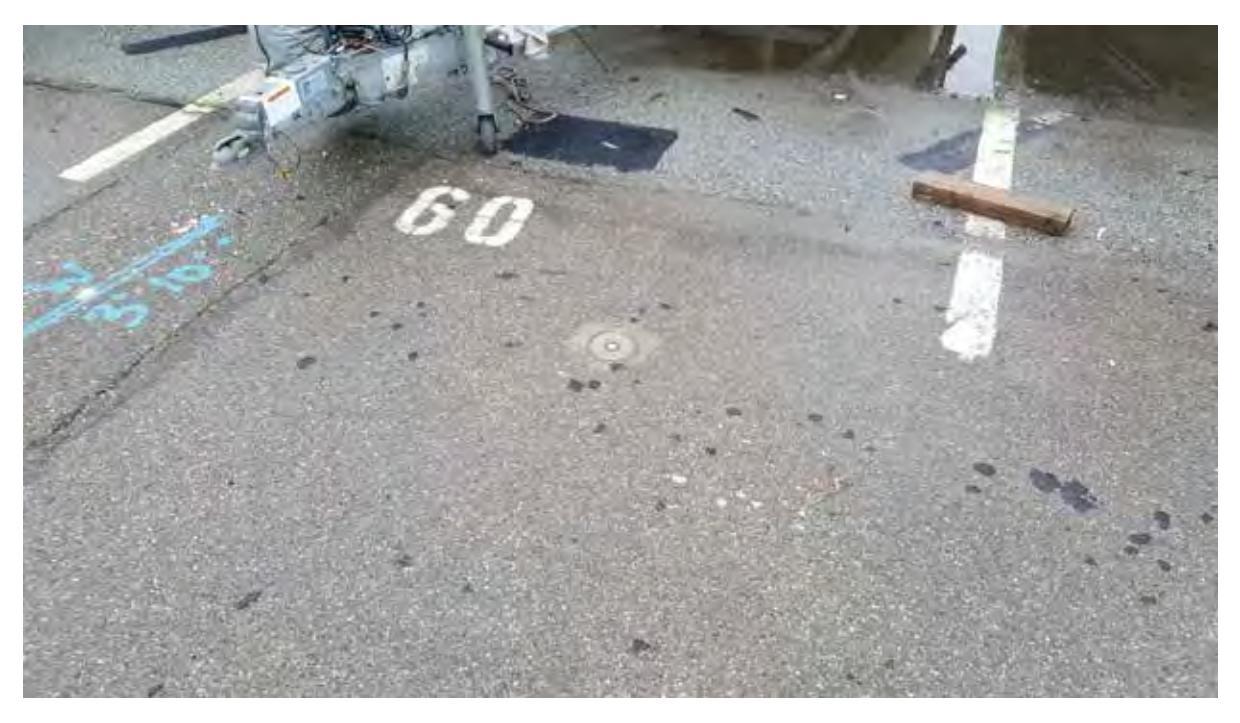
Photograph 26: View of TI Sailing Center yard from approximate centerpoint, looking east (1/8/2019).

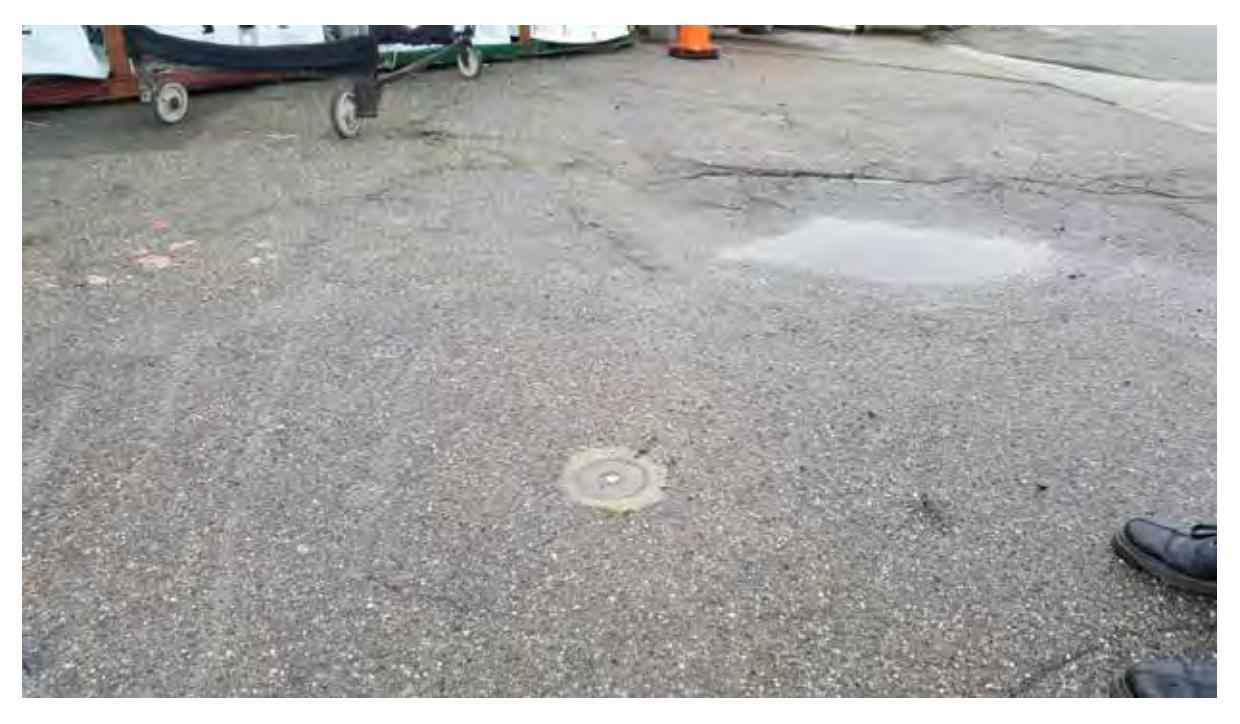
Photograph 27: View of well 21-SG23 at Site 21 (1/8/2019).

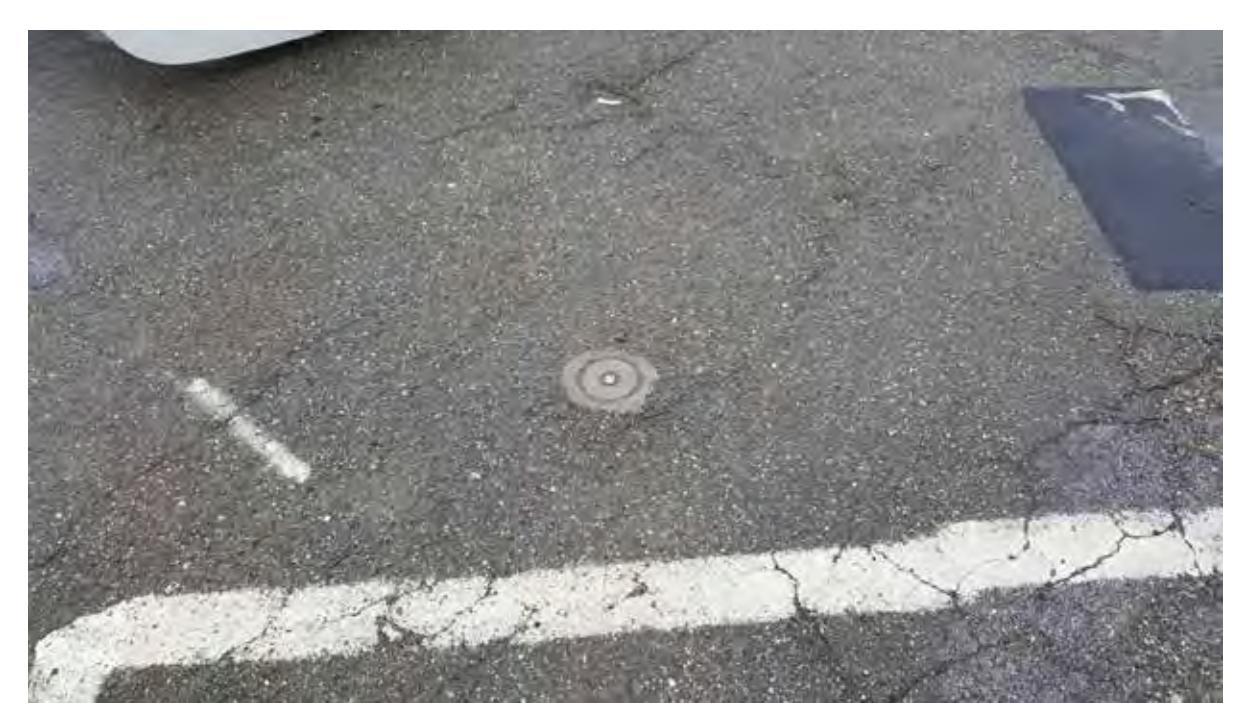
Photograph 28: View of well 21-SG24 at Site 21 (1/8/2019).

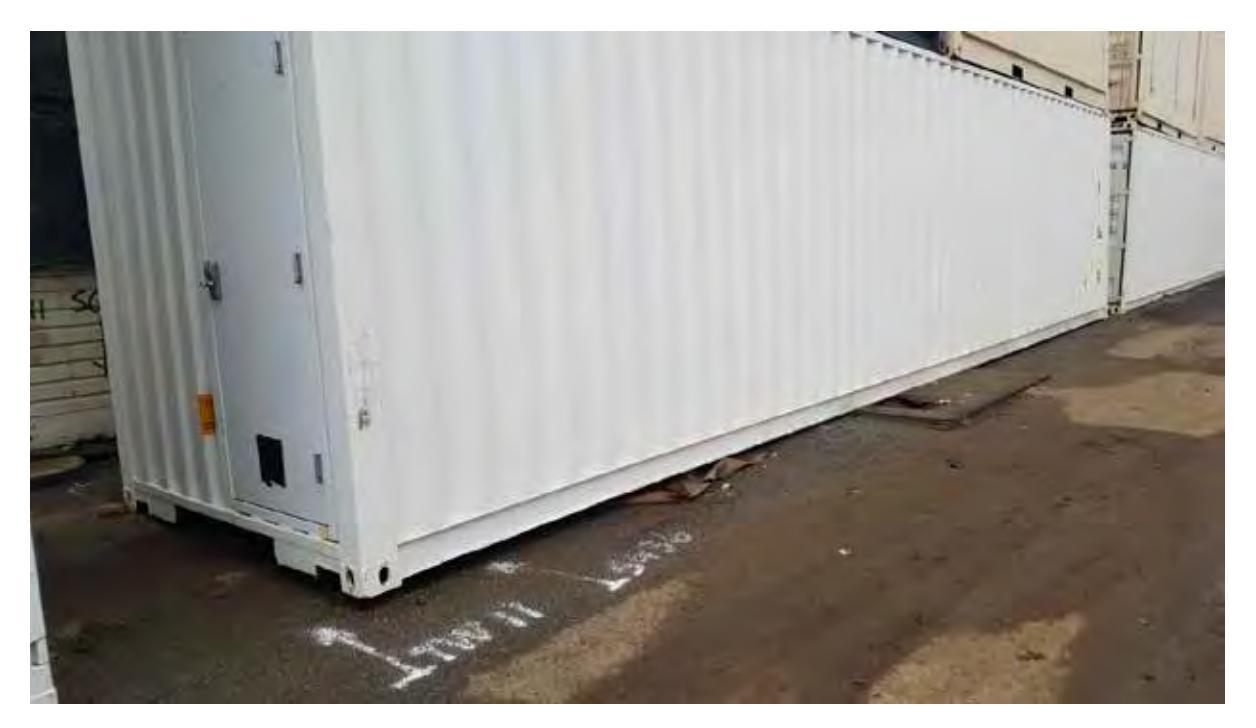
Photograph 29: View of well 21-SG25 at Site 21 (1/8/2019).
