Naval Facilities Engineering Command Southwest BRAC PMO West San Diego, CA

Second Five-Year Review

Former Naval Station Treasure Island, CA

August 5, 2020

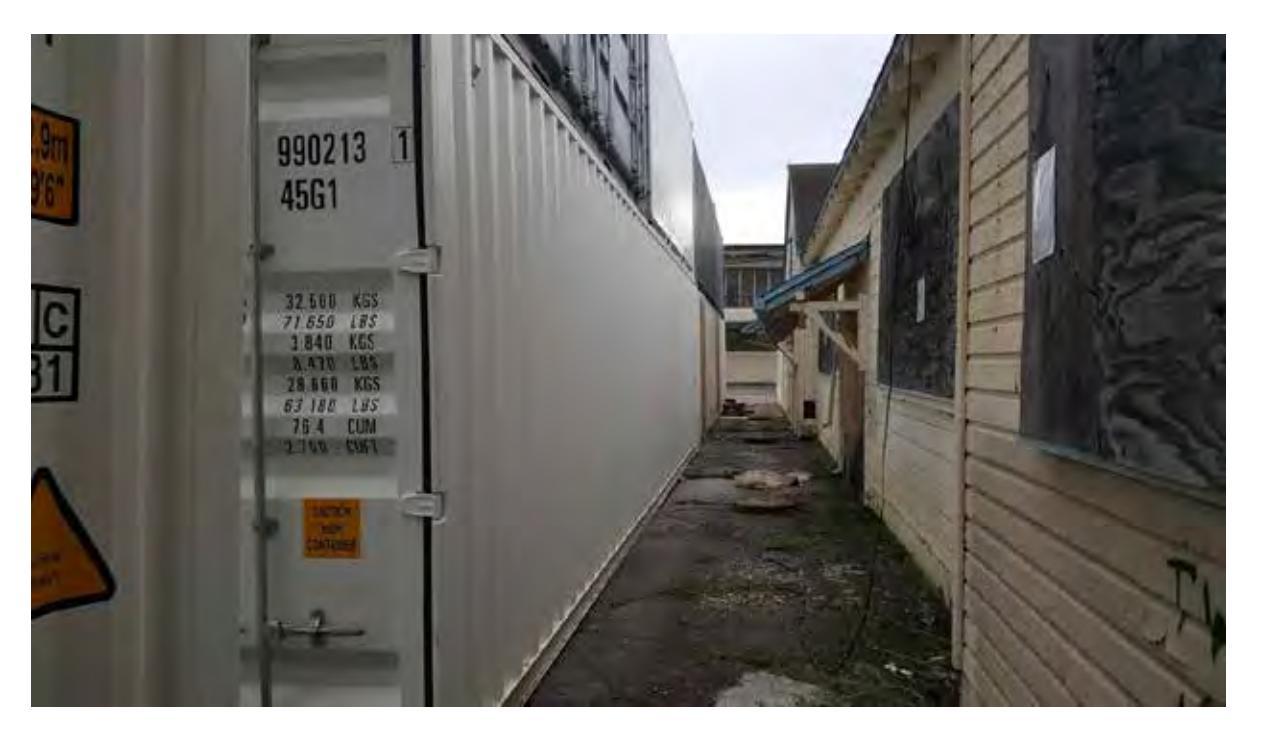
Photograph 1: View of shipping containers covering wells 24-SG-36 and 24-IW21. Note marked well locations from previous monitoring event (1/8/2019).

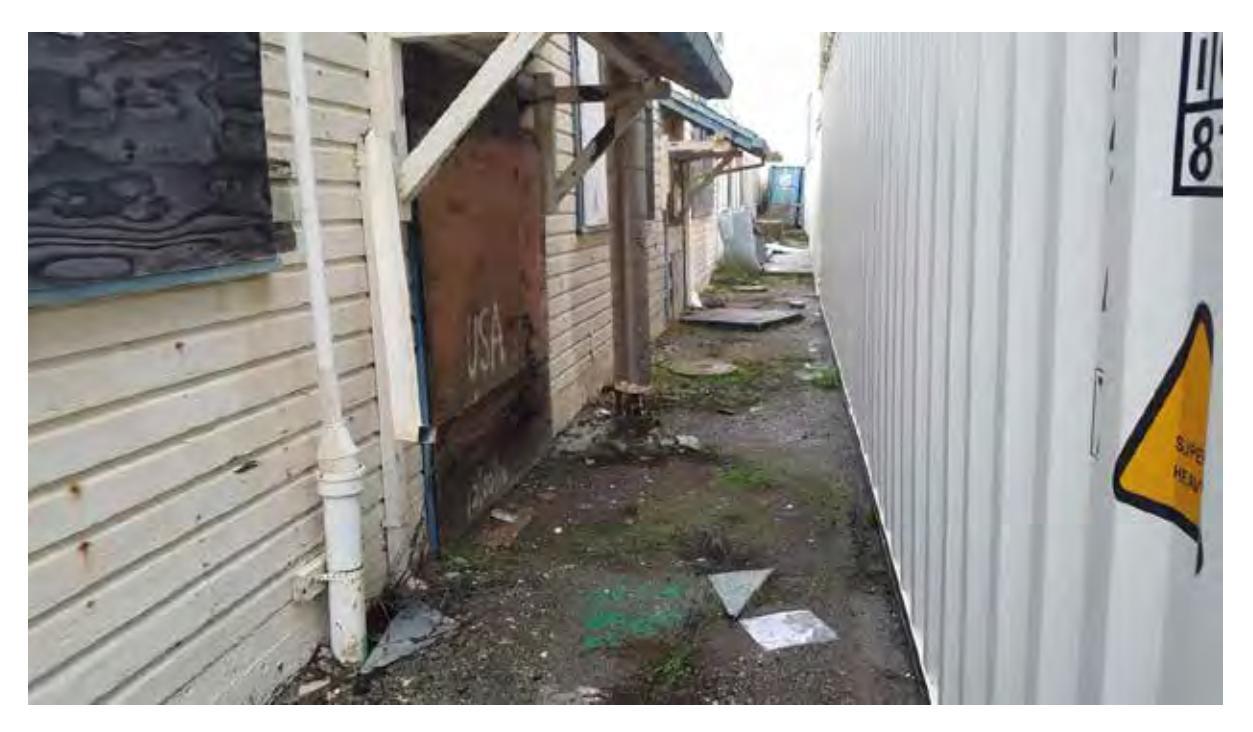
Photograph 2: View of shipping containers stacked adjacent to south wall of Building 99 at Site 24, looking west (1/8/2019).

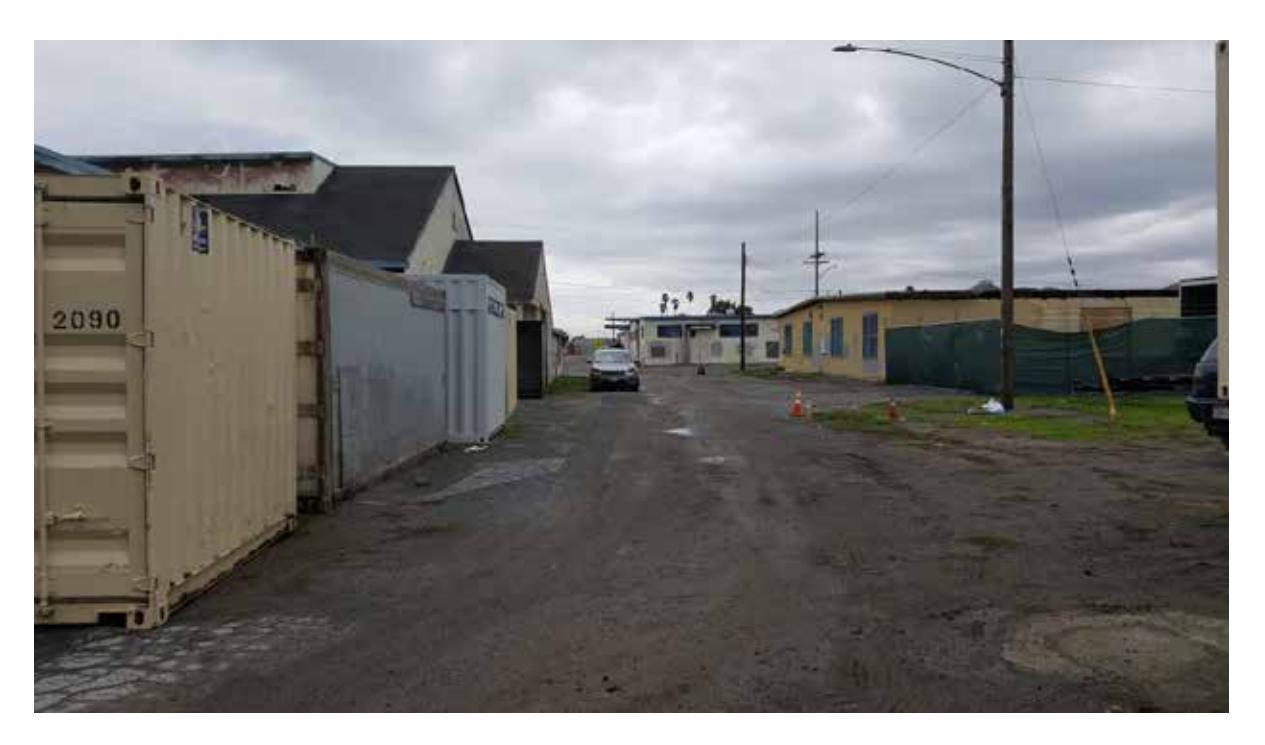
Photograph 3: View of shipping containers stacked adjacent to south wall of Building 99 at Site 24, looking east (1/8/2019).

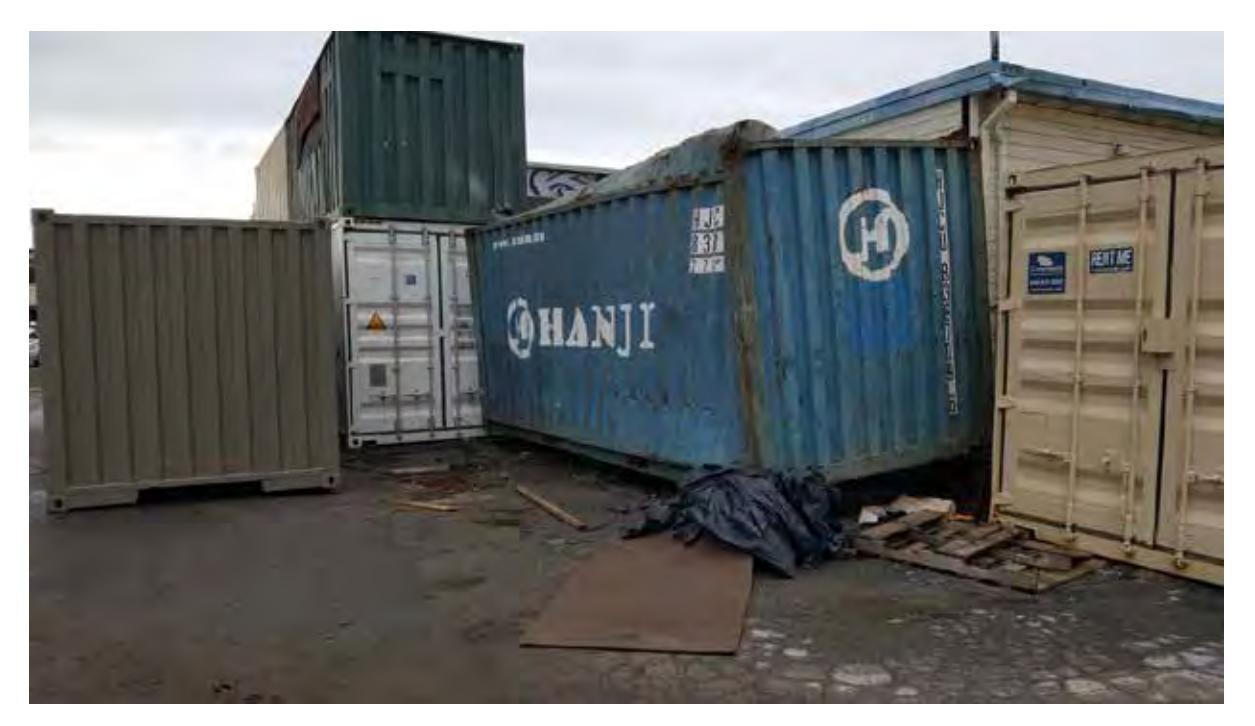
Photograph 4: View of shipping containers placed adjacent to south wall of Building 99 at Site 24, looking east (1/8/2019).

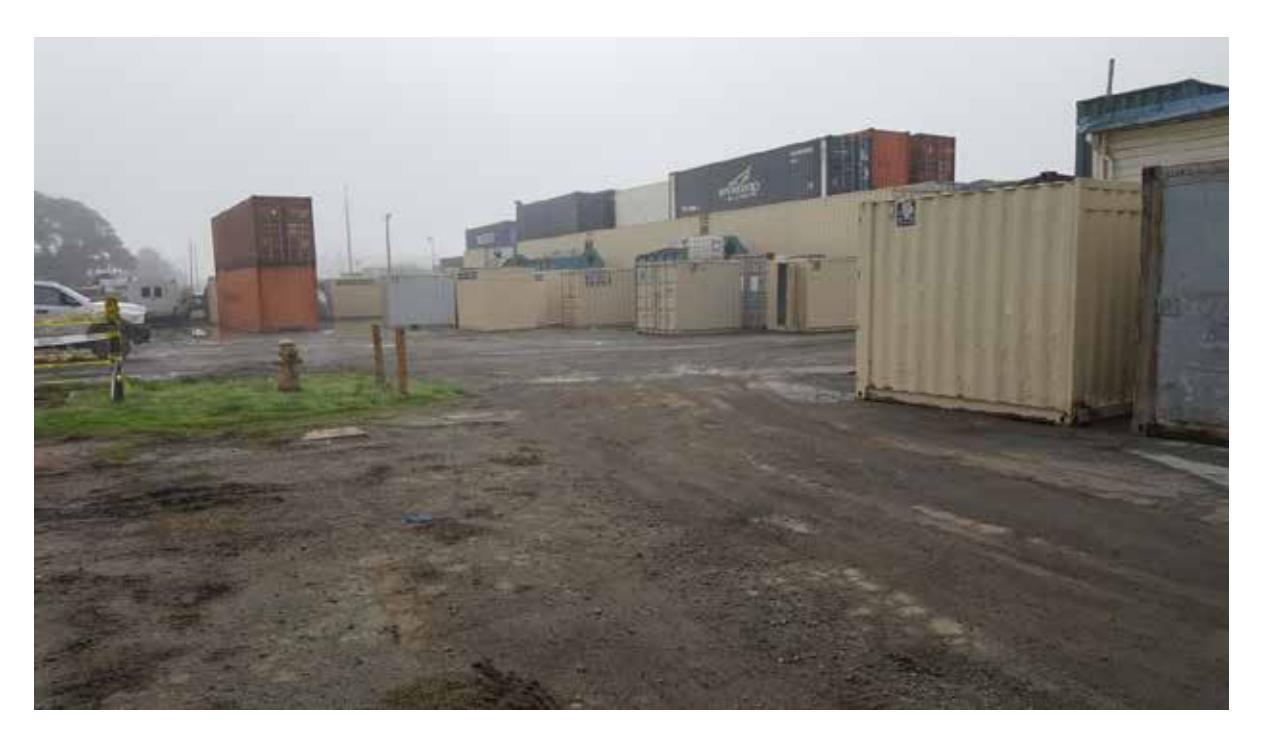
Photograph 5: View of shipping containers stacked adjacent to north and east walls of Building 455 at Site 24, looking south (1/8/2019).

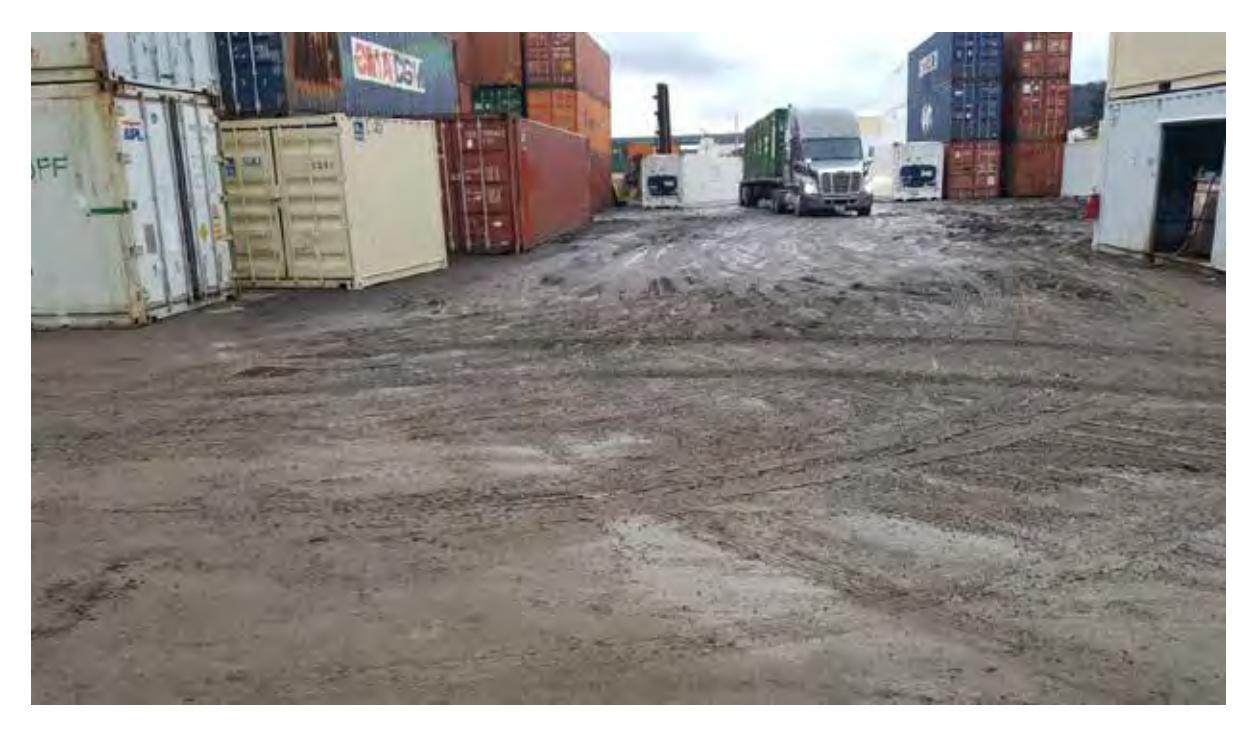
Photograph 6: View of shipping containers stacked adjacent to north and east walls of Building 455 and east wall of Building 99 at Site 24, looking southwest (1/8/2019).

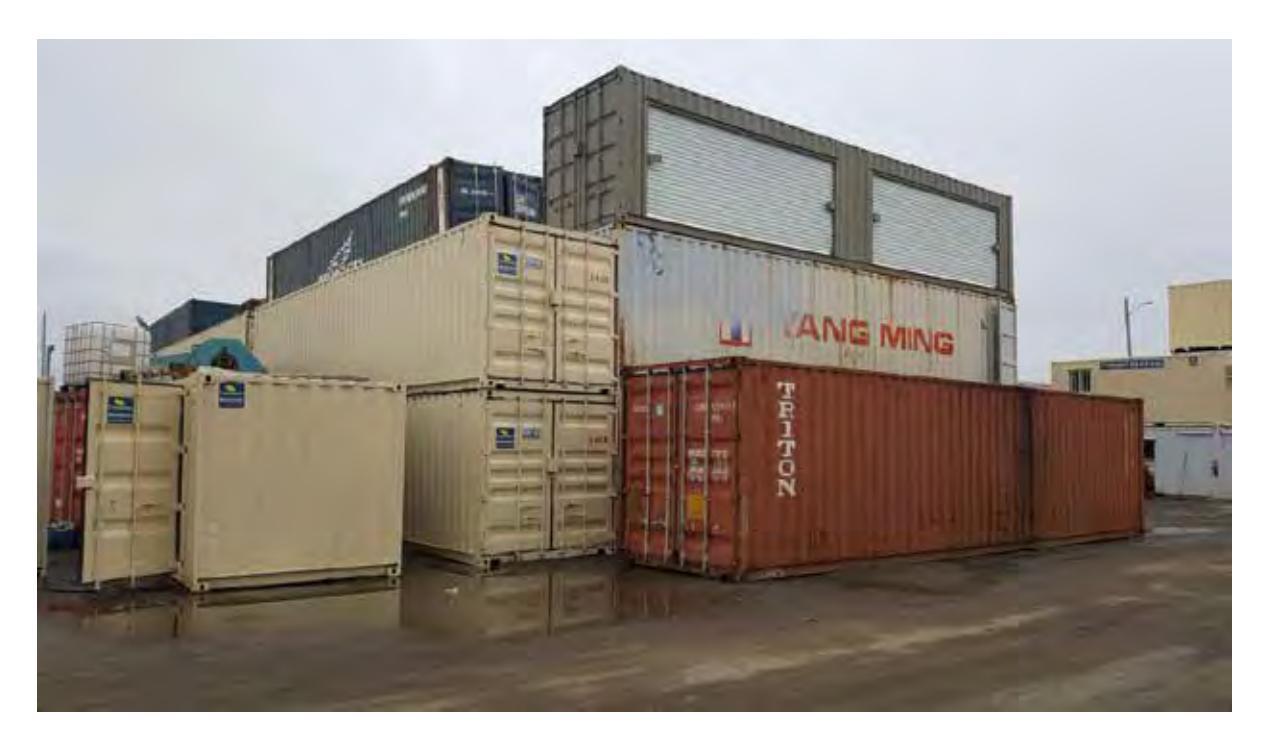
Photograph 7: View of shipping containers stacked near Buildings 455 and 99 at Site 24, looking south. These containers cover wells 24-SG-46, 24-EW29, and 24-BB82 (1/8/2019).

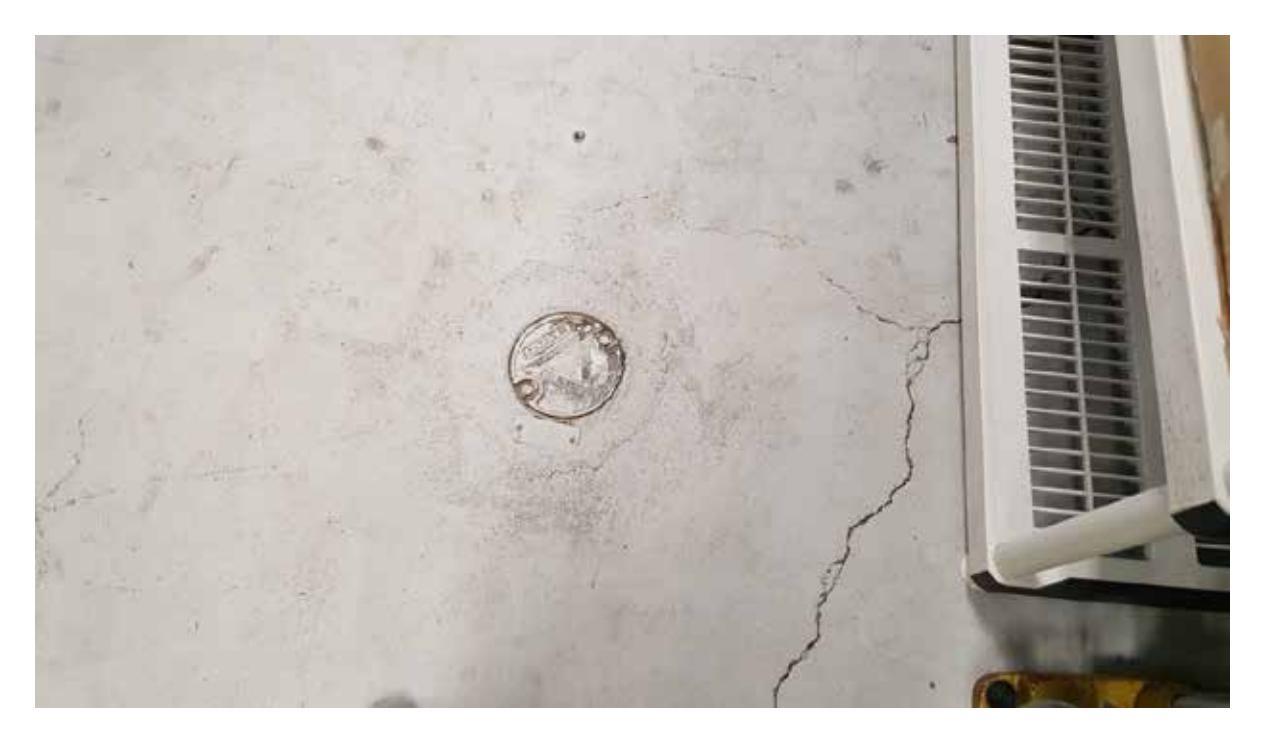
Photograph 9: View of stored materials within Building 96 covering 24-SG-26 at Site 24 (1/10/2019).

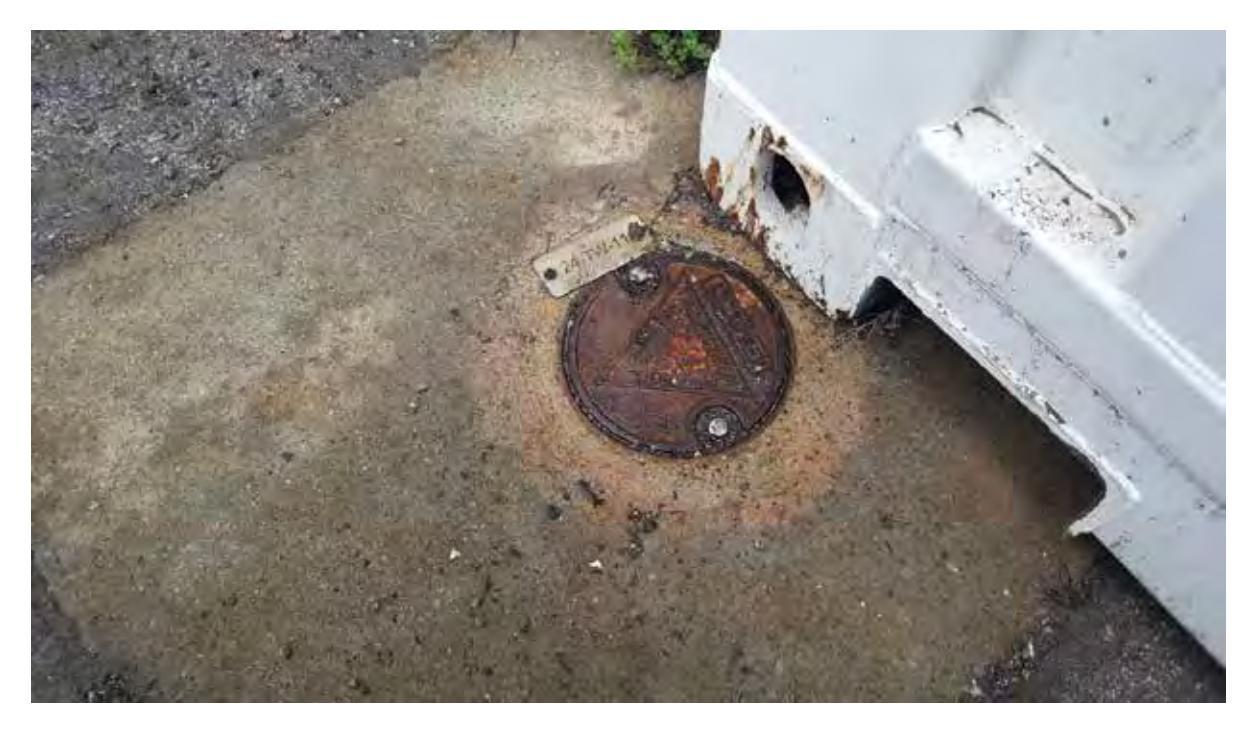
Photograph 11: View of 24-IW9 within Building 96 at Site 24. Note missing bolt (1/10/2019).

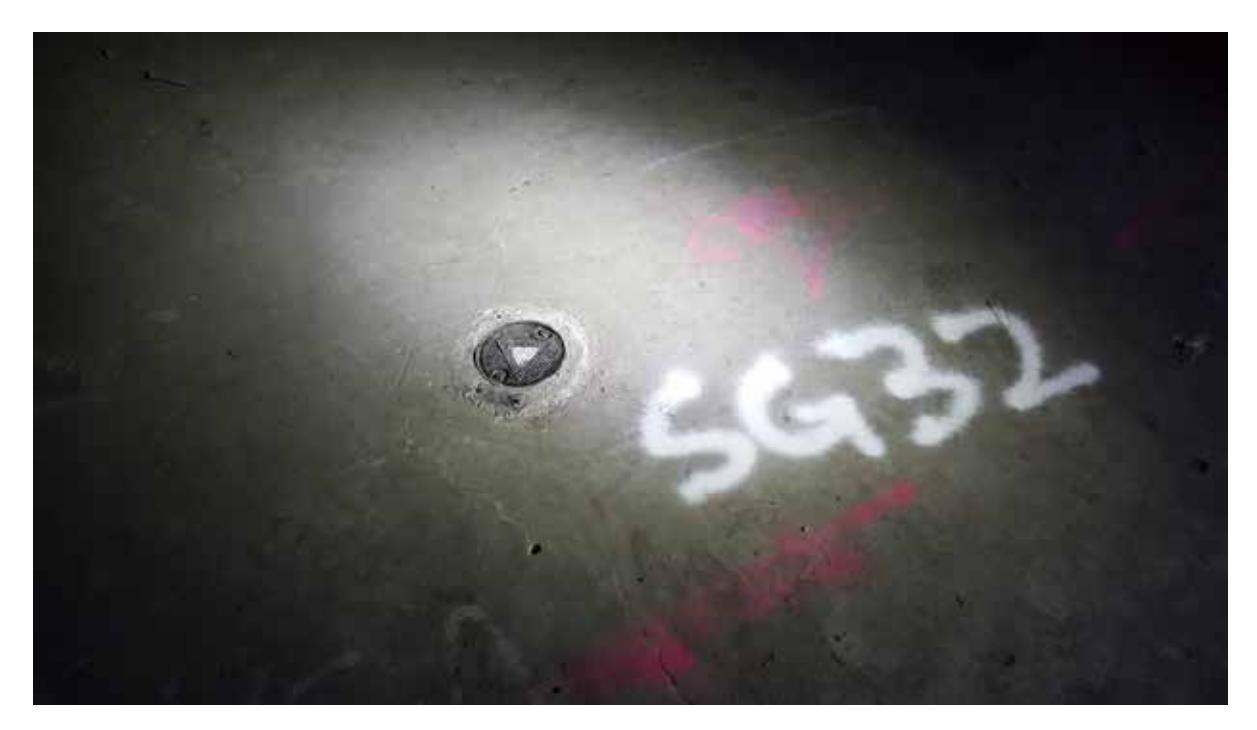
Photograph 12: View of well 24-TW-11 at Site 24 (1/8/2019).

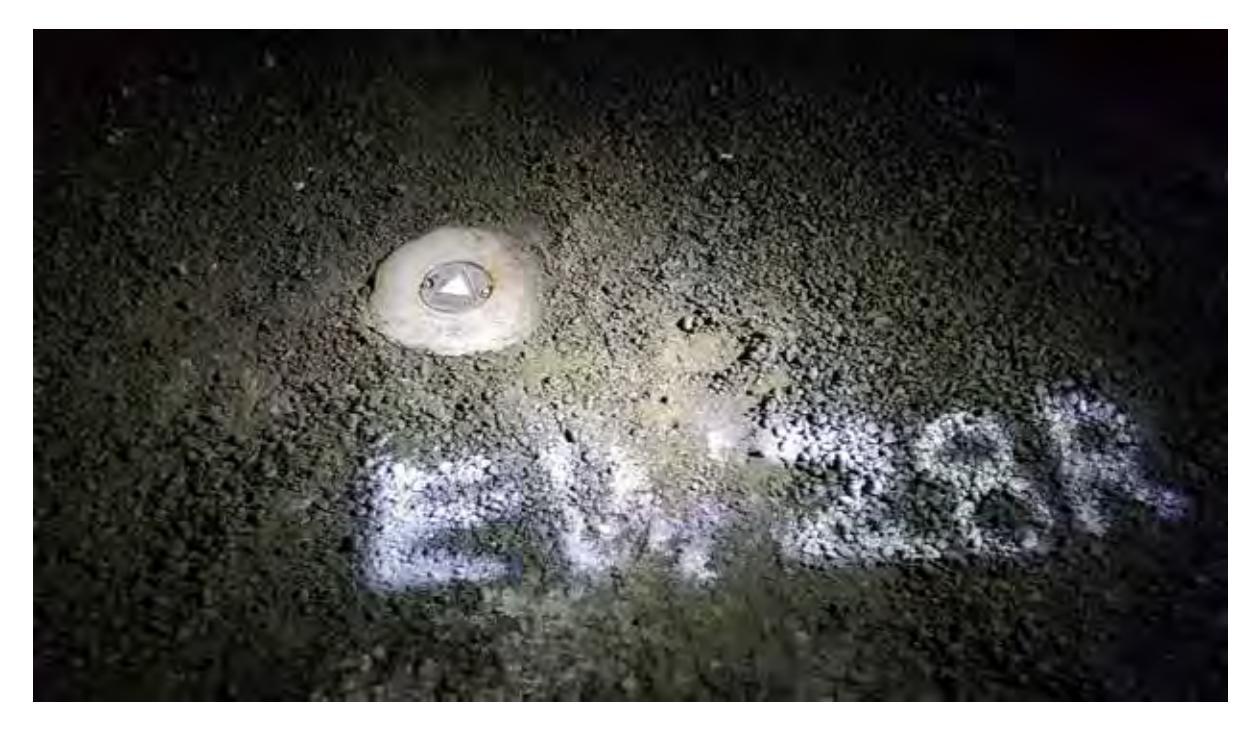
Photograph 13: View of 24-SG-32 within Building 99 at Site 24 (1/10/2019).

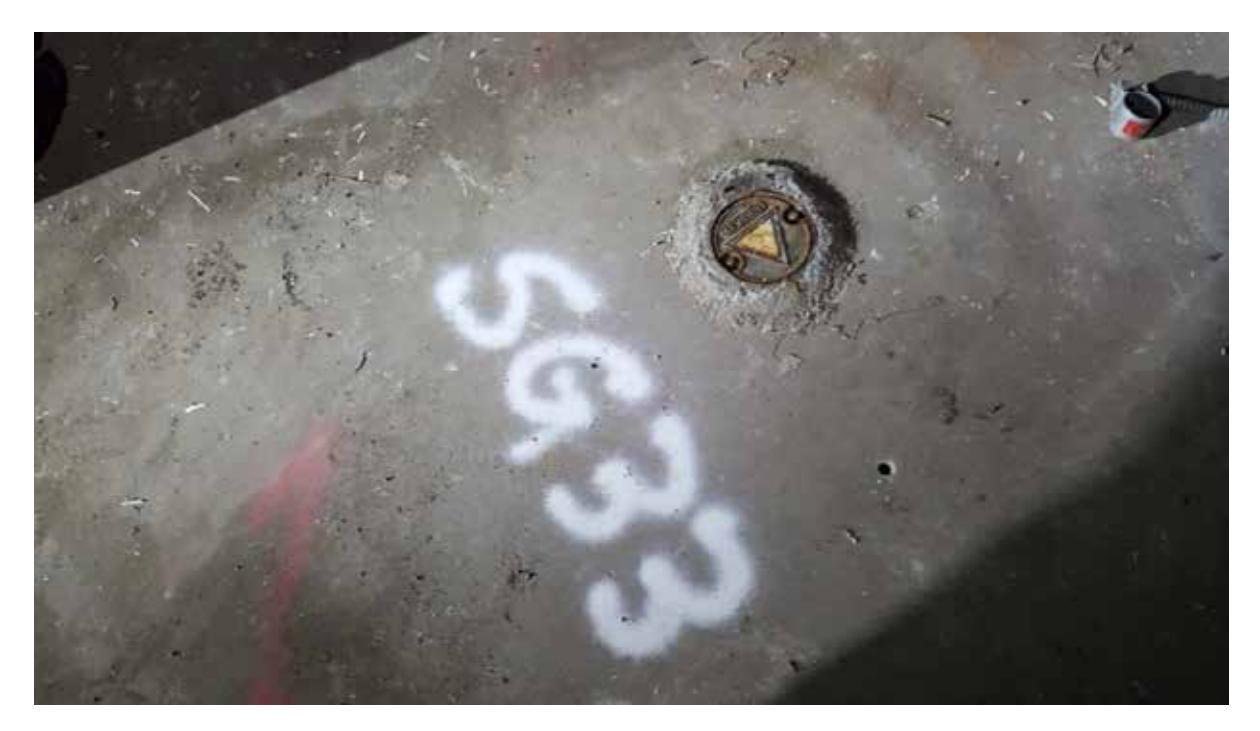
Photograph 14: View of 24-EW28R within Building 99 at Site 24 (1/10/2019).

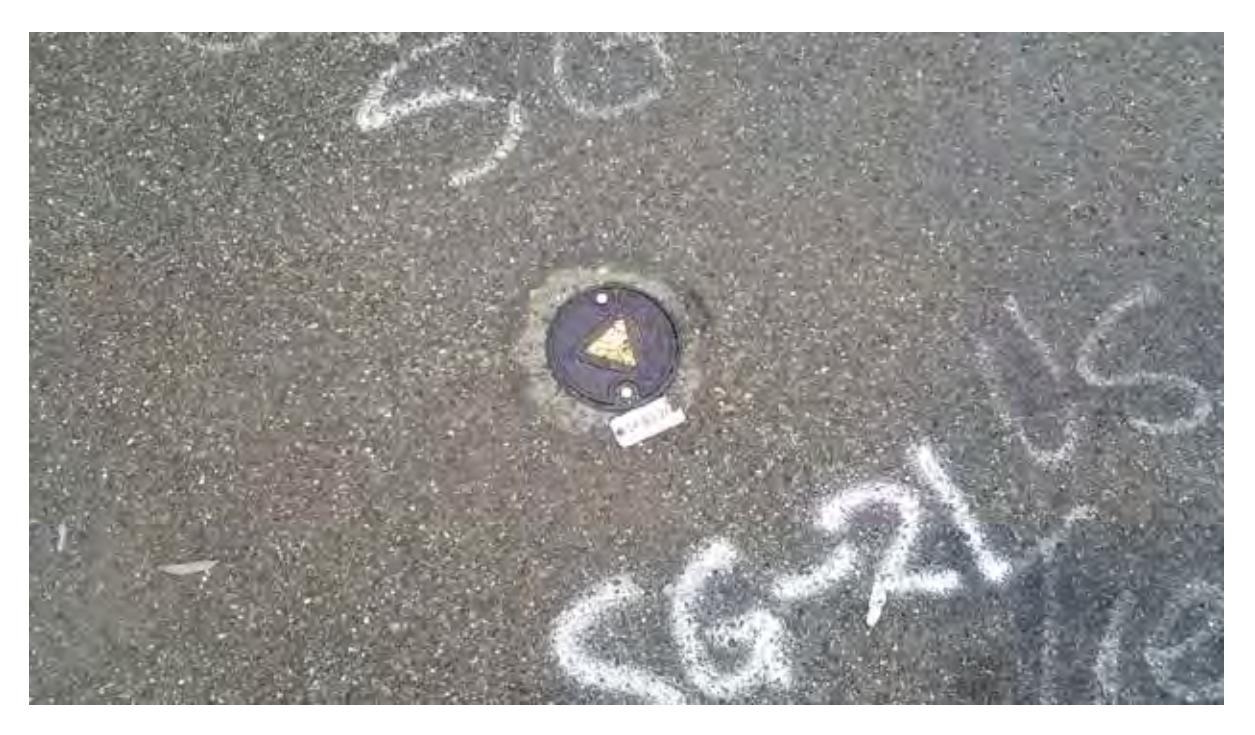
Photograph 16: View of 24-IW4 within Building 99 at Site 24. Note missing bolts (1/10/2019).

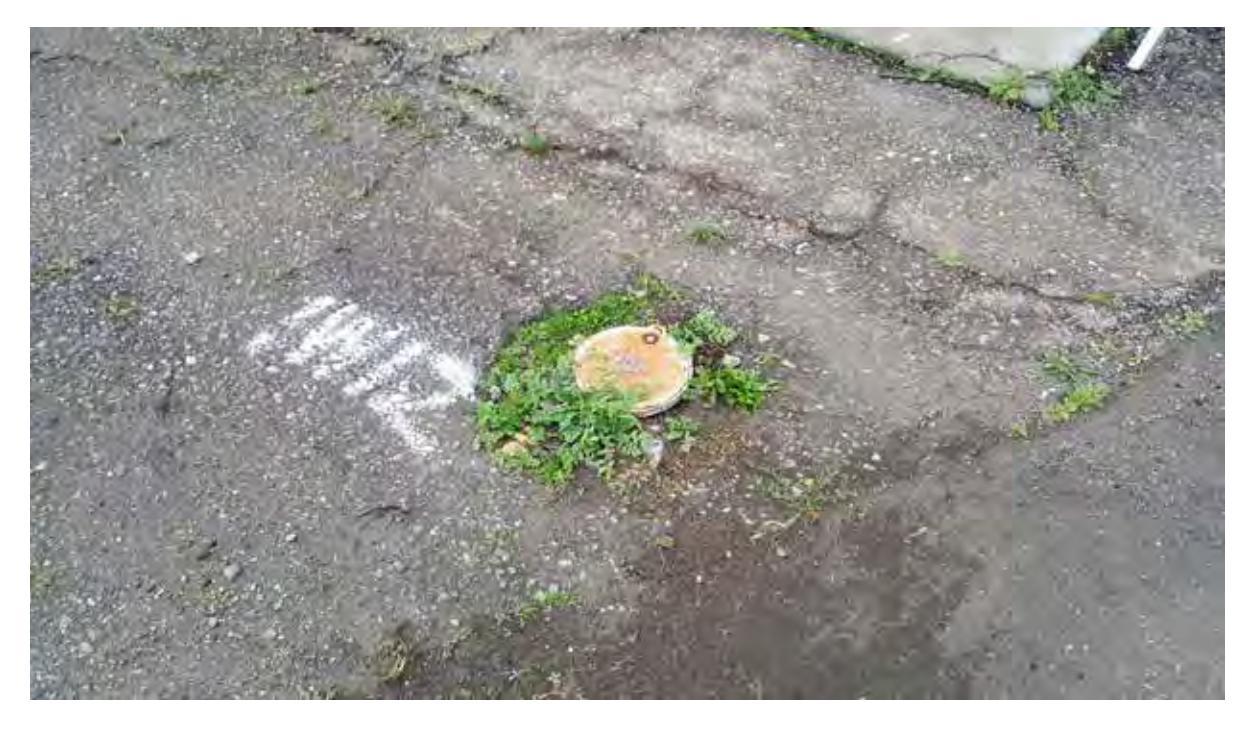
Photograph 17: View of 24-SG-21 at Site 24 (1/8/2019).

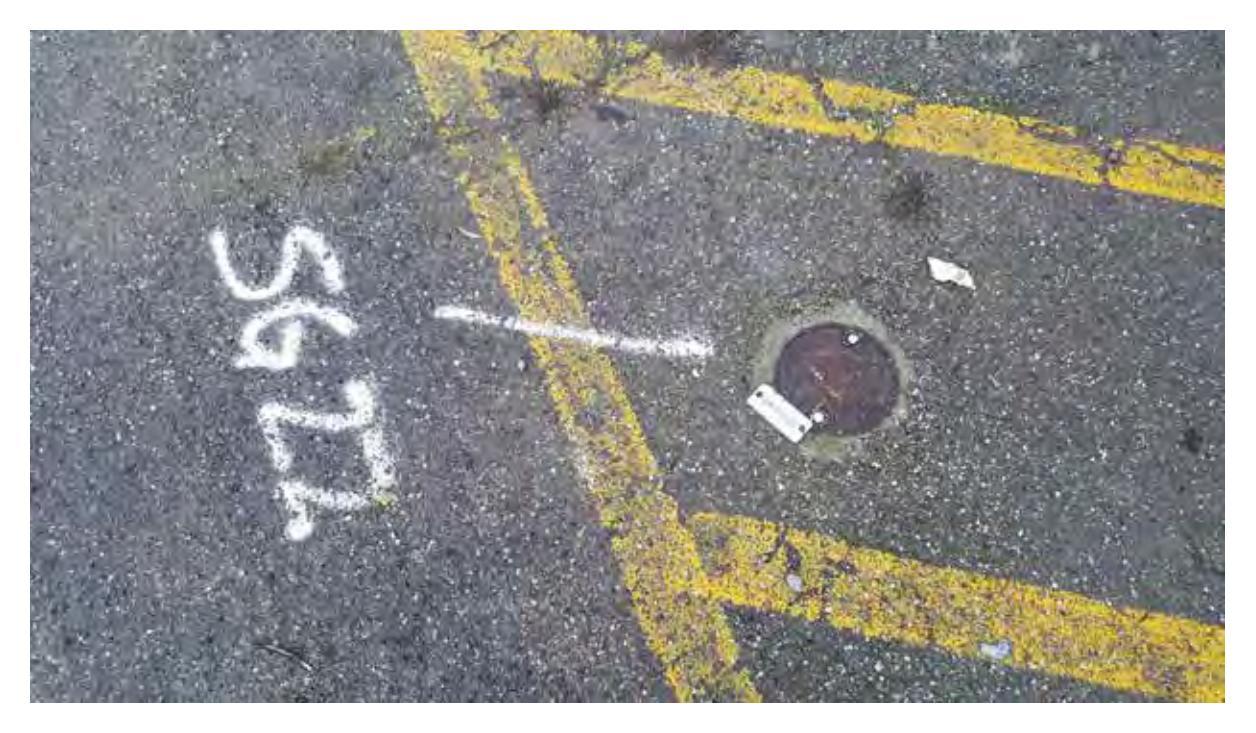
Photograph 19: View of 24-EW15 at Site 24. Note missing bolt (1/8/2019).

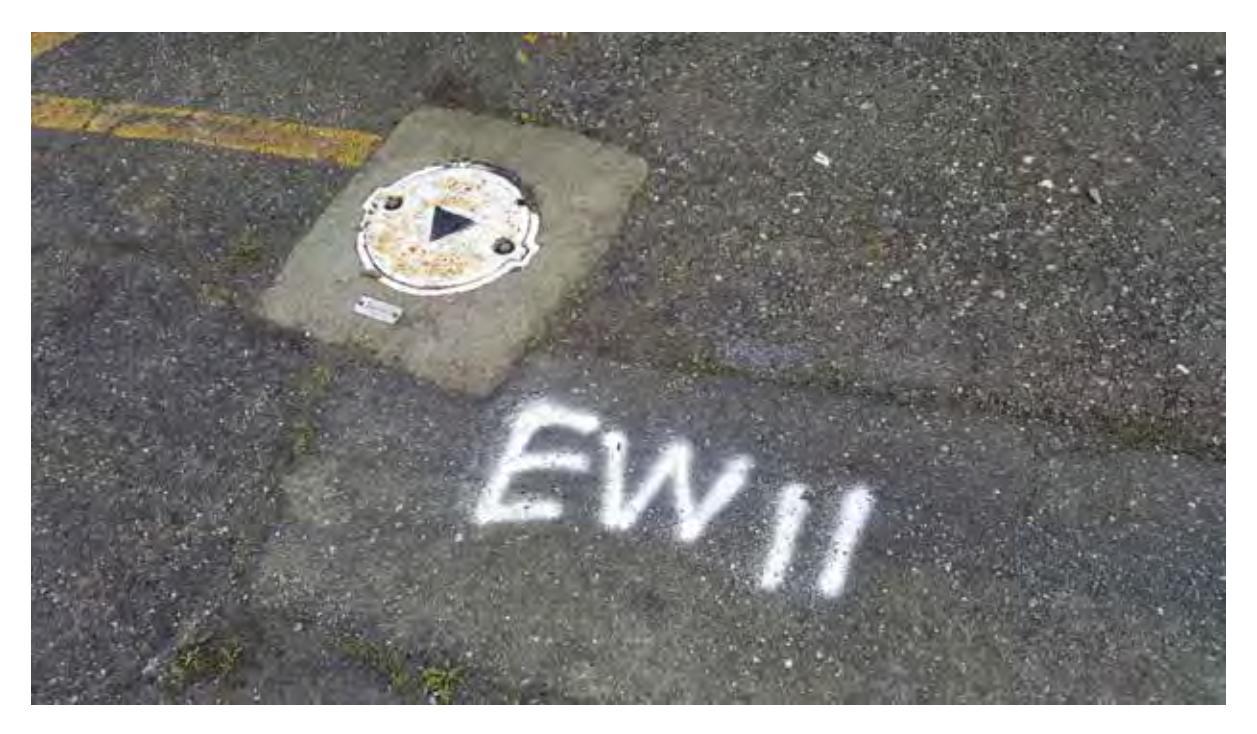
Photograph 20: View of 24-SG-22 at Site 24 (1/8/2019).

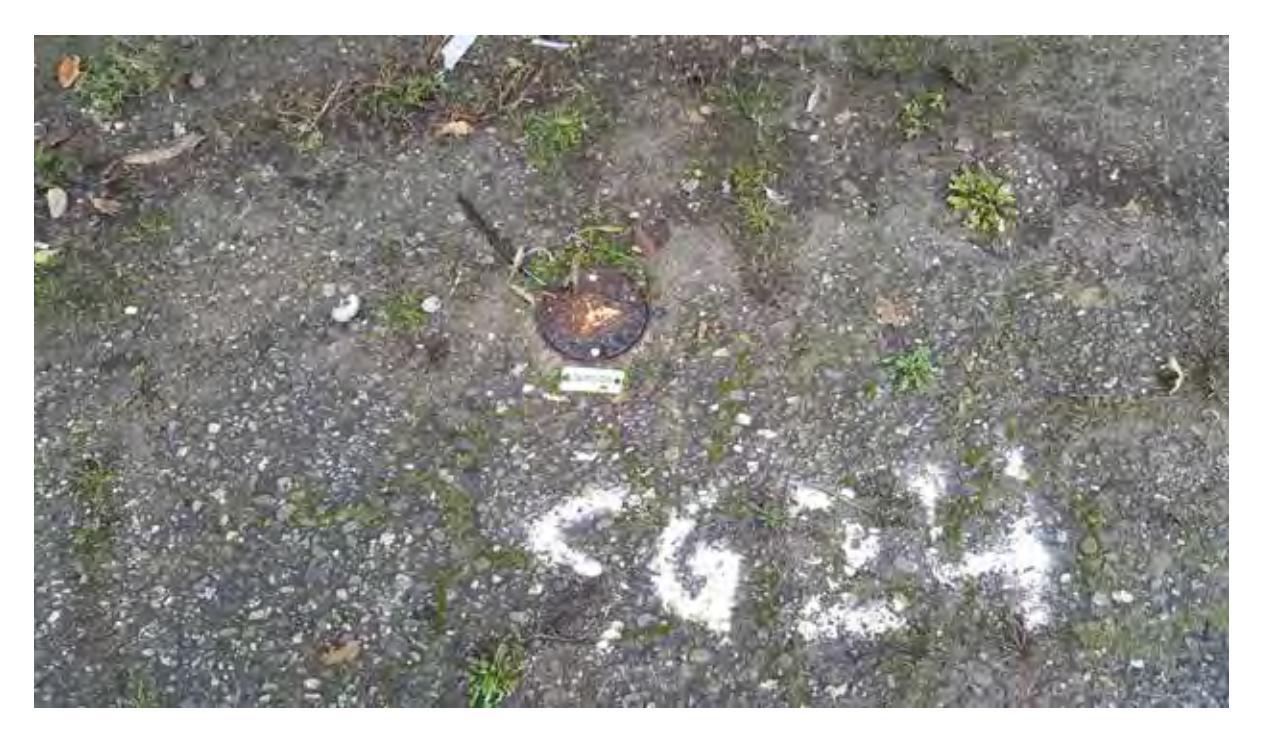
Photograph 21: View of 24-EW11 at Site 24 (1/8/2019).

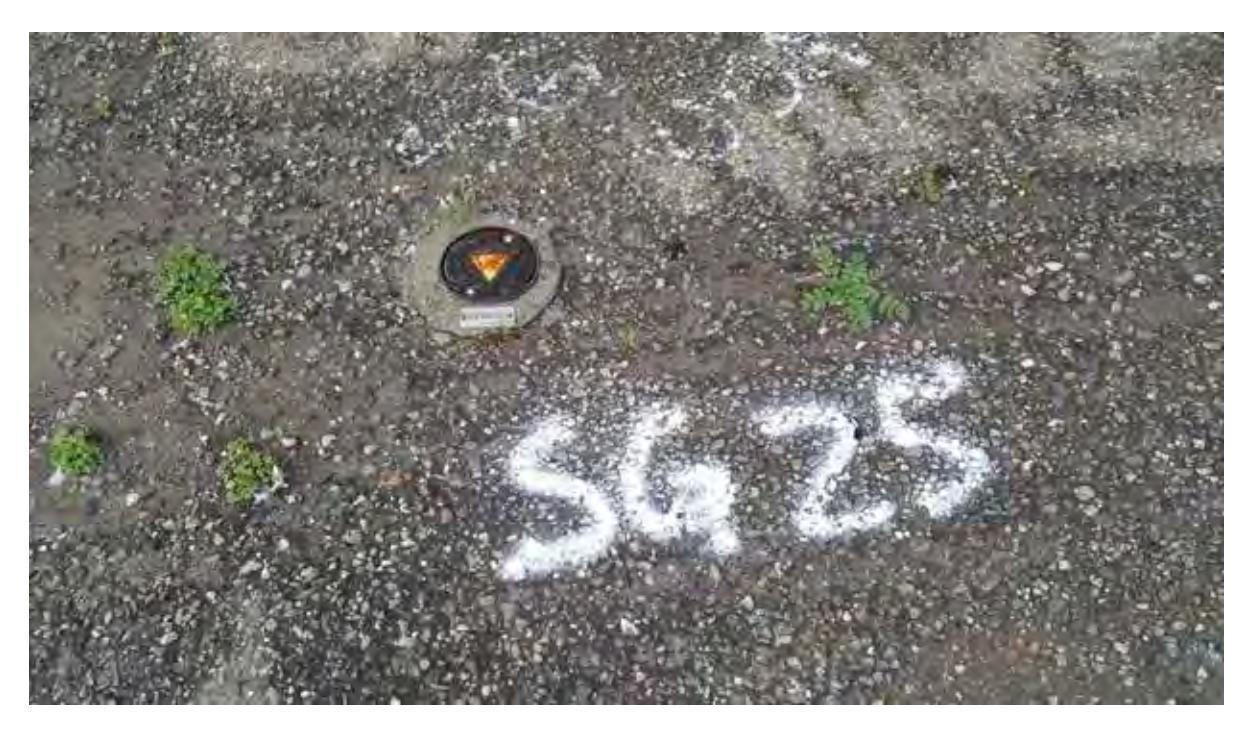
Photograph 22: View of 24-SG-24 at Site 24 (1/8/2019).

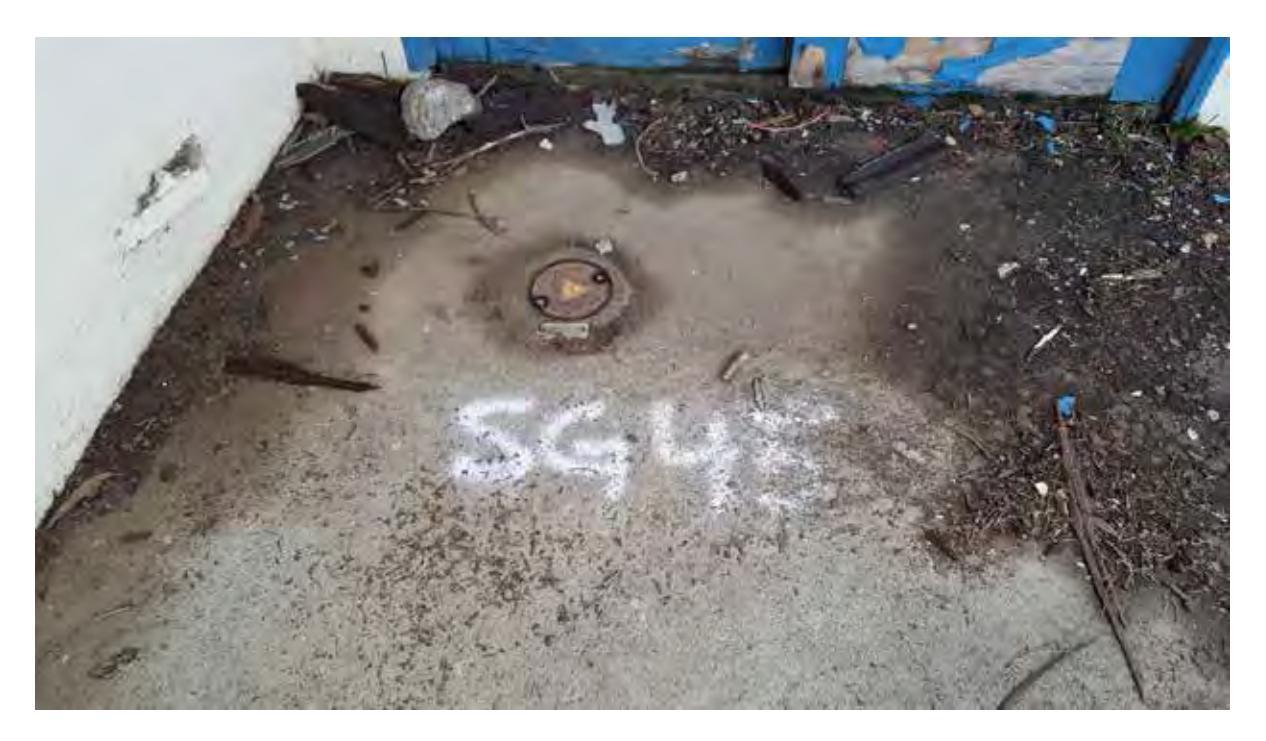
Photograph 25: View of 24-SG-40 at Site 24. Well not flush with ground, and likely damaged by heavy vehicle (1/8/2019).

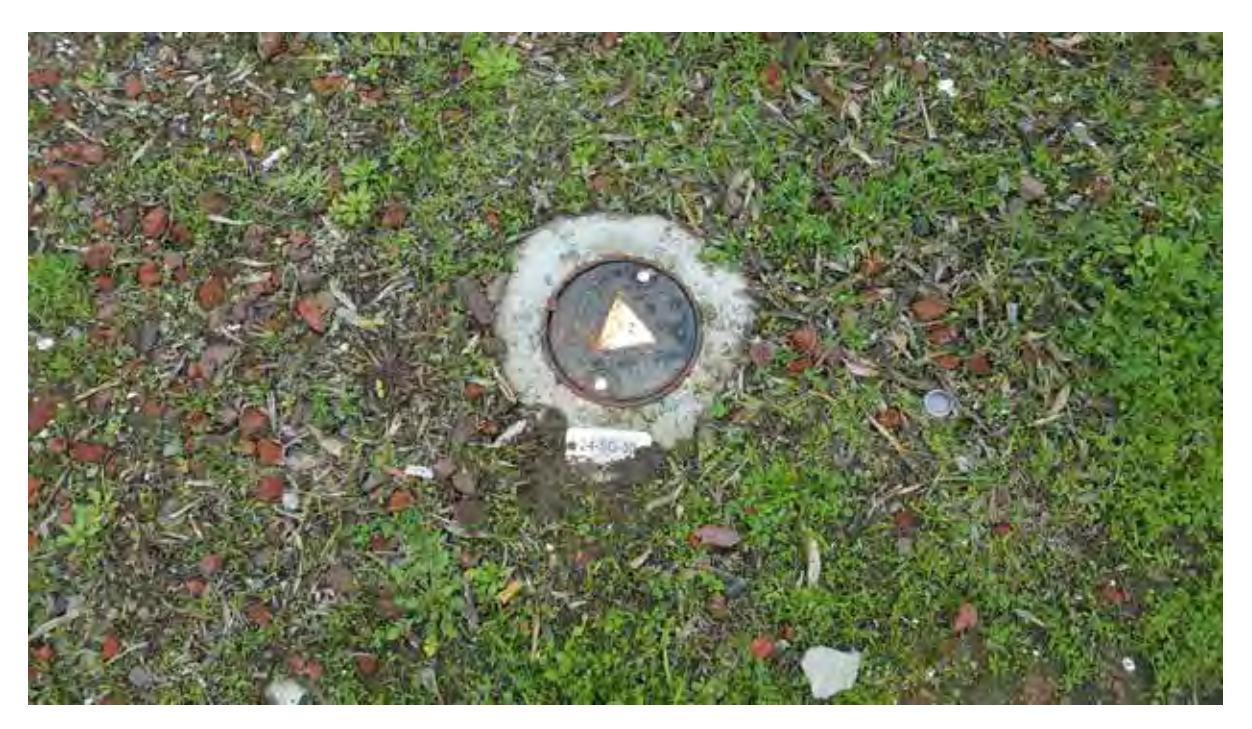
Photograph 40: View of flooded location of 24-SG-34 at Site 24 (1/17/2019).

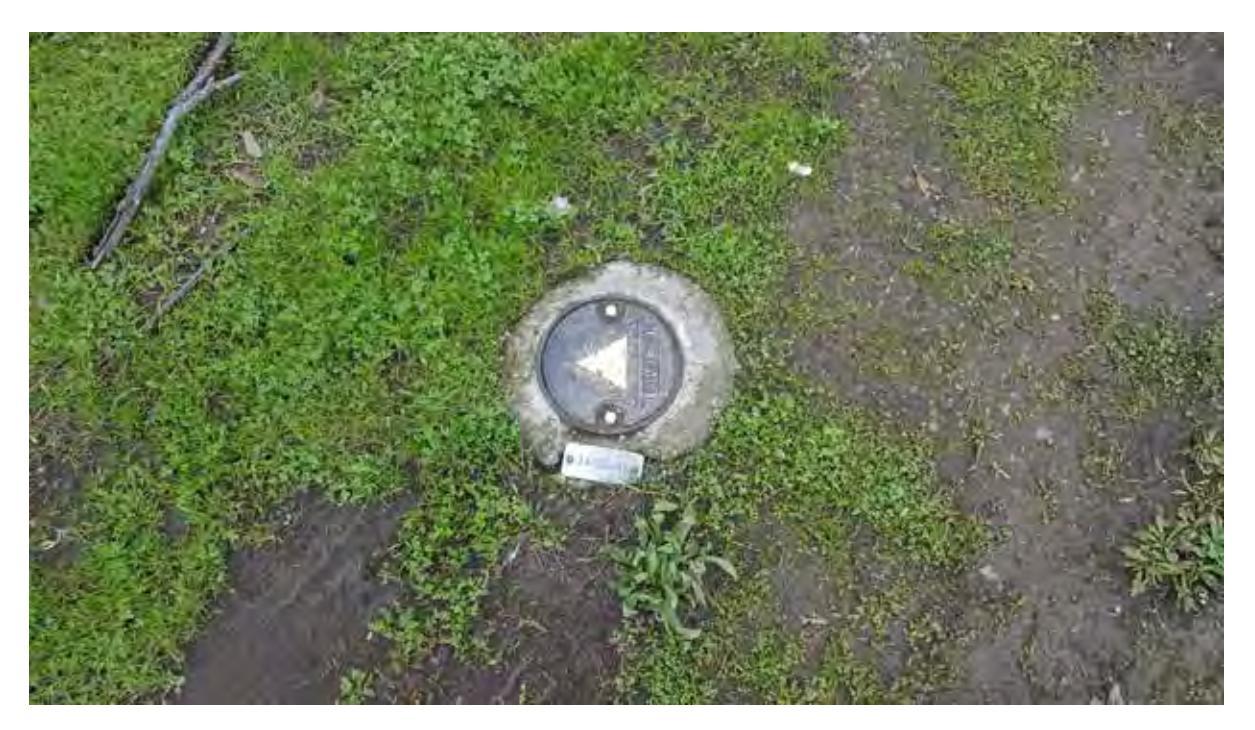
Photograph 42: View of overgrown location of 24-SG-44 at Site 24 (1/17/2019).

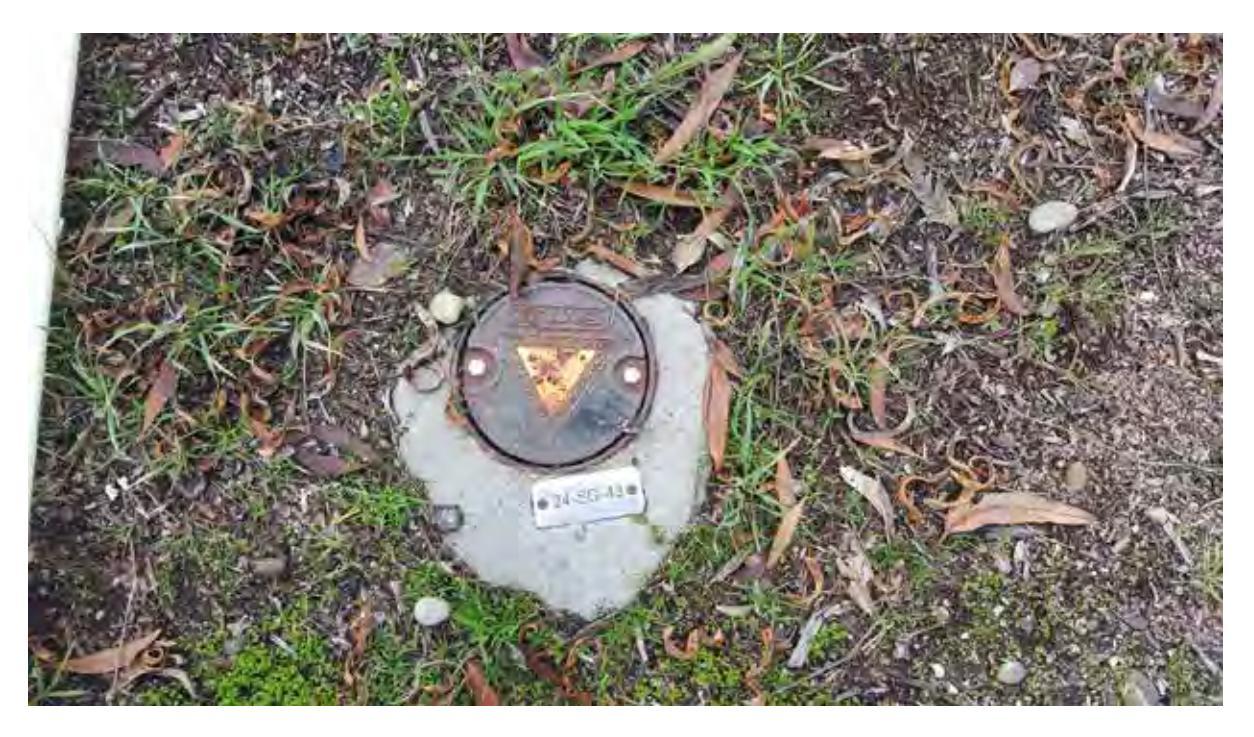
Photograph 47: View of soil covered location of 24-SG-47 at Site 24. Note stacked shipping containers in background (1/17/2019).

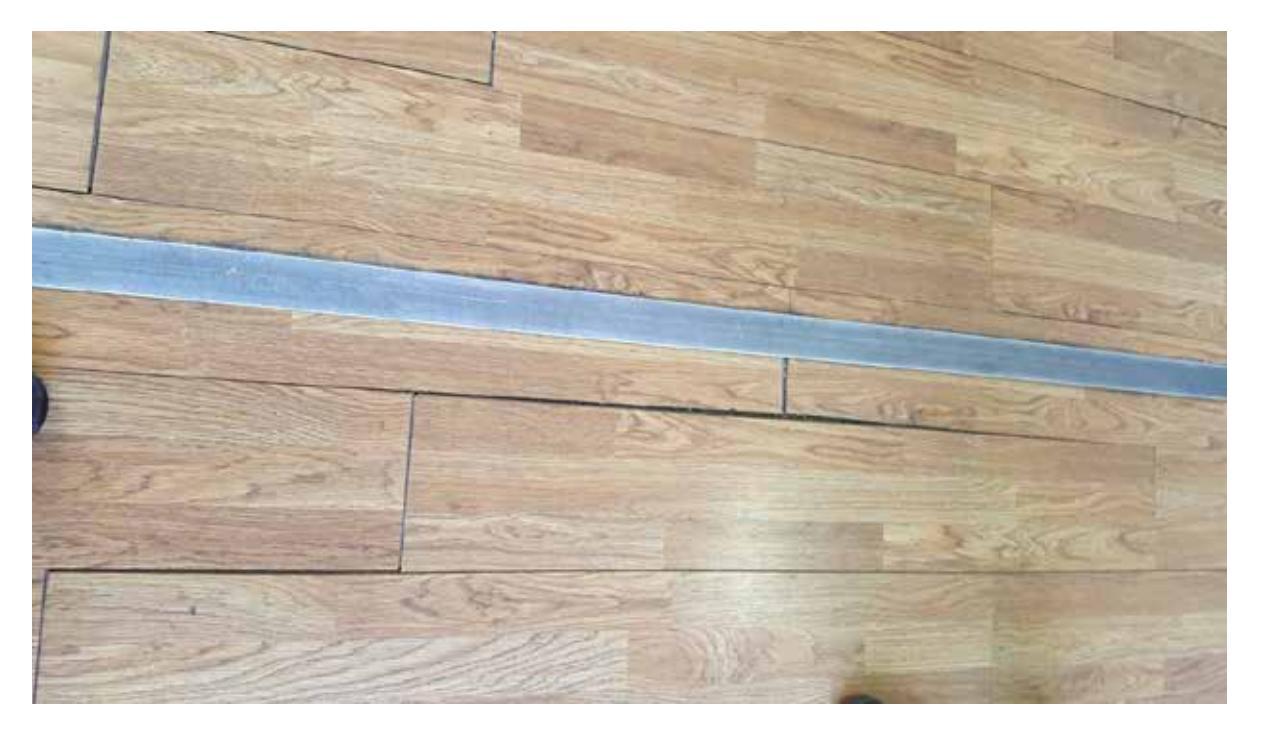
Photograph 6: View of separating floor paneling at center of Site 30 daycare center building interior (1/8/2019).

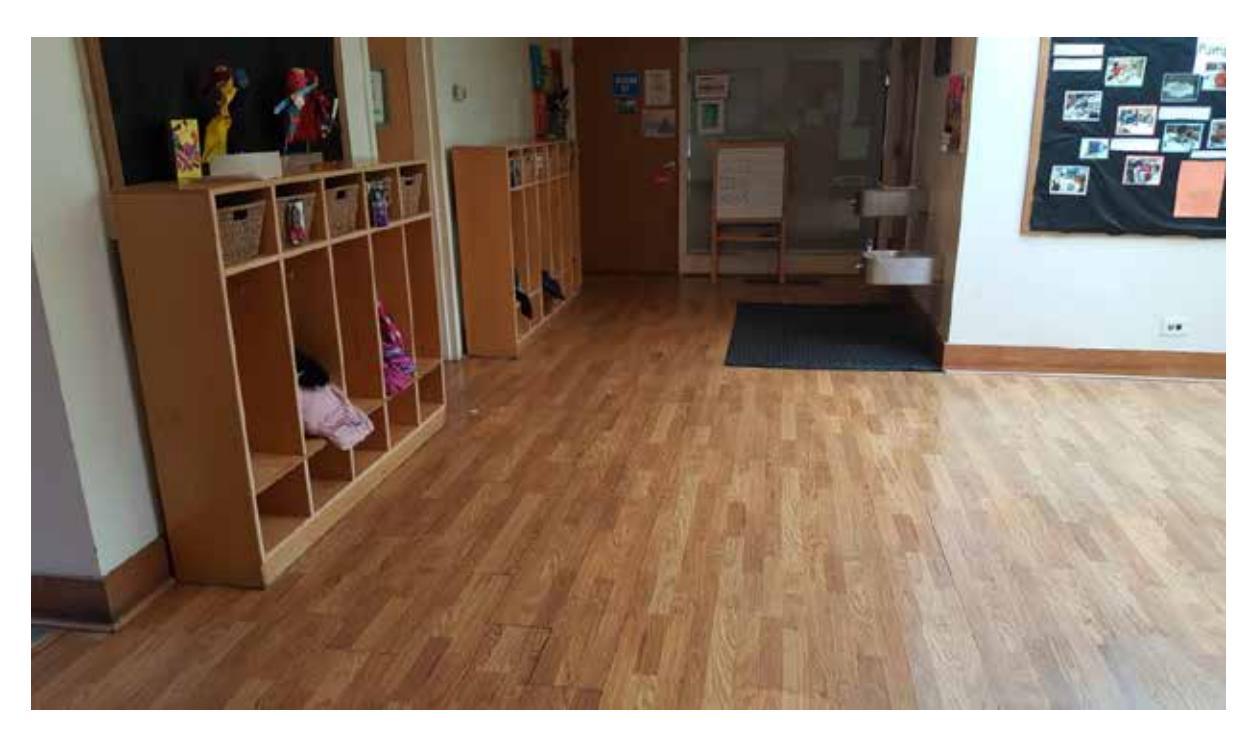
Photograph 7: View of separating floor paneling at center of Site 30 daycare center building interior (1/8/2019).
