Naval Facilities Engineering Command Southwest BRAC PMO West San Diego, CA

Second Five-Year Review

Former Naval Station Treasure Island, CA

August 5, 2020

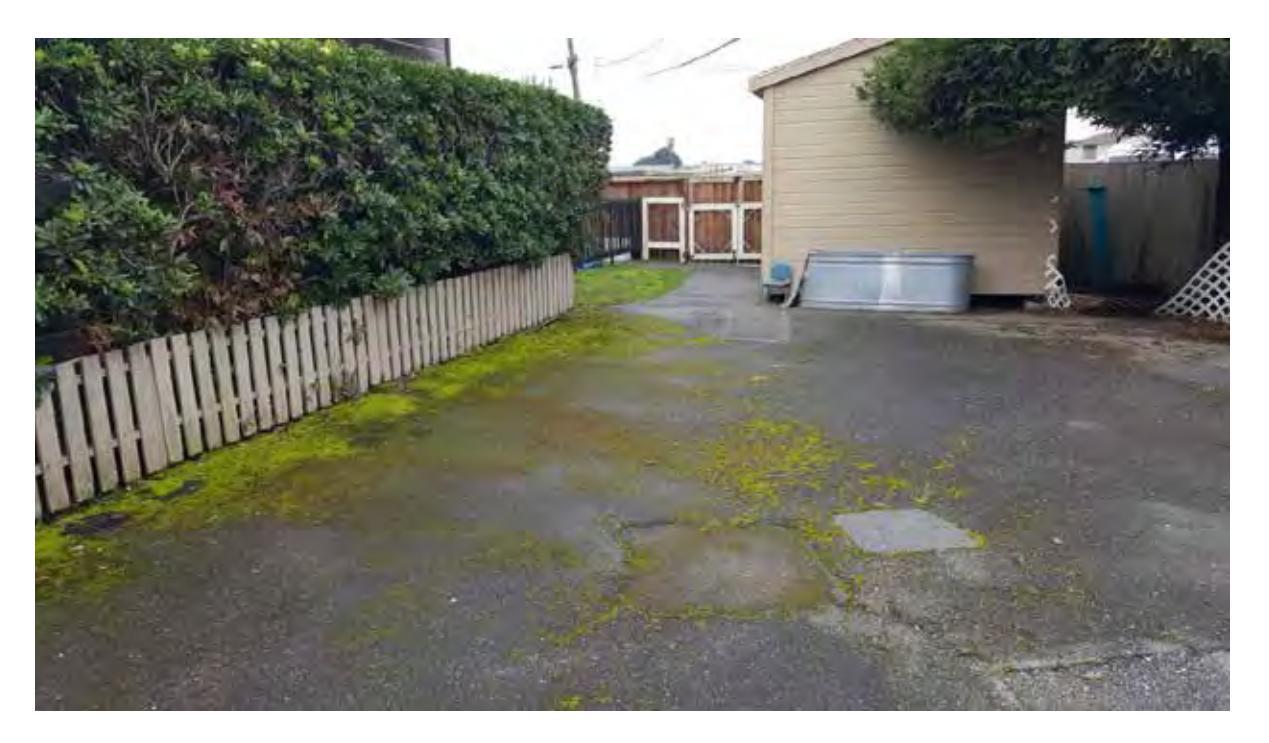
Photograph 10: View of Site 30 from daycare center building north entrance, looking northwest. Note entrance to playground area (black gate) at upper center (1/8/2019).

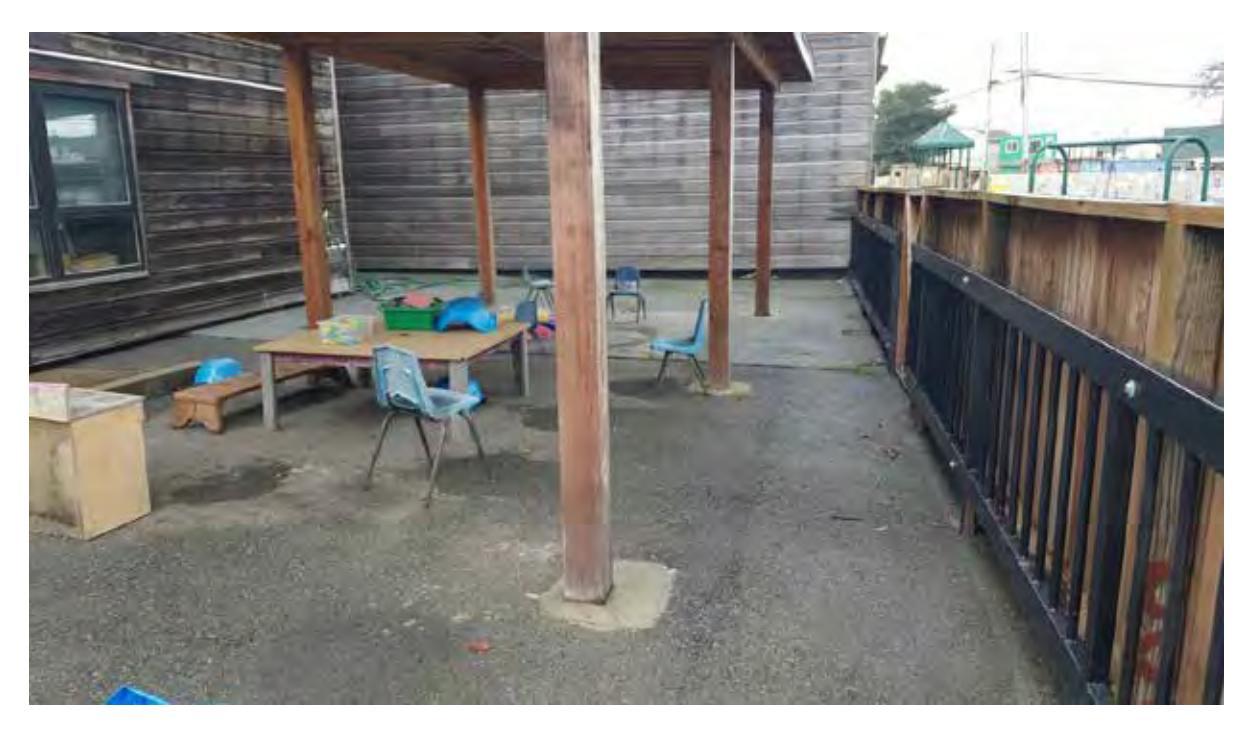
Photograph 11: View of play area adjacent to main playground area at Site 30 from entrance gate, looking south. Note edge of concrete slab covering subterranean soil contaminants at center (1/8/2019).

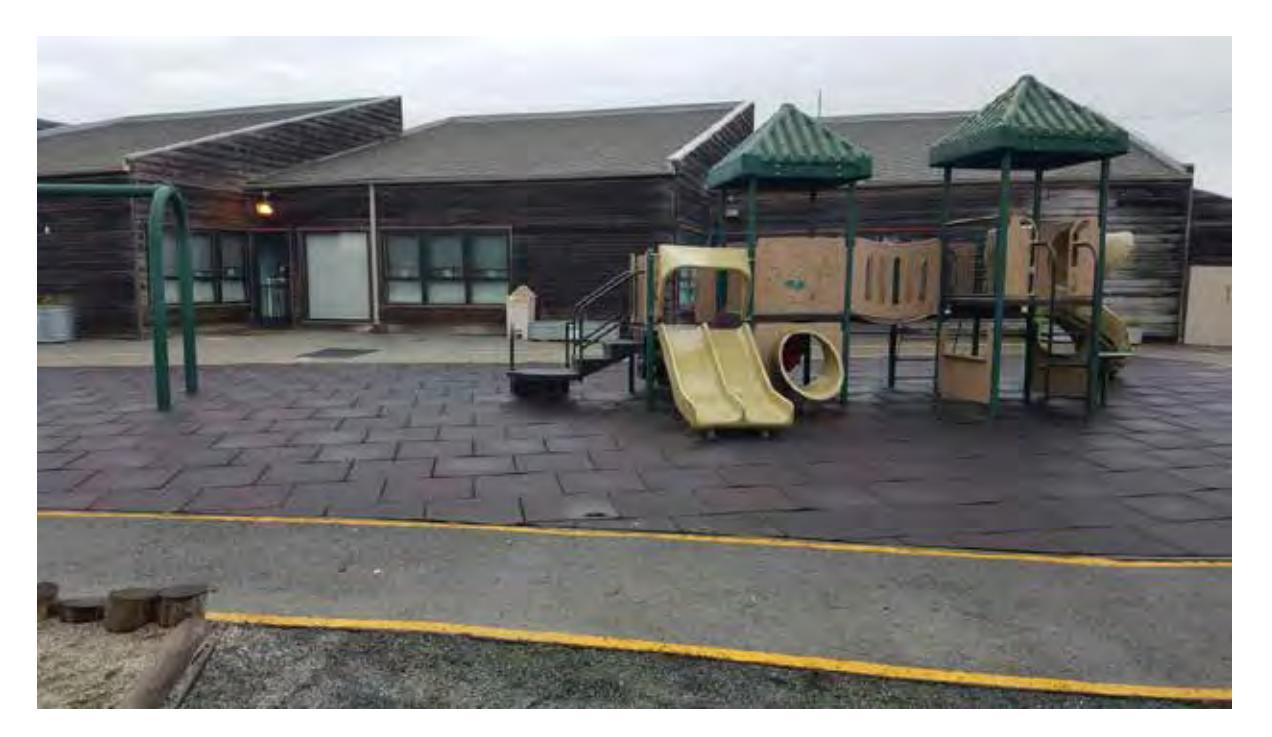
Photograph 12: View of Site 30 main playground area and daycare center building exterior from centerpoint of western fence line, looking east (1/8/2019).

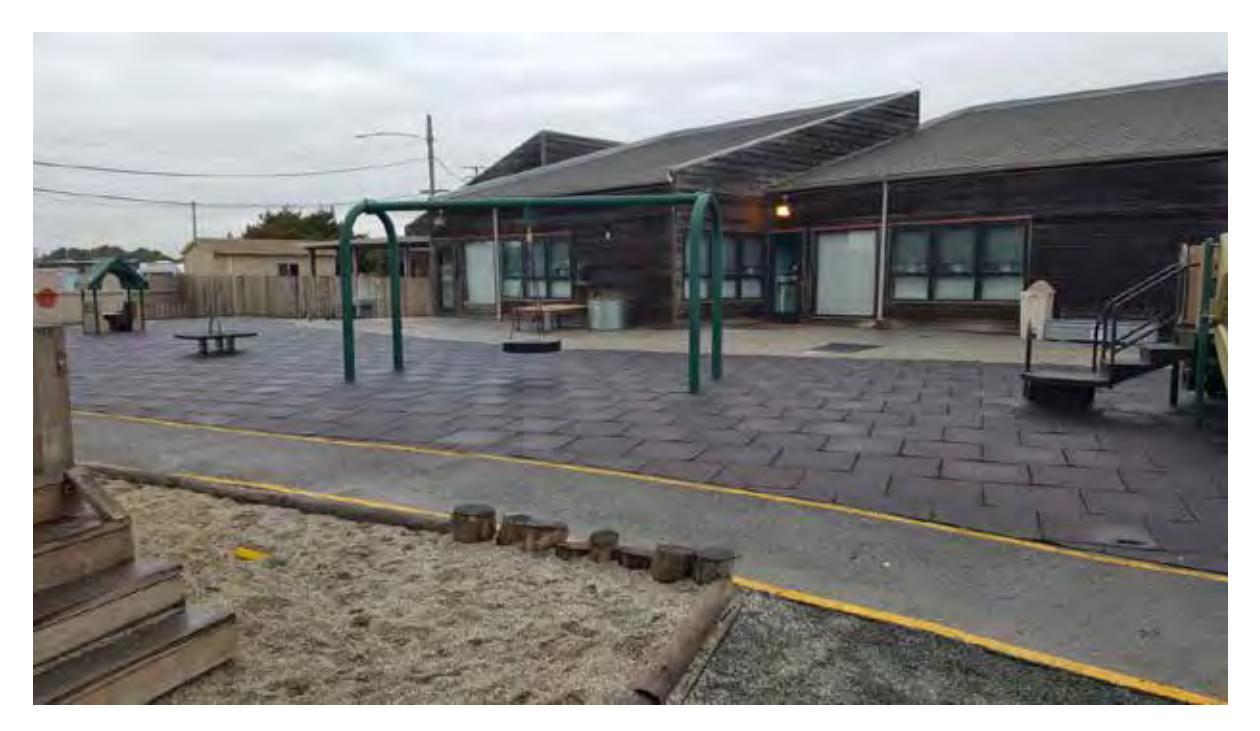
Photograph 13: View of Site 30 main playground area and daycare center building exterior from centerpoint of western fence line, looking northeast. Note concrete slab (pale color) between building exterior and play area (1/8/2019).

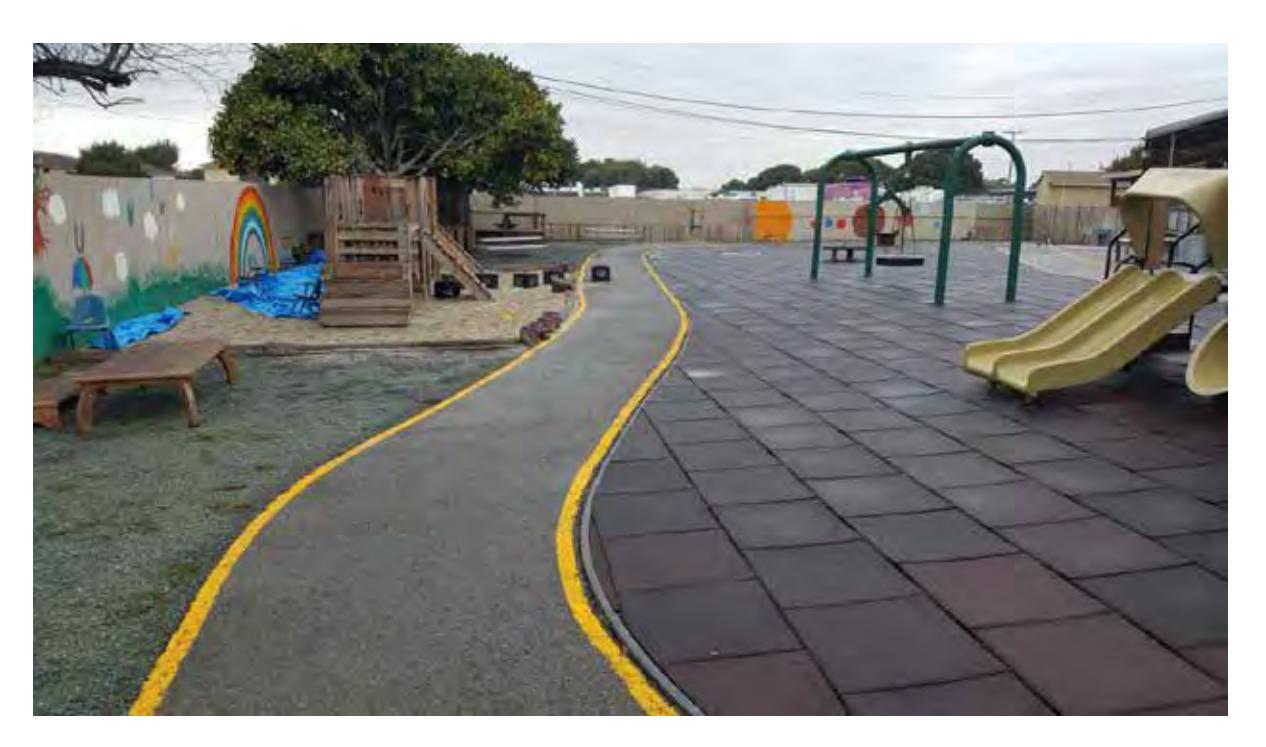
Photograph 14: View of Site 30 main playground area and daycare center building exterior from centerpoint of western fenceline, looking northeast (1/8/2019).

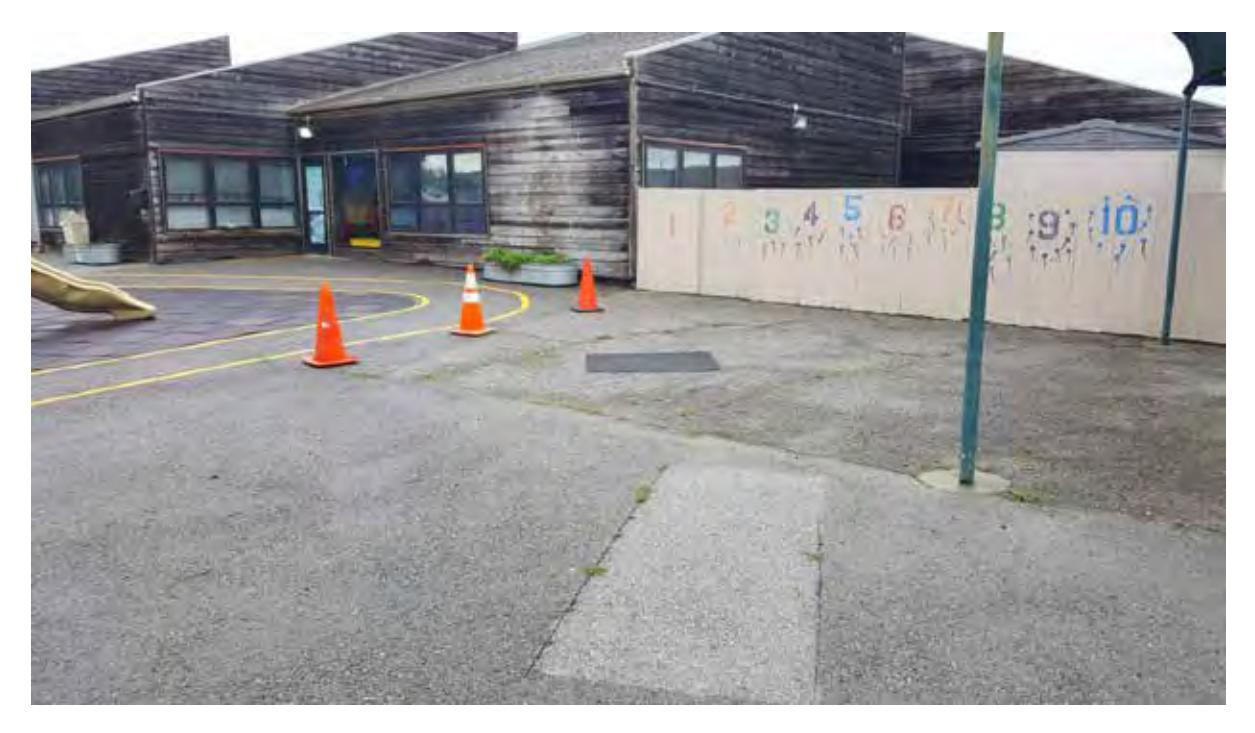
Photograph 15: View of southern edge of Site 30 main playground and daycare center building exterior, looking north (1/8/2019).

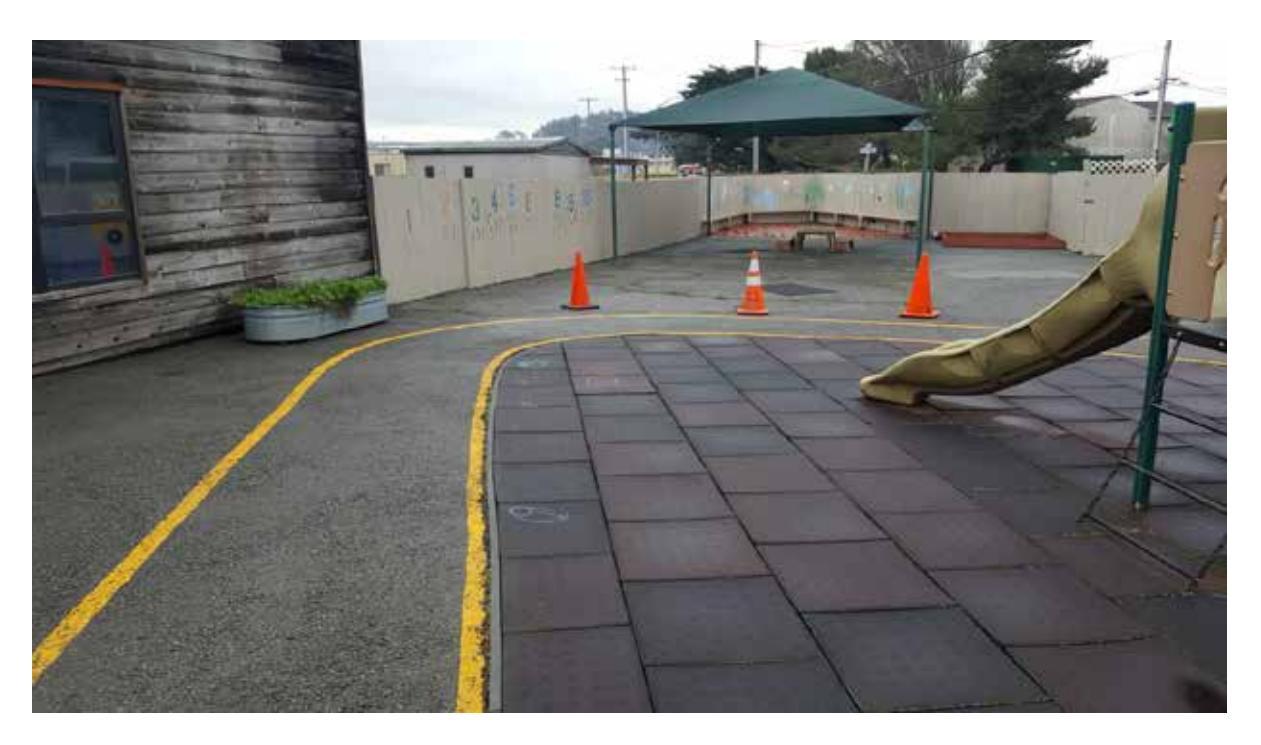
Photograph 16: View of southern edge of Site 30 main playground and daycare center building exterior, looking south (1/8/2019).

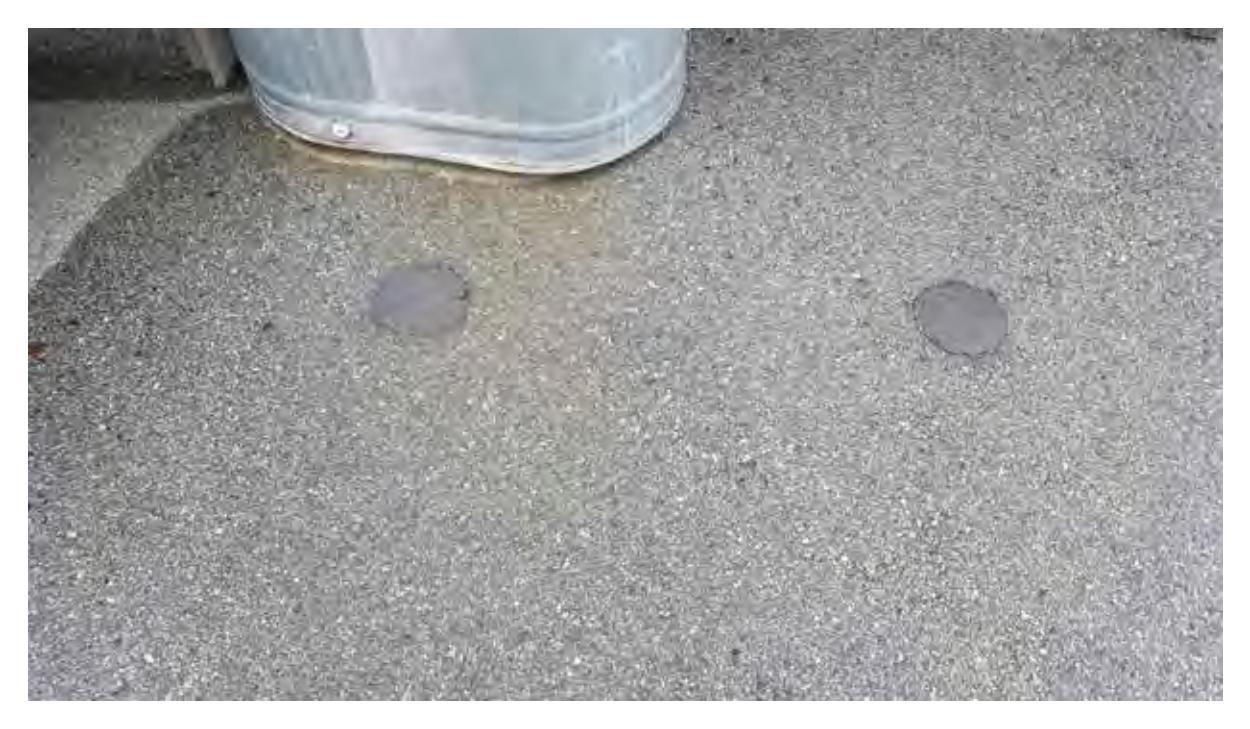
Photograph 19: View of patched former soil sampling locations in playground area of Site 30 (1/8/2019).

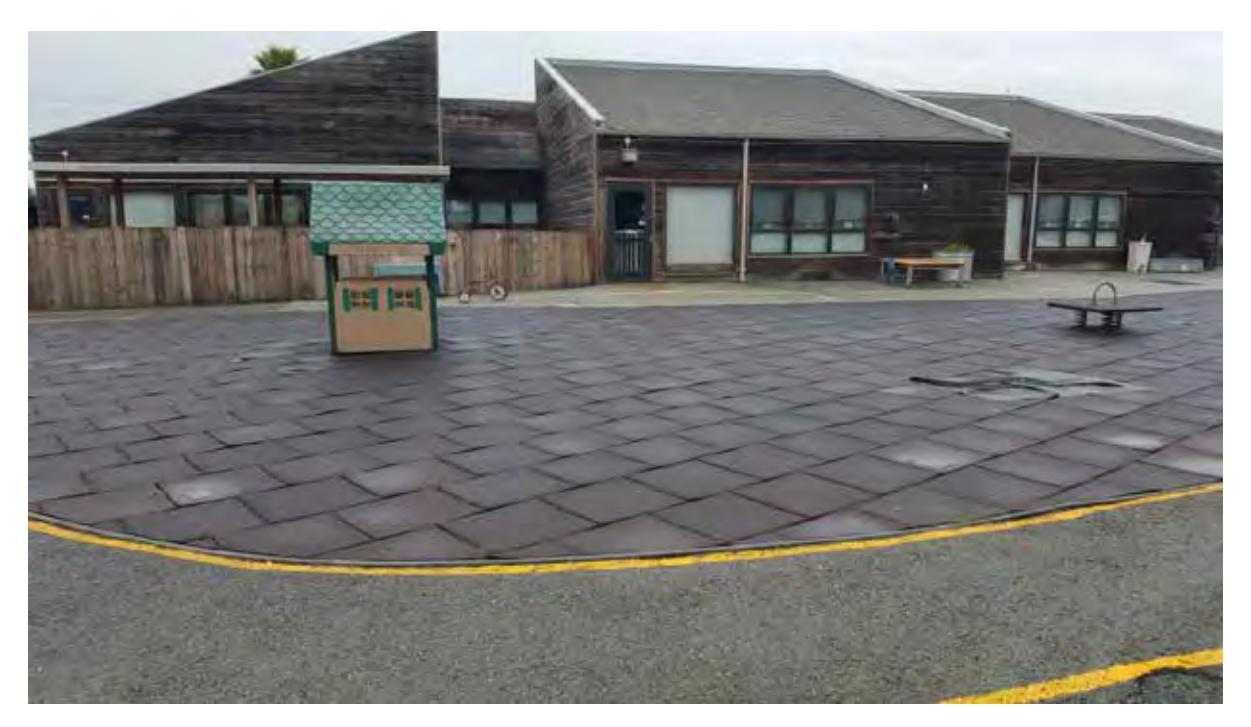
Photograph 23: View of northern portion of Site 30 main playground and daycare center building exterior from western boundary fenceline, looking east. Note upturned rubber surface tiles adjacent to metal panel set within play area at right (1/8/2019).

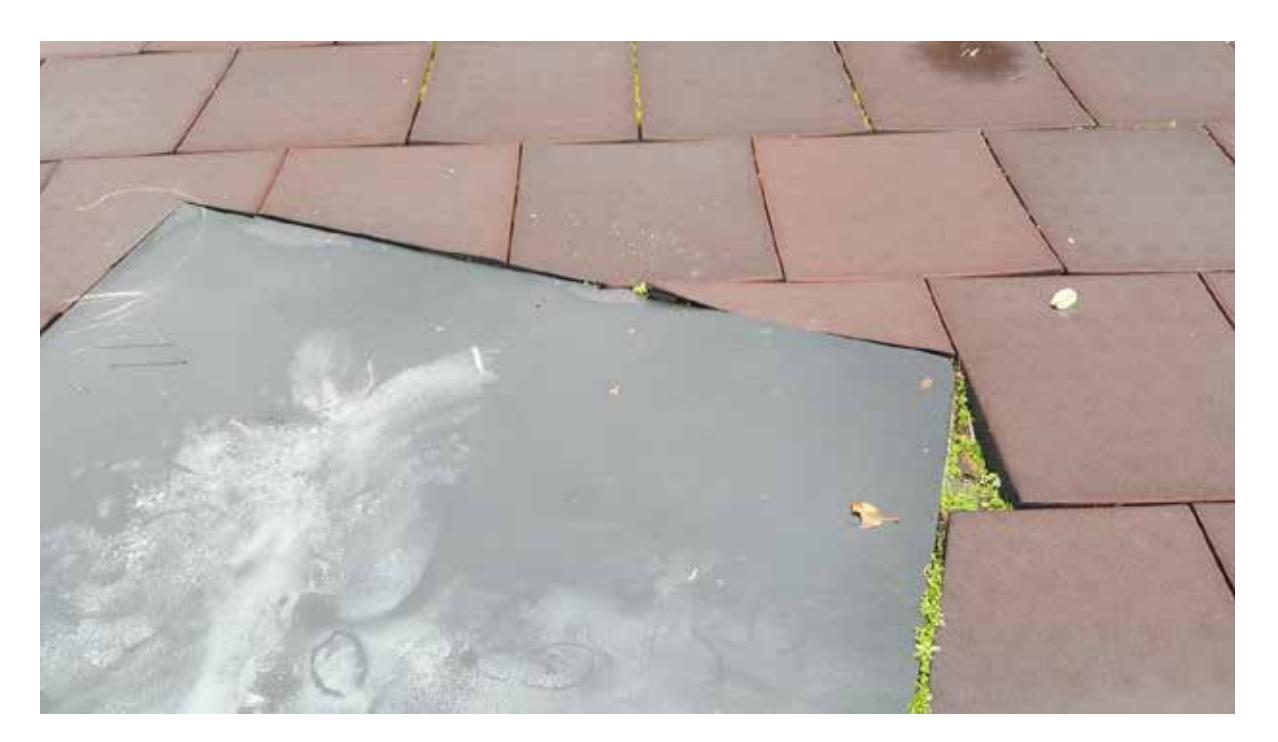
Photograph 24: View of vegetation growth adjacent to metal panel within rubber tiled play area at Site 30. Note upturning of edges of several rubber tiles (1/8/2019).
Site 30 Photographs
