# Materials Investigation of the Experimental OceanGate Submersible Titan

U.S. Coast Guard Marine Board of Investigation  
September 25, 2024

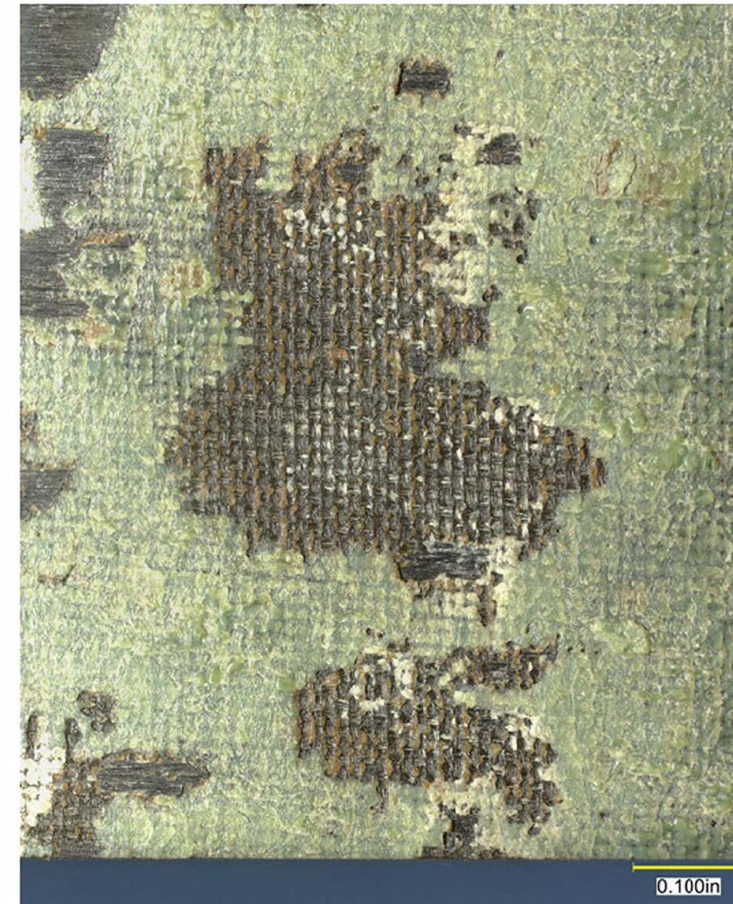
**Debris removed**

# Rubbing Damage – Debris Collected in Voids

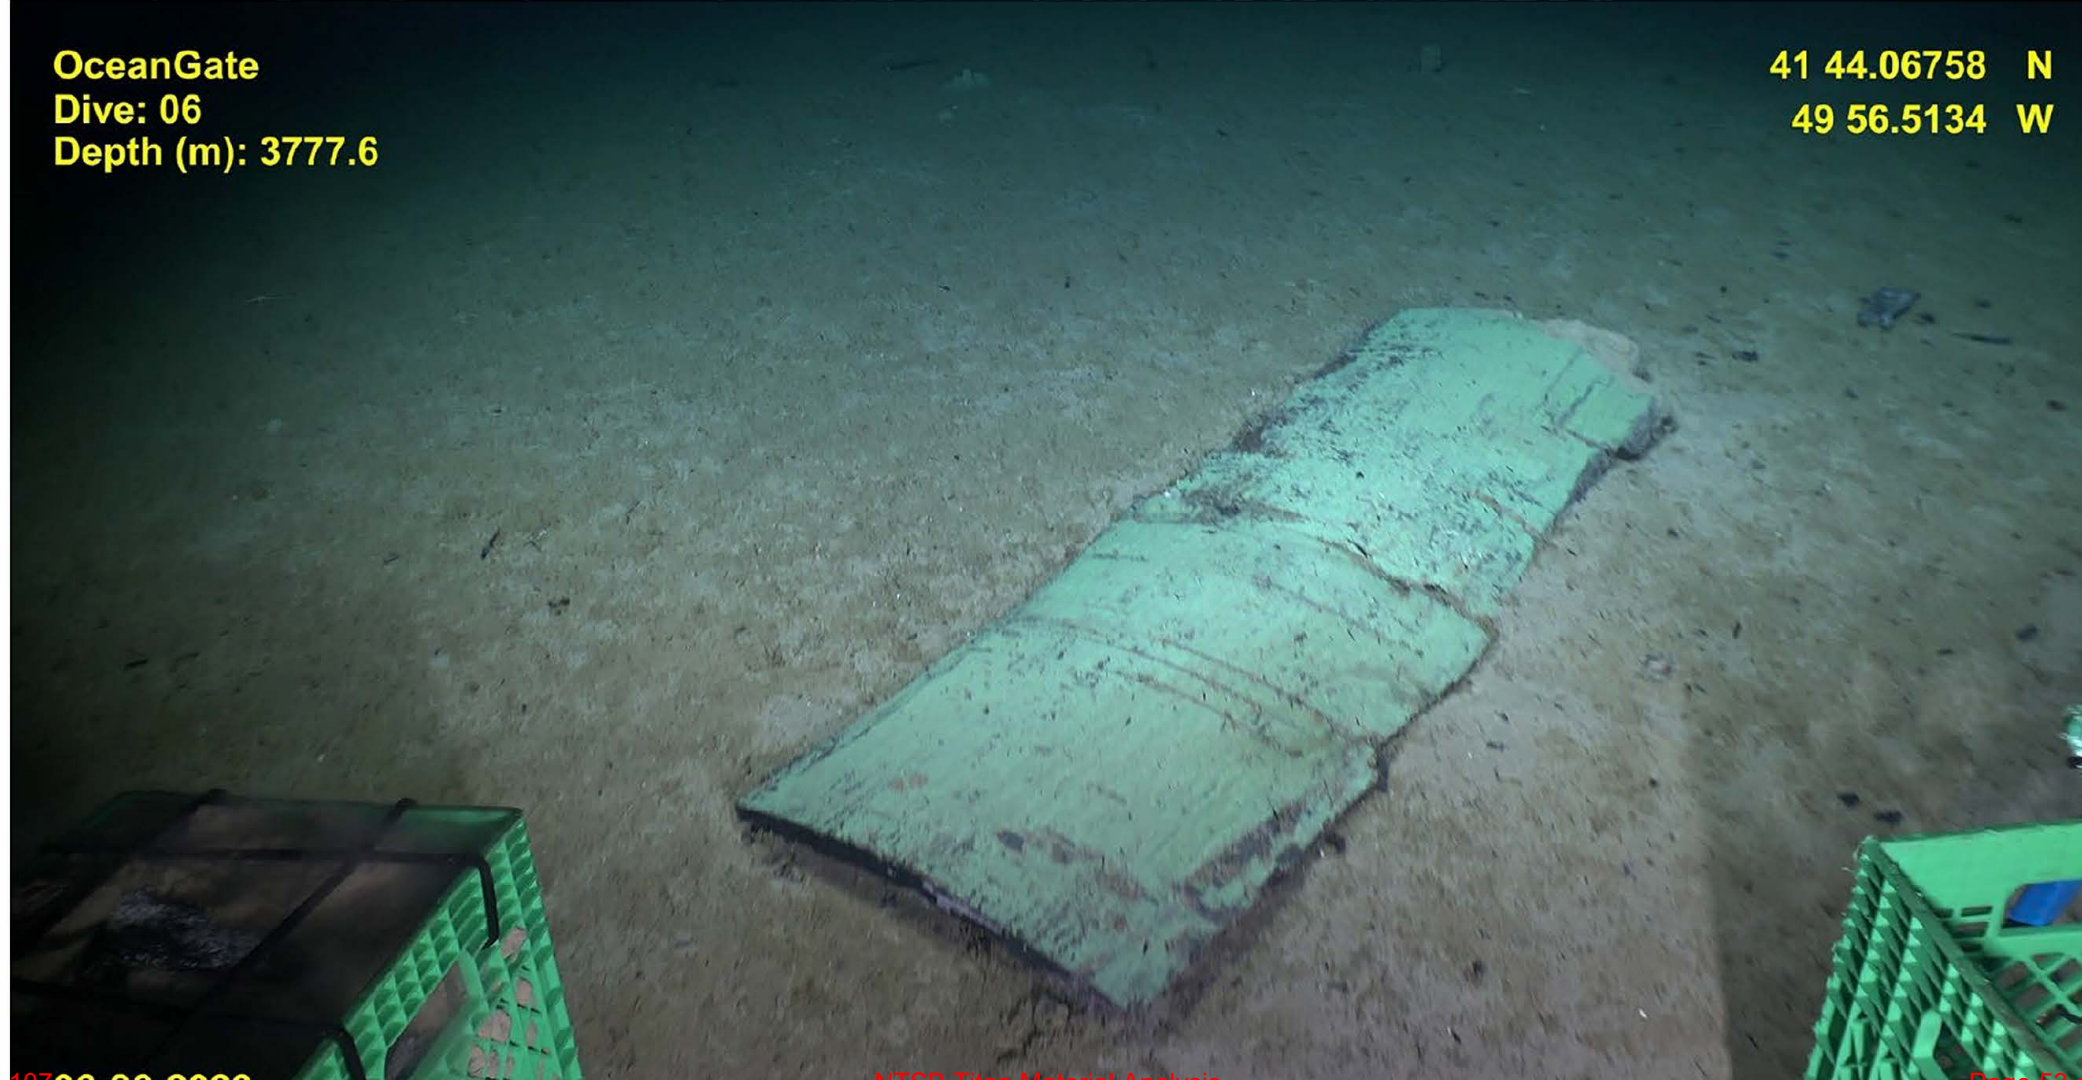
## Retrieved Single Layer 1 Piece

Rubbing features found at the layer 1/2 interface.
